RECALL CAMPAIGN BULLETIN

Classification: EL19-041c	Reference: NTB19-090c	Date: November 22, 2019
------------------------------	--------------------------	----------------------------

VOLUNTARY RECALL CAMPAIGN 2018-2019 FRONTIER; AV CONTROL UNIT (INFOTAINMENT) SOFTWARE UPDATE

CAMPAIGN ID #: R1911
NHTSA #: 19V654
APPLIED VEHICLES: 2018-2019 Frontier (D40)

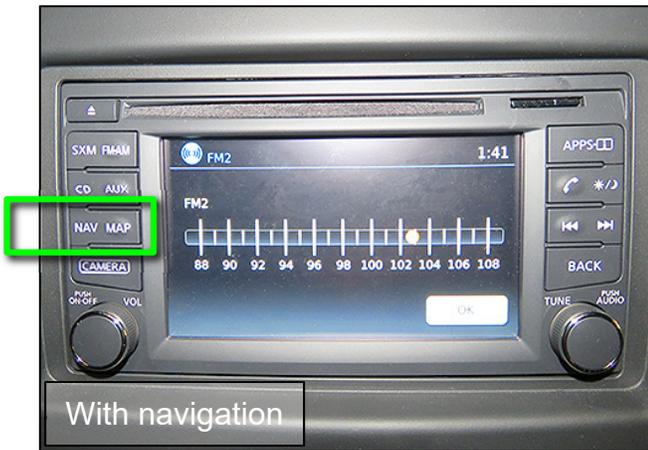
2. Confirm which audio system is present in the vehicle (see Figure 3 and Figure 4 below).
 - If the vehicle is equipped with navigation, as shown in Figure 3 below, continue to step 3.
 - If the vehicle is NOT equipped with navigation, as shown in Figure 4 below, skip to step 24 on page 11.

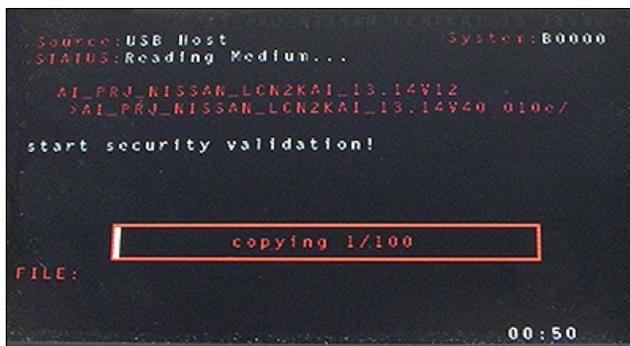
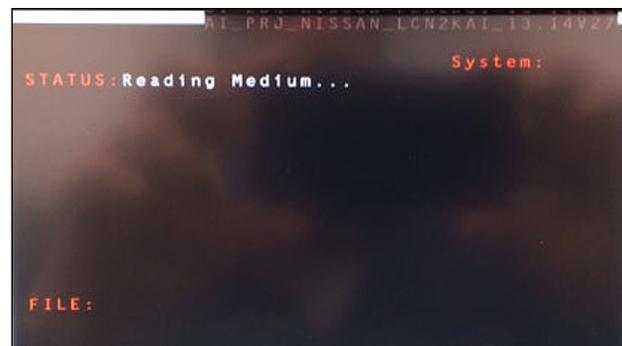
- The screen in Figure 12 will be displayed during the update.
- Figure 13 may display before the update begins. **DO NOT** remove the USB drive during the update.

16. Wait until the update is complete (this can take up to 60 minutes).

IMPORTANT: If directed to skip to step 16 due to screen message “**Insert update Media**”, it may take 3-5 minutes before the USB drive is recognized and for the update to begin.

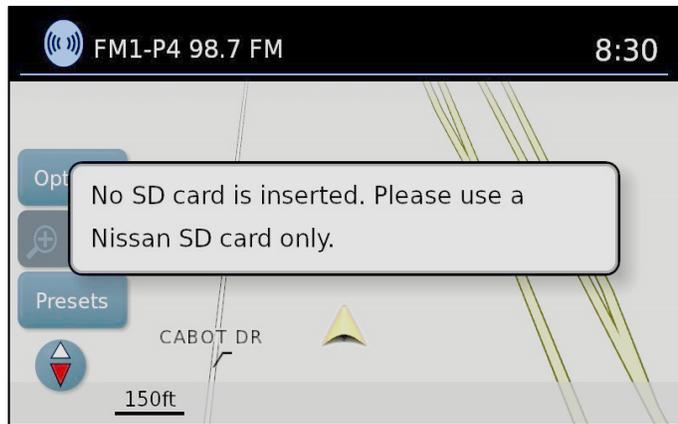
Figure 15

- If the message “No SD card is inserted. Please use a Nissan SD card only” is displayed (Figure 15), proceed to step 18 on page 9.

18. Remove and reinsert the map SD card from the card slot.
- After the map SD card is reinserted, the **APPLICATION** screen will display (Figure 17).

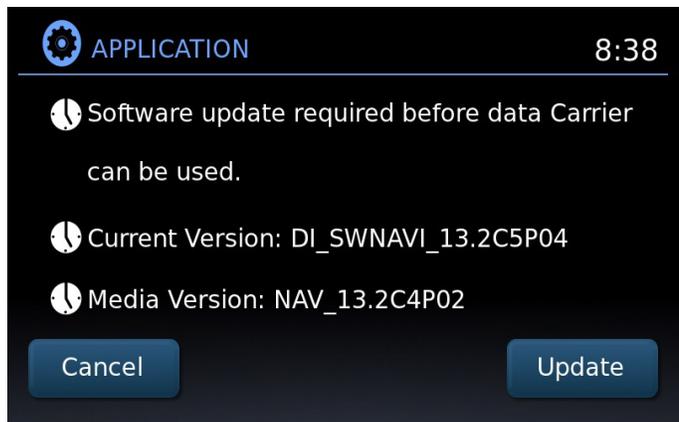
Figure 16

- If the **APPLICATION** screen is displayed (Figure 16), proceed to step 19 on page 9.

19. Select **Update**.

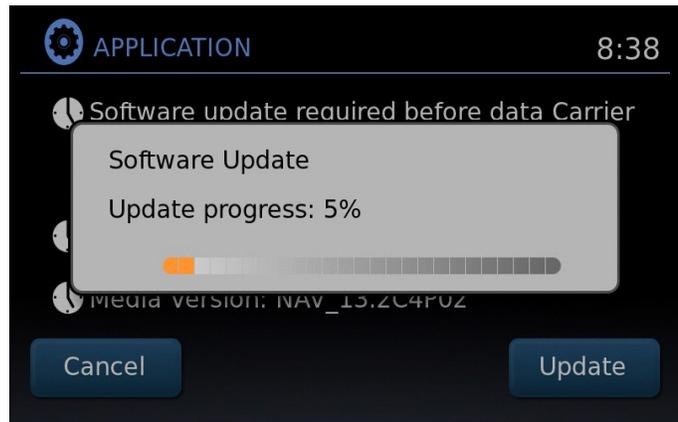
- The update will take about 1 minute to complete, and the screen in Figure 18 will display.

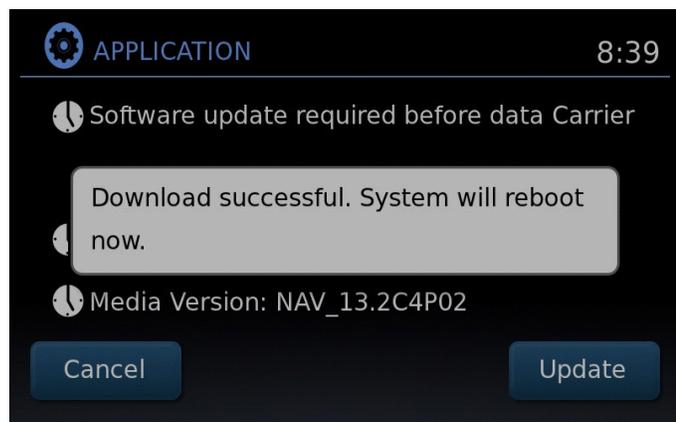
Figure 19

- The message "Download successful. System will reboot now" will display and the audio unit will reboot (Figure 19).
- After the system reboots, the update is complete.

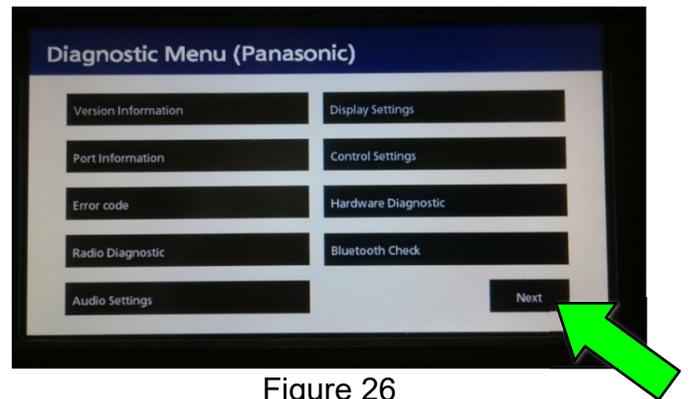
HINT: A screen similar to the one in Figure 26 will appear.

d. Select **Next** at the bottom right side of the screen.
