RECALL CAMPAIGN BULLETIN

VOLUNTARY RECALL CAMPAIGN 2018-2019 PATHFINDER; DISPLAY CONTROL UNIT (INFOTAINMENT) SOFTWARE UPDATE

CAMPAIGN ID #: R1911
NHTSA #: 19V654
APPLIED VEHICLE: 2018-2019 Pathfinder (R52)

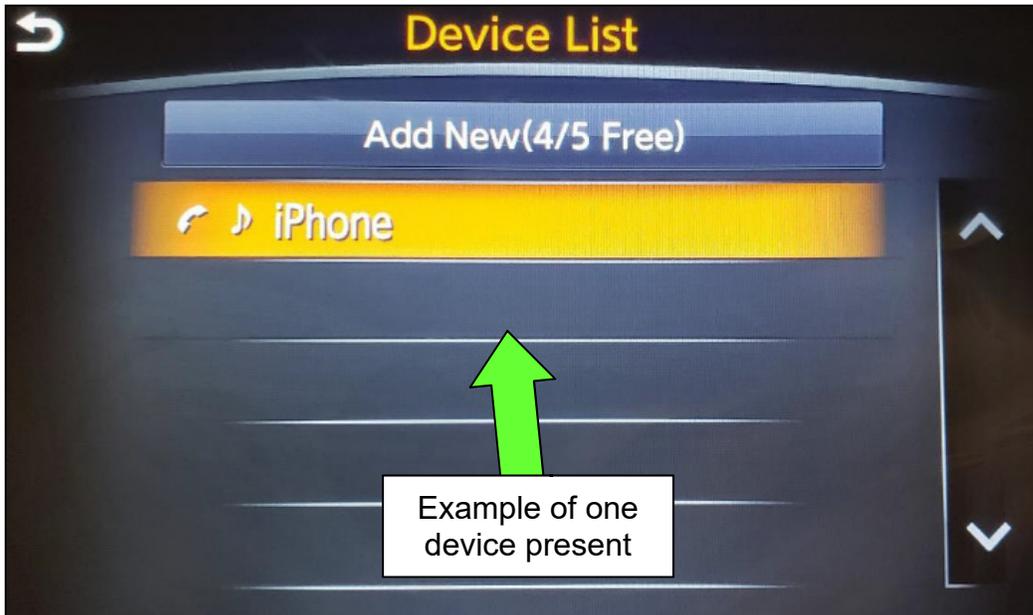
Figure 8

- **YES**, there are more listed devices: Perform steps 4 and 5 until all listed devices are deleted.
- **NO**, there are no listed devices: Proceed to step 7.

IMPORTANT: All paired (listed) devices must be deleted before proceeding to step 7.
