RECALL CAMPAIGN BULLETIN

Classification: AN19-031a	Reference: NTB19-088a	Date: February 9, 2021
------------------------------	--------------------------	---------------------------

VOLUNTARY RECALL CAMPAIGN 2018-2019 ROGUE SPORT; AV CONTROL UNIT (INFOTAINMENT) SOFTWARE UPDATE

CAMPAIGN ID #: R1911
NHTSA #: 19V-654
APPLIED VEHICLES: 2018-2019 Rogue Sport (J11)

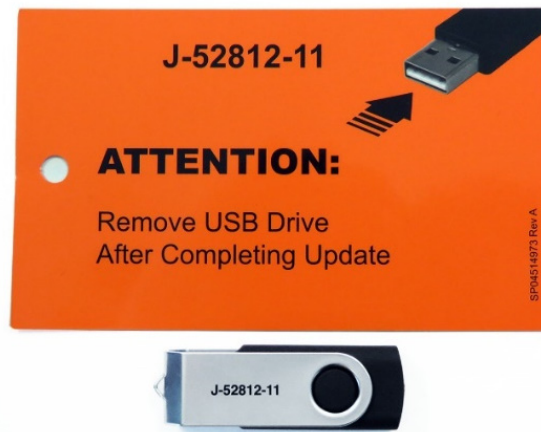
Figure 1

- Confirm “**J**” is the letter displayed in the 10th position of the VIN
- Proceed to **Update AV Control Unit – 2018 Rogue Sport (USB drive J-52812-11)** on page 4
