# RECALL CAMPAIGN BULLETIN

Classification: EL19-030	Reference: NTB19-078	Date: October 14, 2019
-----------------------------	-------------------------	---------------------------

## VOLUNTARY RECALL CAMPAIGN 2018-2019 ROGUE AND ROGUE HYBRID; AV CONTROL UNIT (INFOTAINMENT) SOFTWARE UPDATE

**CAMPAIGN ID #:** R1911  
**NHTSA #:** 19V-654  
**APPLIED VEHICLES:** 2018-2019 Rogue (T32)  
2018-2019 Rogue Hybrid (T32H)

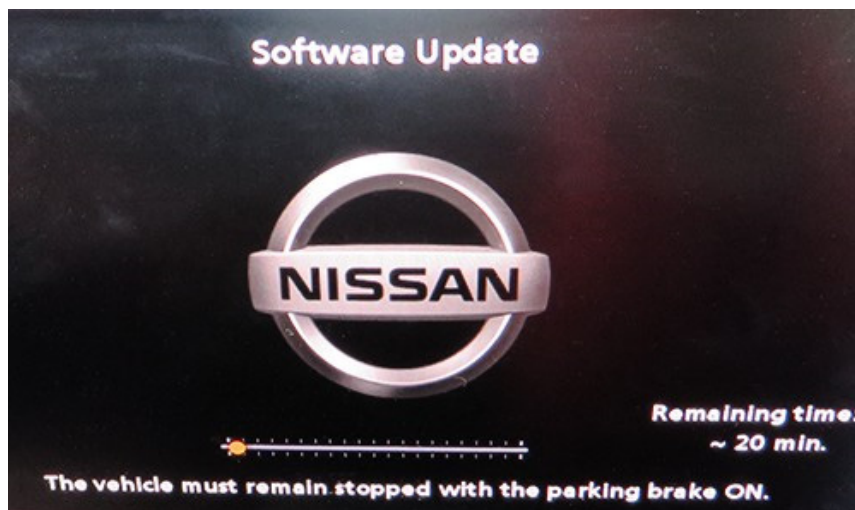
Figure 6

7. Wait for the software update to complete.
  - Follow the on-screen instructions while waiting.

**HINT:** The software update will take 15-25 minutes.

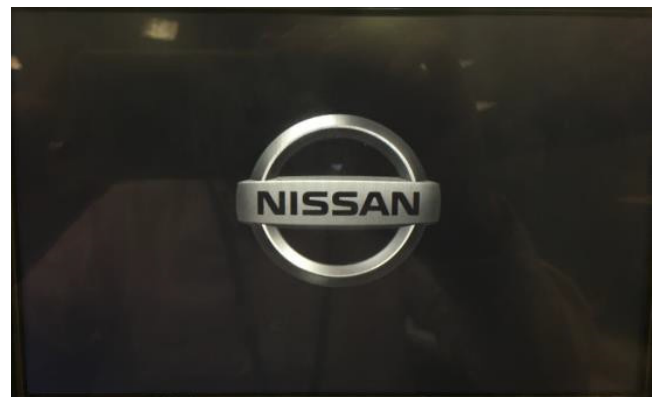
Figure 8

9. Allow the reboot to complete (approximately 30 seconds).
  - The Nissan logo will be displayed during the reboot.
10. Turn the ignition OFF.
