SIB 65 20 19

## RECALL CAMPAIGN 19V-698: DRIVER'S FRONT AIR BAG MODULE – PRIOR PARTS REPLACEMENT

This Service Information Bulletin (Revision 4) replaces SI B65 20 19 **dated February 2022**.

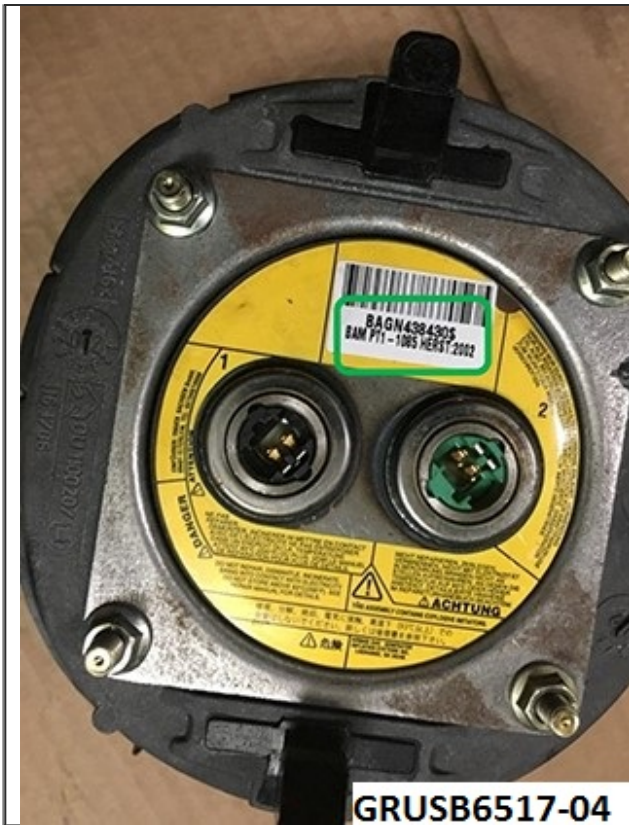
2. Check the label on the back of the driver's air bag.

Is the label yellow with a white number sticker with printed serial number **BAM PT1-1085** (as shown on left) printed below the bar code?

Air bags from other manufacturers (non-Takata), or Takata air bags with different chemical compositions (white label) are not affected by this recall and **DO NOT** need to be replaced.

**YES**- replace air bag
