Subject: BMW Recall 19V-698 : Driver's Front Air Bag Module – Prior Parts Replacement

SIB 65 20 19

RECALL CAMPAIGN 19V-698: DRIVER'S FRONT AIR BAG MODULE – PRIOR PARTS REPLACEMENT

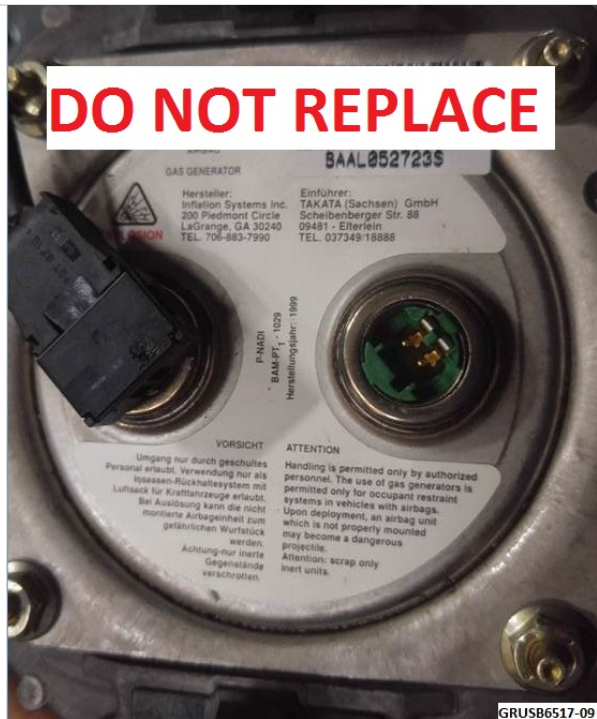
Note:

Air bags from other manufacturers (non-Takata), or Takata air bags with different chemical compositions (white label) are not affected by this recall and DO NOT need to be replaced.
