**SIB 65 20 19**

2022-02-04

**RECALL CAMPAIGN 19V-698: DRIVER'S FRONT AIR BAG MODULE – PRIOR PARTS REPLACEMENT**This Service Information Bulletin (Revision 2) replaces SI B65 20 19 **dated March 2020**.**What's New** (Specific text highlighted):

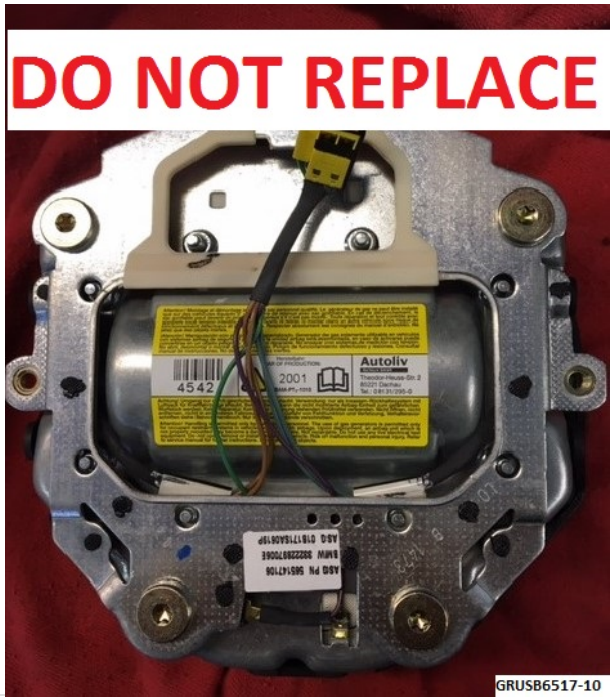
GRUSB6517-10

**Note:**  
Air bags from other manufacturers (non-Takata), or Takata air bags with different chemical compositions (white label) are not

affected by this recall and **DO NOT** need to be replaced.

Parts returned to warranty for this recall that are not manufactured by 'Takata', and don't have the **YELLOW label** as noted above will be debited. **WHITE label** Takata gas generators contain a different chemical composition and are NOT part of this recall

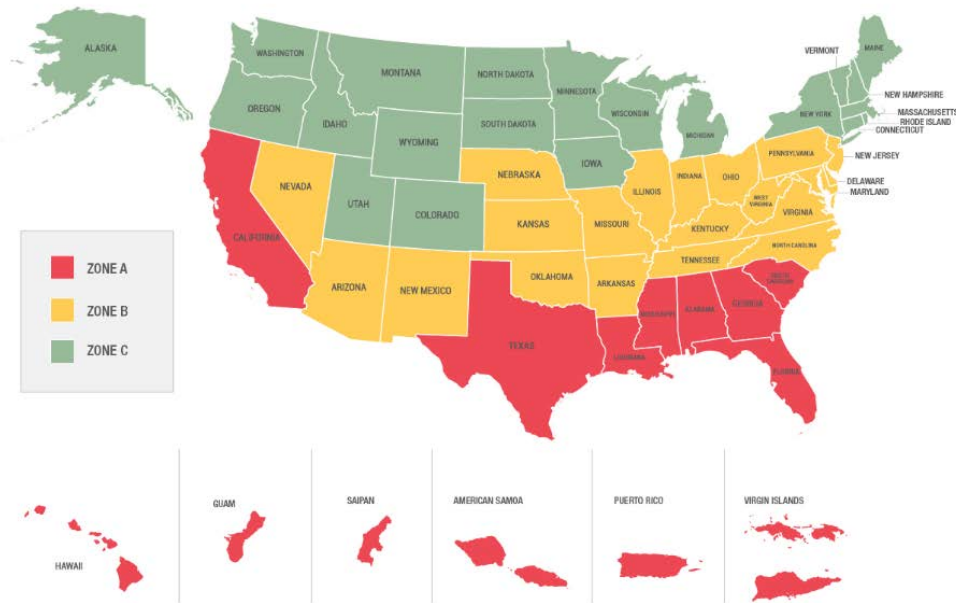
Per the NHTSA, geographic zones have been established based on the temperature fluctuations and humidity and the exposure time required under those environmental conditions to degrade the propellant to the point where it poses an unreasonable risk to safety. High Absolute Humidity (“HAH”) definitions are as follows:

<b>“HAH” or “A”</b>	Time until unsafe propellant degradation is projected between 6-9 years.
<b>“Non-HAH” or “Non-A”</b>	Covers vehicles that have not been identified by the vehicle manufacturer as having been originally sold or ever registered in the HAH region. <b>This includes Zones B and C.</b>
<b>“B”</b>	Time until unsafe propellant degradation is projected between 10-15 years.
<b>“C”</b>	Time until unsafe propellant degradation is projected between 15-20 years.
