SIB 65 20 19

RECALL CAMPAIGN 19V-698: DRIVER'S FRONT AIR BAG MODULE – PRIOR PARTS REPLACEMENT

This Service Information Bulletin (Revision 5) replaces SI B65 20 19 **dated March 2023**.

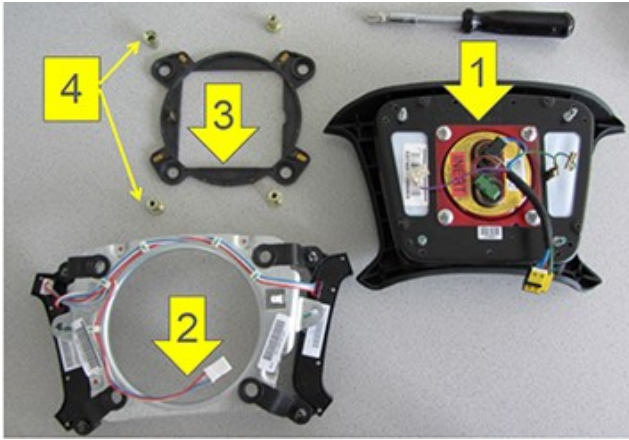
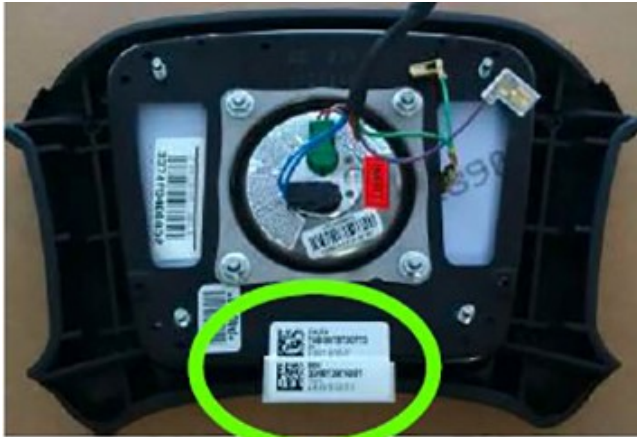
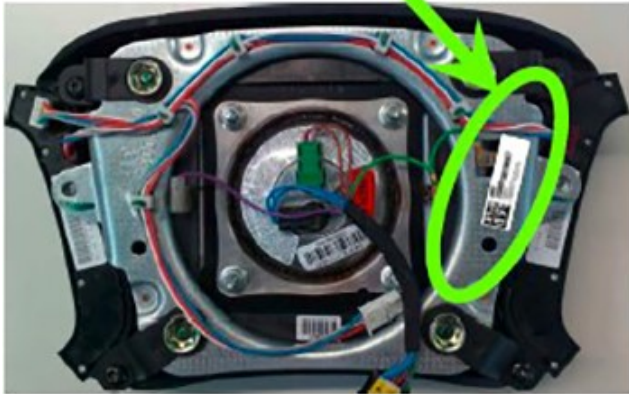
On vehicles with a basic steering wheel, the horn ring must be remounted to the new part.

Have the new airbag module ready and remove one of the two stickers with the barcode and the serial number of the airbag module.

This must be glued on the horn ring after assembly.
