SIB 65 24 19

RECALL 19V-852: DRIVER'S FRONT AIR BAG (NADI) INFLATOR

This Service Information Bulletin (Revision 2) replaces SI B65 24 19 dated December 4, 2019.

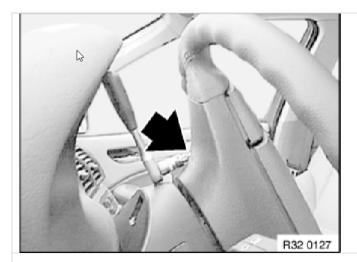
The serial number on the installed air bag must be compared to the serial number list in the procedure section to determine if it needs to be replaced.

The following check can be performed at the customer's location:

Follow all safety precautions when handling air bags.

Remove Basic Drivers air bag as per
