Field campaign

Topic	Power Assisted Steering - Pipe Union - Incorrect Dimensions (RE19/27)
Market area	Bentley: worldwide (2WBE),Hongkong-Macau (5HK)
Brand	Bentley
Transaction No.	2057135/1
Campaign number	RB41
Note	
Type	Recall Campaign
US code

Supersport - Supersport Convertible - Continental 24

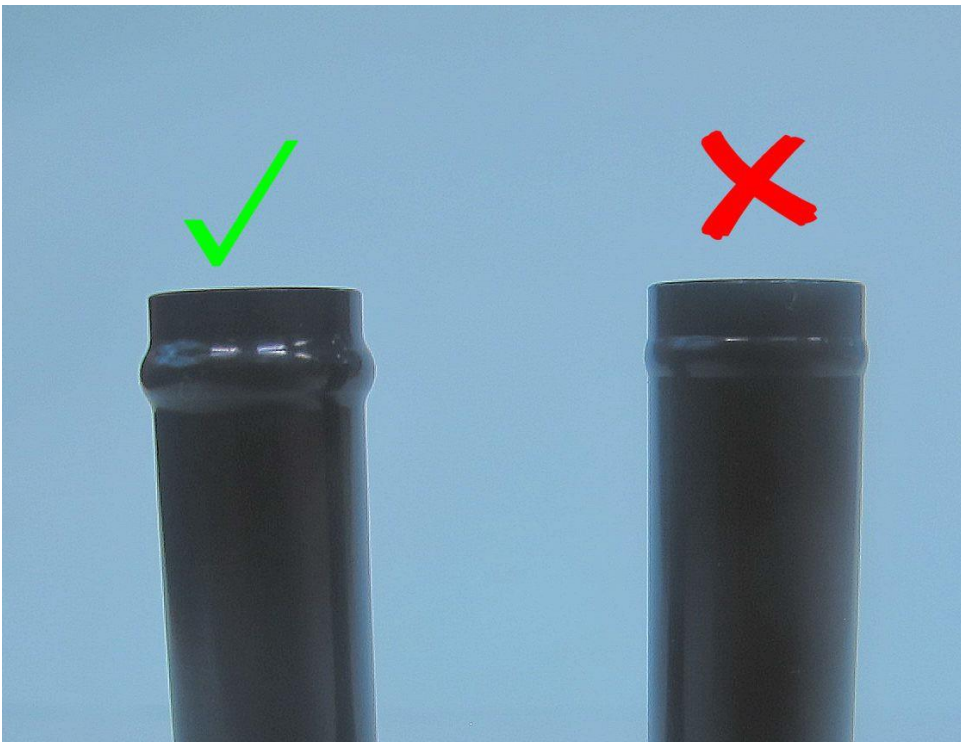
Two Power Assisted Steering (PAS) cooler stub pipes have been manufactured incorrectly. The fitting shape and dimension may not provide a robust mechanical seal, the associated hoses could therefore leak PAS fluid.

Should the PAS hose detach, the vehicle will lose the hydraulic steering fluid, which could result in the loss of steering control. The hydraulic steering fluid leak increases the risk of a vehicle fire and of an accident to following traffic. No customer accidents have been reported relating to this issue.

PAS cooler stub pipes with correct fitting shape and dimensions to be installed.

Bentley authorised retailers will replace the incorrect stub pipes with dimensionally correct parts. This will take approximately one hour.
