# Product Safety Recall

## N192273510 Loose Alternator Cable

**Release Date:** December 2019

| <b>Condition</b> | General Motors has decided that a defect which relates to motor vehicle safety exists in certain 2019 – 2020 model-year Chevrolet Silverado 1500 and GMC Sierra 1500 vehicles. The B+ battery cable rings in these vehicles may have been contaminated with glue residue at the supplier. During normal vehicle operation, the glue may soften and cause the nut that attaches the B+ battery cable to the alternator to loosen over time, which could lead to an intermittent electrical connection or arcing. During the supplier’s assembly process, excess glue may not have been completely removed from the B+ battery cable rings, resulting in glue contamination that could affect the joint connection between the cable ring and the alternator. An intermittent electrical connection between the B+ battery cable and the alternator could cause the vehicle to stall. The intermittent connection could also lead to arcing, which could generate sufficient heat to damage surrounding material and increase the risk of a fire. |

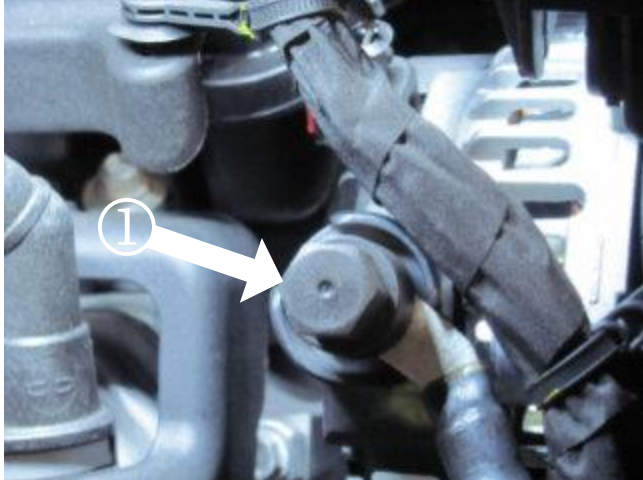
5459036

4. Inspect the cable terminal (1), cable terminal on the generator (2) and attachment nut for any signs of heat damage.
  - If **NO HEAT DAMAGE** is found, proceed to step # 5.
  - If **ANY HEAT DAMAGE IS INDICATED, STOP THE REPAIR**, properly reassemble nut at the generator (Important: use caution when reassembling so that damage to nut does not occur). Service parts are currently NOT available. This vehicle must be held and not delivered to customers, dealer-traded, released to auction, used for demonstration purposes or any other dealer use until further instructions are received.

**Important: A small amount of glue is expected to be present around the shrink sleeve. The inspection procedure is for glue contamination on the cable terminal where it mounts to the terminal on the generator. This contamination prevents the fastener from tightening as designed and may loosen with heat and vibration.**

**Important: Use caution when dis-assembling so that damage to nut does not occur.**

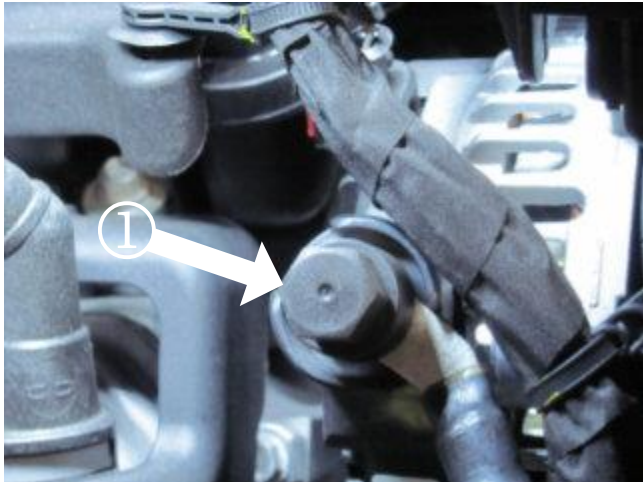
5459036

6. Inspect the cable terminal (1), cable terminal on the generator (2) and attachment nut for any signs of heat damage.
  - If **NO HEAT DAMAGE** is found, proceed to step # 7.
  - If **ANY HEAT DAMAGE IS INDICATED, STOP THE REPAIR**, properly reassemble nut at the generator (Important: use caution when reassembling so that damage to nut does not occur). Service parts are currently NOT available. This vehicle must be held and not delivered to customers, dealer-traded, released to auction, used for demonstration purposes or any other dealer use until further instructions are received.

**Important: A small amount of glue is expected to be present around the shrink sleeve. The inspection procedure is for glue contamination on the cable terminal where it mounts to the terminal on the generator. This contamination prevents the fastener from tightening as designed and may loosen with heat and vibration.**

**Important: Use caution when dis-assembling so that damage to nut does not occur.**
