Subject: **3 New Takata Recalls (Effective Today, January 16, 2020)**

RECALL CAMPAIGN 20V-016: REPLACE PASSENGER'S FRONT AIR BAG MODULE

RE: Recall 20V-016: Replace Passenger's Front Air Bag Module – B65 02 20

**Passenger Front Air Bag Module
Safety Recall 20V-016
BMW X5 and X6
Model Year 2007-2012
Initial: 1/14/2020**

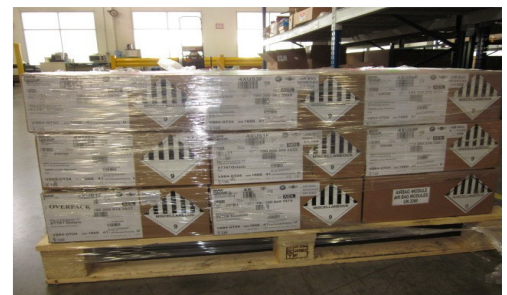
Place the recall airbag components neatly on a pallet, and securely shrink-wrap them to the pallet.

Note: The total height of the pallet and boxes cannot exceed 60 inches.

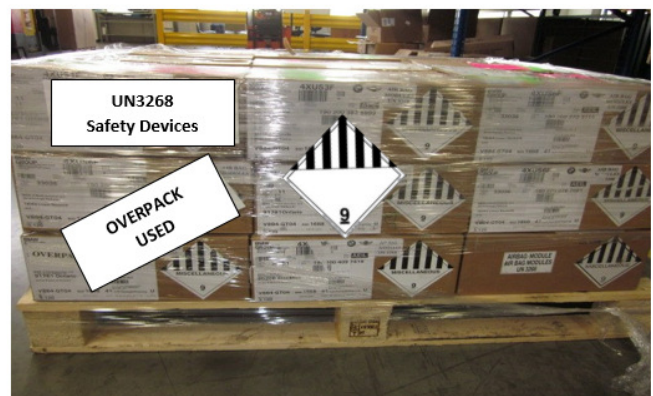
Securely attach the following labels on each side of the shrink-wrapped pallet.

- o Class 9 Label
- o UN3268 Safety Device *
- o OVERPACK USED *
