SAFETY RECALL BULLETIN

SUBJECT: DRIVER SIDE TAKATA NADI INFLATOR – SAFETY RECALL CAMPAIGN		No: SR-20-001	
		DATE: February 2021	
		MODEL: 1998-2000 Montero	
CIRCULATE TO:	<input checked="" type="checkbox"/> GENERAL MANAGER	<input checked="" type="checkbox"/> PARTS MANAGER	<input checked="" type="checkbox"/> TECHNICIAN
<input checked="" type="checkbox"/> SERVICE ADVISOR	<input checked="" type="checkbox"/> SERVICE MANAGER	<input checked="" type="checkbox"/> WARRANTY PROCESSOR	<input checked="" type="checkbox"/> SALES MANAGER

This campaign bulletin instructs dealers to replace the Takata Non-Azide Driver air bag Inflator (NADI) with the countermeasure part.

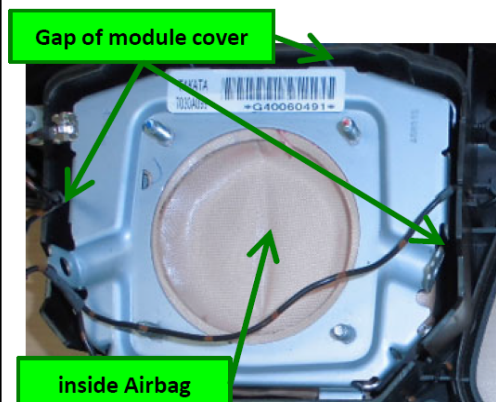
2. Remove the inflator.

- Do not drop the removed nuts into the air bag or into the gap of the module cover.
If dropped , remove them securely.
- Check that there are 4 nuts after the completion of work.
- Do not reuse nuts.

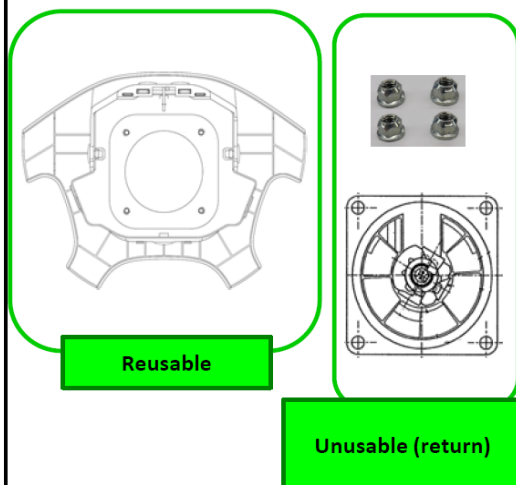
1. Check all removed parts are available (not scrapped)

2. Old inflator, 4 nuts and cut squib harness (instructed in next page)

All of these parts must be returned within the same box the new inflator kit were contained

- Place the old inflator and removed parts in the same replacement kit packaging.
- Do not mix up with other inflator packaging.

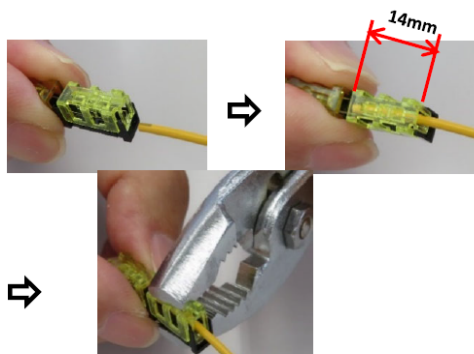
(4) Remove the junction connectors from the replacement kit and install them to the harness. (both 2 pcs)

- Without removing harness cover, insert harness from the hole of the junction connector until hitting to end of connector. (this position is approx. 14mm)
- Pinch the junction connector securely until the claw of the connector locks

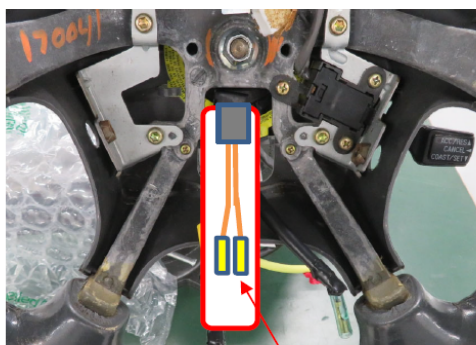
(5) Condition after attaching both connectors to the squib harnesses shown as left figure.

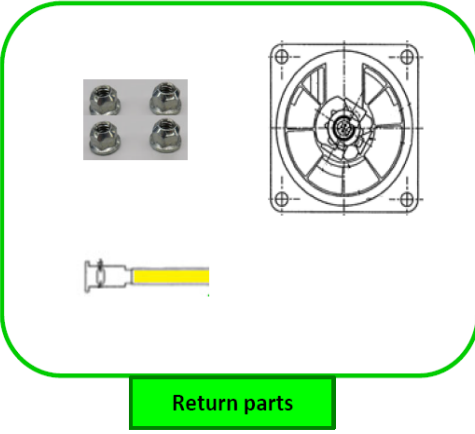
<p>Return parts</p>	<p>1. Old inflator, 4 nuts, and cut squib harness (instructed in next page)</p> <p>All of these parts must be returned within the same box the new inflator kit were contained</p> <p>Caution:</p> <ul style="list-style-type: none"> - Ensure the 4 nuts are the old parts removed. - Return the old inflator in the same replacement kit box - Do not mix up with other inflator packaging.
