Bentley Bulletin

20-059

Subject: Safety Recall – Fuel Line Quick Connector (RE20/14)

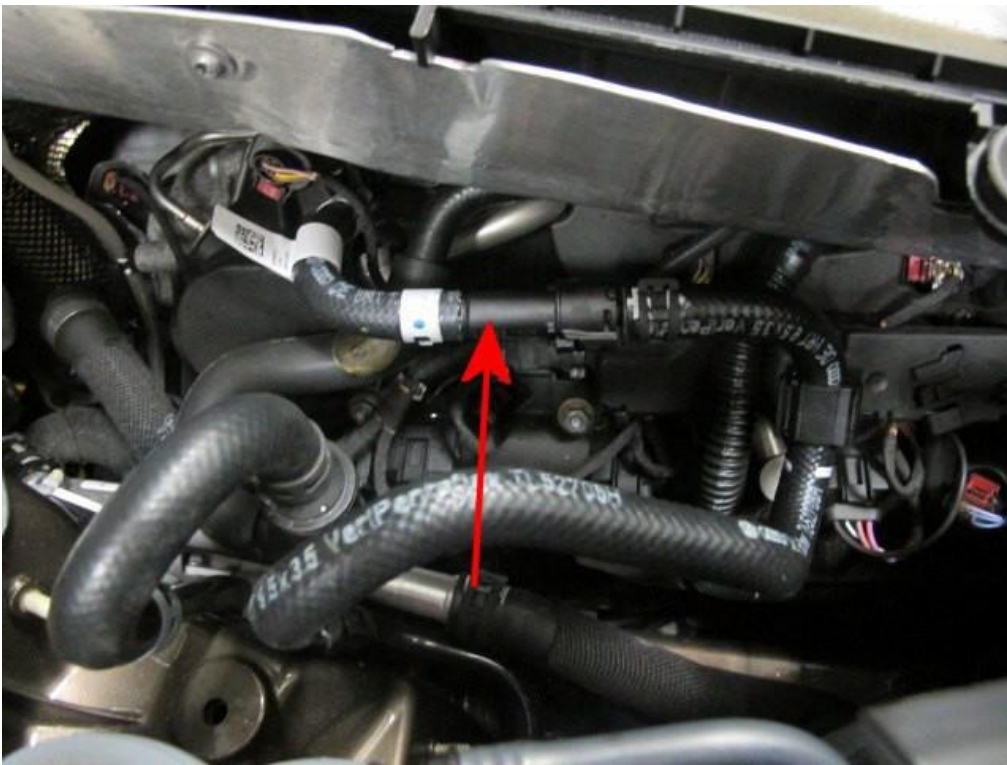
- Referring to Figure 1 - Identify the fuel feed hose which is located at the rear of Bank 1 - *The next part of the process requires the fuel hose removing*
