FL863AB

Creation Date:	June 2022
Revised Date:	July 2025
NHTSA #	20V-567
Transport Canada #	2020-444

Subject: Freightliner Cascadia Brake Light Illumination

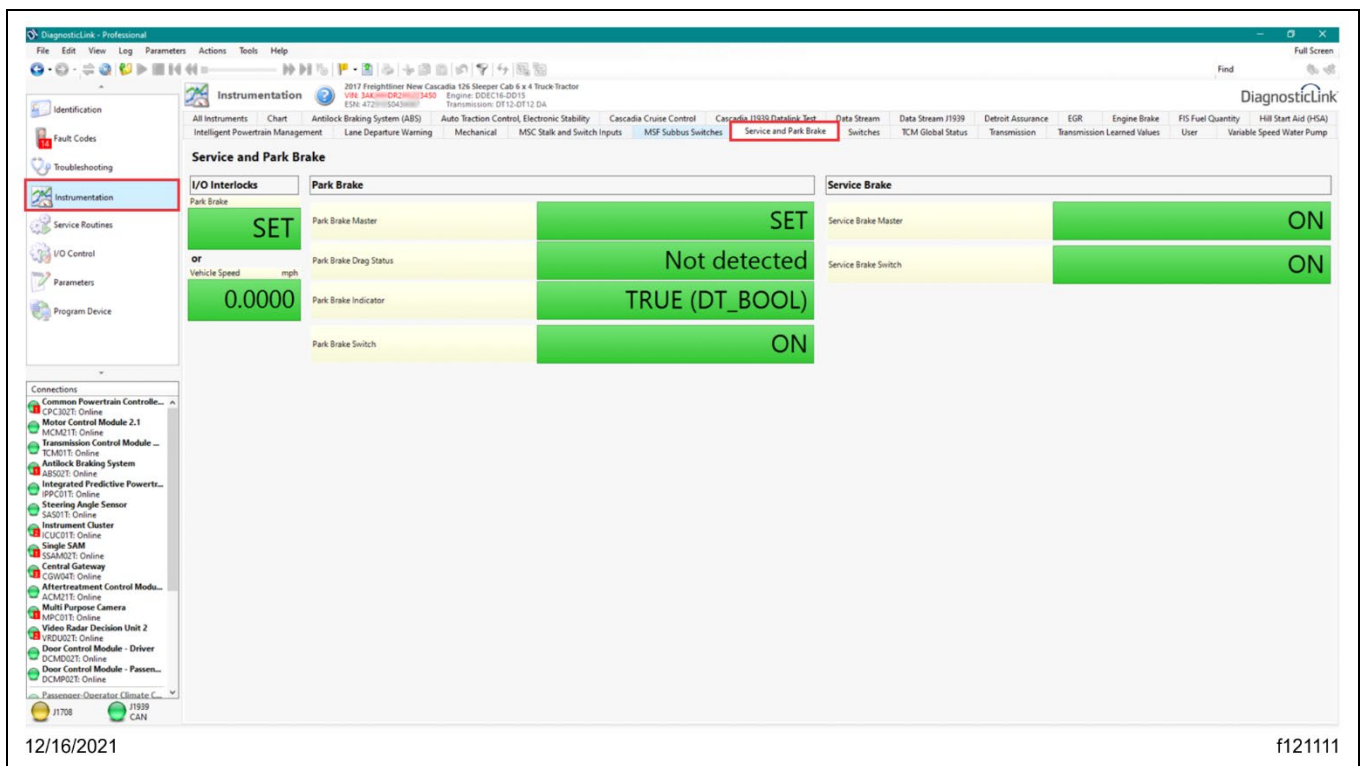
Fig. 6, Service Brake Panel Status When the Brake Pedal is Pressed

The 'Service Brake' panel status should show both 'OFF' in normal state when brakes are not applied, as shown in [Fig. 7](#), and show as 'ON' when the brake foot pedal is pressed, or if so equipped, when the trailer hand valve is pulled. See [Fig. 6](#). A slight delay between status of 'OFF' and 'ON' is normal.

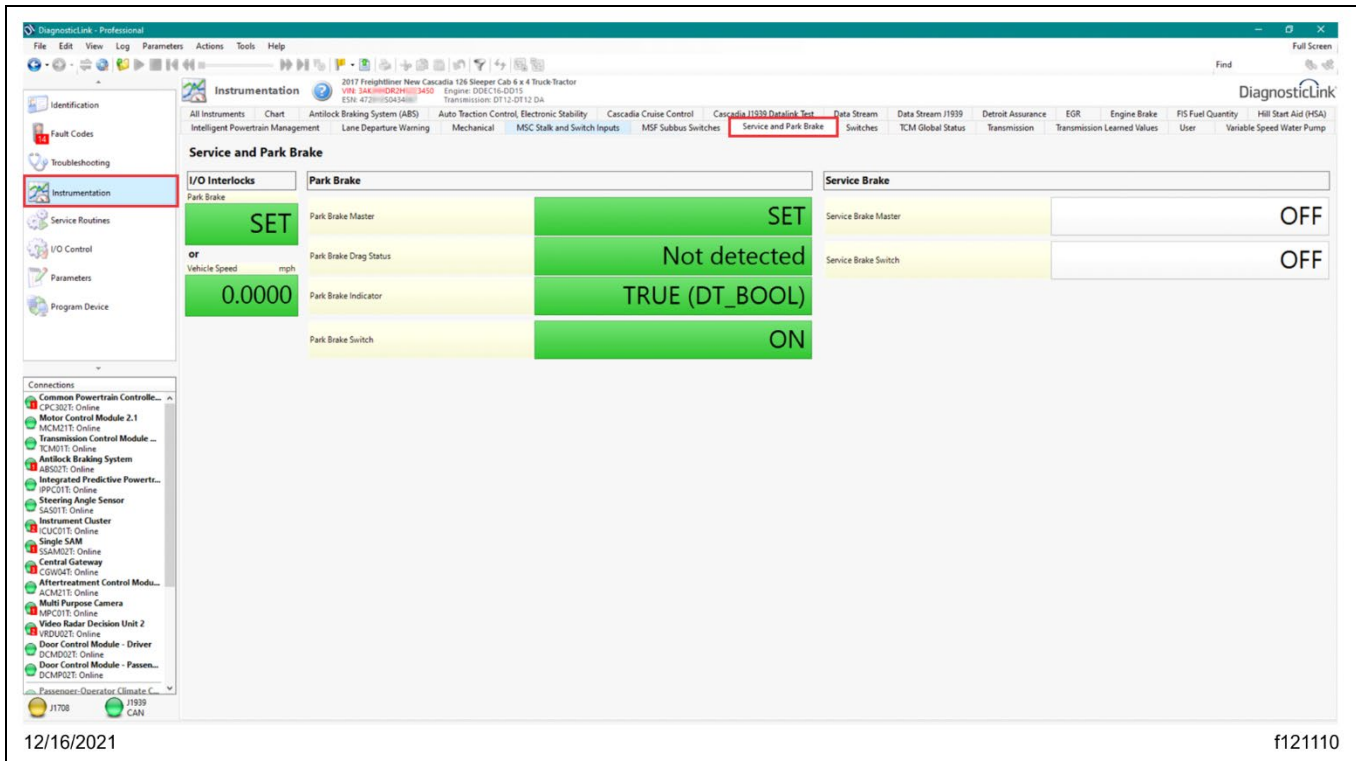
Fig. 7, Service and Park Brake Panel Status in Normal State

If the brake light function is not correct, check that jumper harness matches the acceptable variations shown in [Fig. 5](#), and is fully connected to the dash harness and to the brake pressure switch.

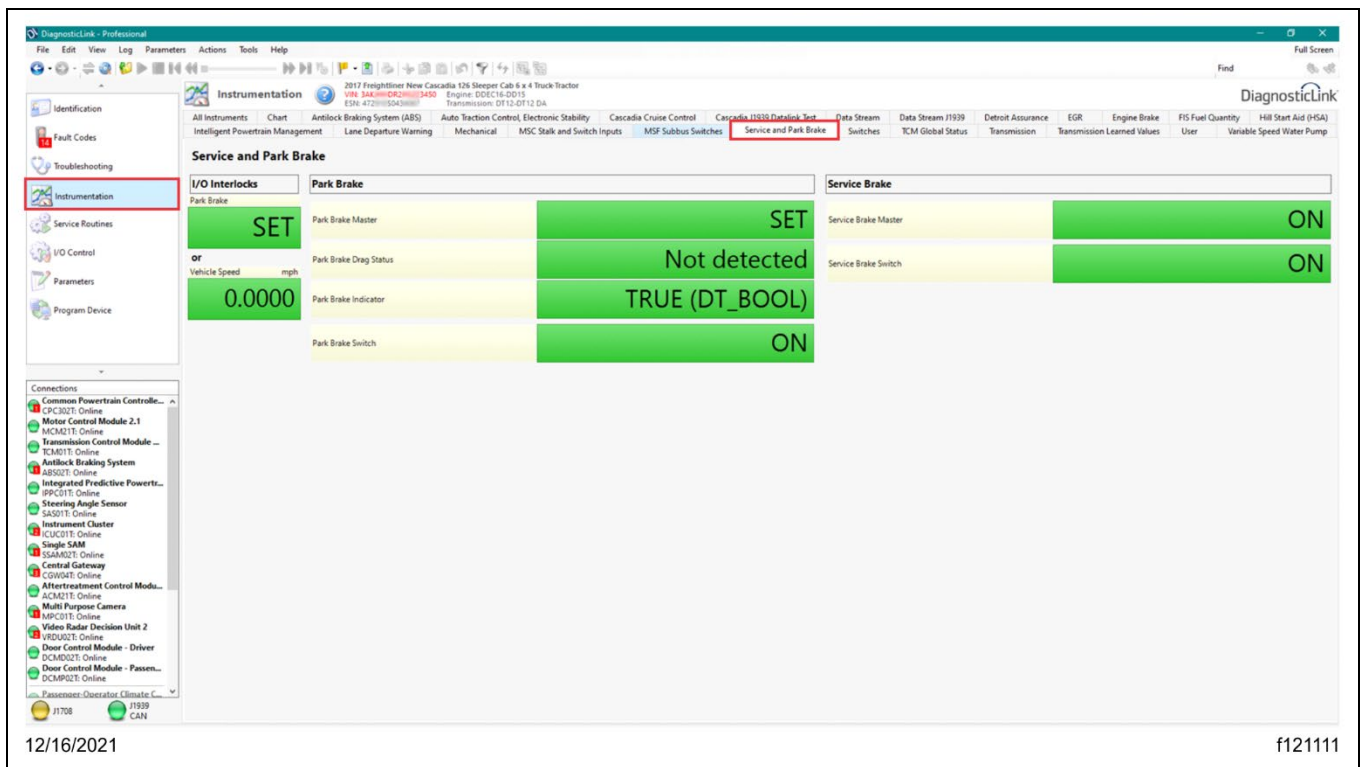
Fig. 25, Service Brake Panel Status When the Brake Pedal is Pressed

The 'Service Brake' panel status should show both 'OFF' in normal state when brakes are not applied, as shown in [Fig. 26](#), and show as 'ON' when the brake foot pedal is pressed or if so equipped, when the trailer hand valve is pulled. See [Fig. 25](#). A slight delay between status of 'OFF' and 'ON' is normal.

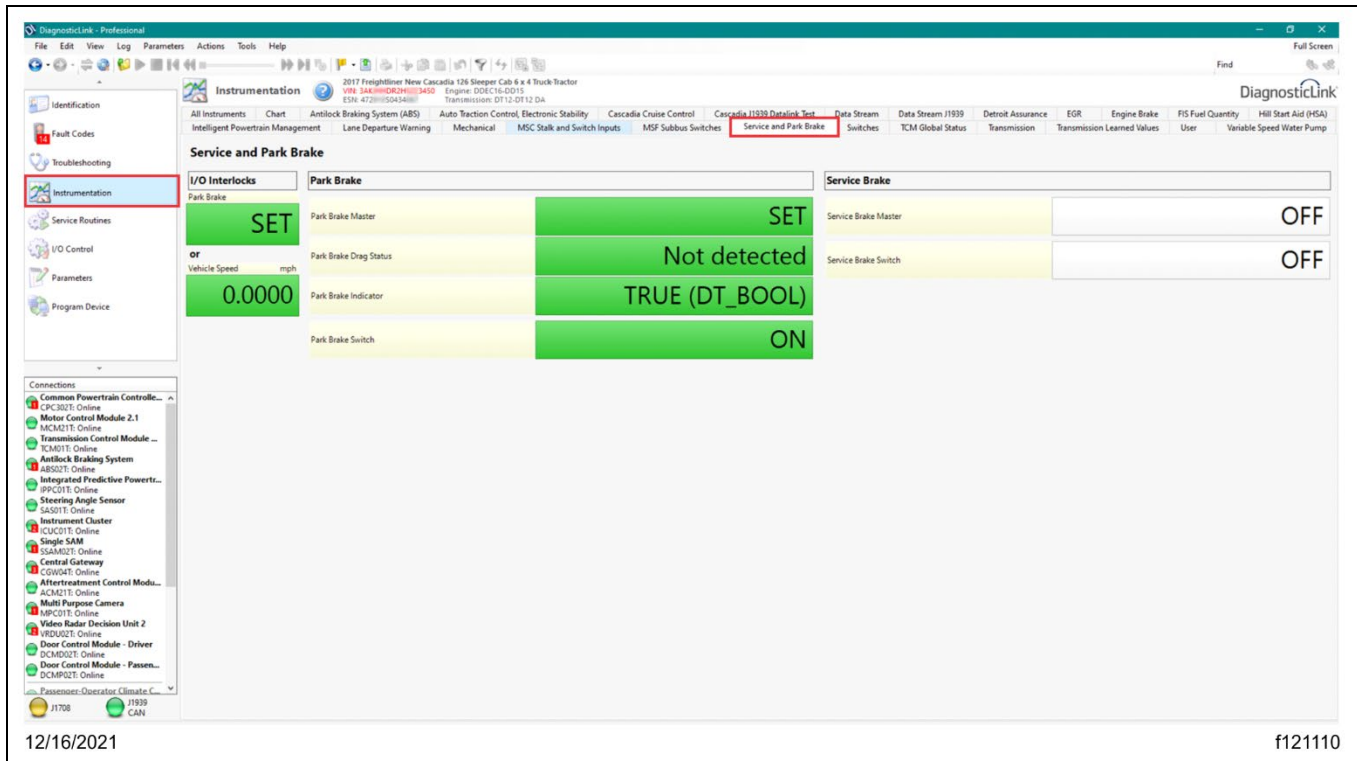
Fig. 26, Service and Park Brake Panel Status in Normal State

If the brake light function is not correct, check that jumper harness matches the acceptable variations on [Fig. 12](#) and is fully connected to dash harness and to brake pressure switch.
