PRODUCT CAMPAIGN BULLETIN

<p>APPLICABILITY: 2003-14 MY Legacy 2003-14 MY Outback 2003-06 MY Baja 2009-13 MY Forester 2004-11 MY Impreza 2004-14 MY WRX and STI</p> <p>SUBJECT: Takata Front Passenger Airbag Module / Inflator “Like for Like” Recall</p>	<p>NUMBERS: TKA-20 TKB-20 TKC-20</p> <p>DATE: 01/06/20</p> <p>NHTSA ID: 20V001 20V002 20V003</p>
---	---

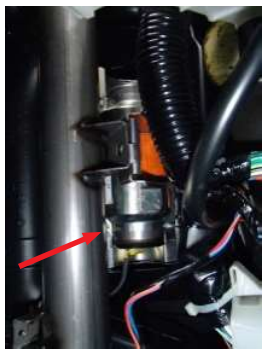
Model Years	Carline	Part Number	Type	Procedure / How to Identify	ZF TRW End Collar Color	ZF/TRW: OK - Do NOT replace the Inflator or Module Assembly. Process Claim for INSPECTION ONLY.	TAKATA: NG - Replace the Inflator or Module Assembly per the table.
2004-05MY	IMPREGA WRX	98279FE070 98279FE07A	Inflator	<ol style="list-style-type: none"> For these models, there is no need to remove any parts. Check the inflator collar from the bottom backside of the instrument panel (IP) on the passenger side. <ul style="list-style-type: none"> If the color of the collar is Pink, it is a ZF TRW inflator. If no collar is found, it is a Takata inflator. 	Pink

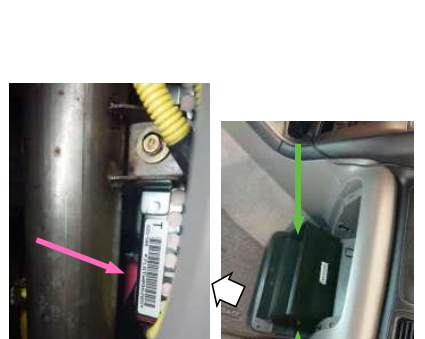
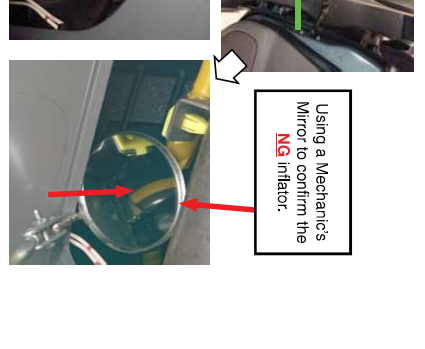
<div style="border: 1px solid black; padding: 5px; width: fit-content; margin: 5px auto;"> Using a Mechanic's Mirror to confirm the NG inflator. </div>

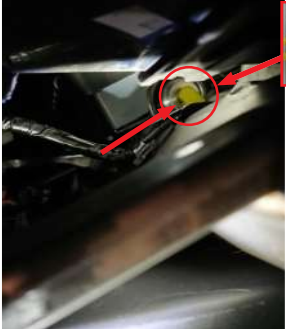
<p>Harness connector is a combination of Black and Yellow.</p>
