PRODUCT CAMPAIGN BULLETIN

<p>APPLICABILITY: 2003-14 MY Legacy 2003-14 MY Outback 2003-06 MY Baja 2009-13 MY Forester 2004-11 MY Impreza 2004-14 MY WRX and STI</p> <p>SUBJECT: Takata Front Passenger Airbag Module / Inflator “Like for Like” Recall</p>	<p>NUMBERS: TKA-20R TKB-20R TKC-20R</p> <p>DATE: 01/06/20</p> <p>REVISED: 10/30/23</p> <p>NHTSA ID: 20V001 20V002 20V003</p>
--	--

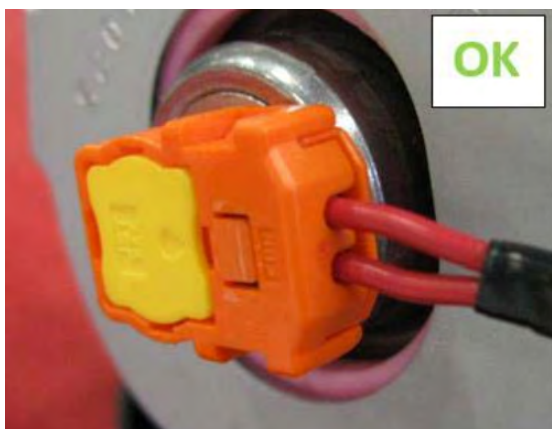
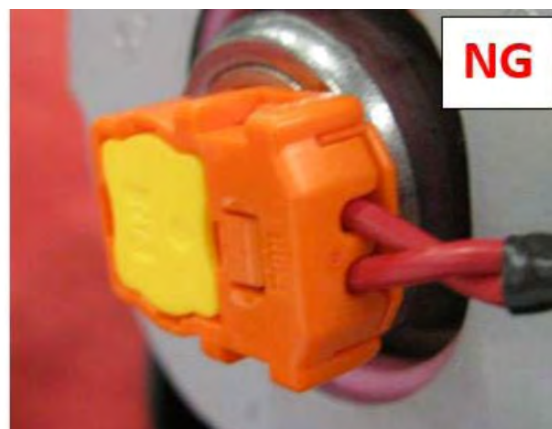
BEFORE connecting the harness to the inflator, make sure the harness is not twisted as shown below.

STEP 16- The new inflator wiring harness has 2 “sides” with 2-pin connectors on both ends. The side with the black harness tube goes with the black inflator connector and the other side (yellow harness tube) will connect to the orange connector. The end of the inflator aligned with the new Stopper Plate (A) will have a black harness connector while the connector on the opposite end of the inflator will be orange. This makes it impossible to install the harness backwards as the tangs (shown in Step 17) are also in different positions.

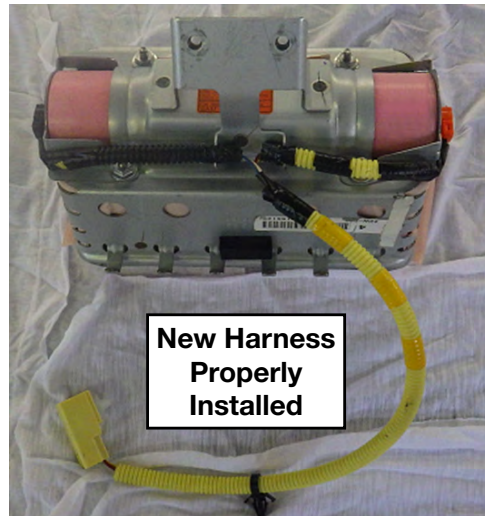
VERY IMPORTANT: After connecting the new harness to the inflator, **both sides MUST be routed as shown** in the “New Harness Properly Installed” photo below.

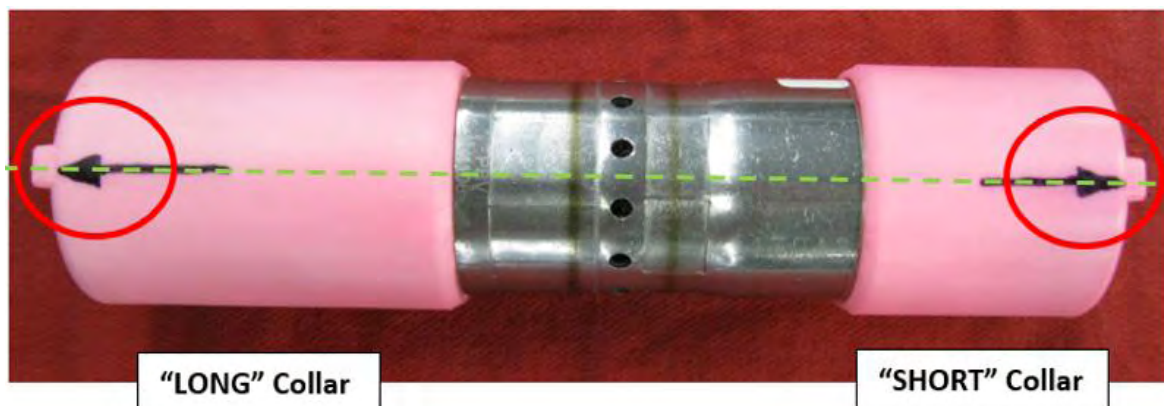
STEP 9- Inspect the new **Type 2** inflator to confirm the locating protrusions on each of the pink collar portions are aligned as shown below. The “short” collar can be rotated as needed to align it with the protrusion on the “long” collar if necessary.

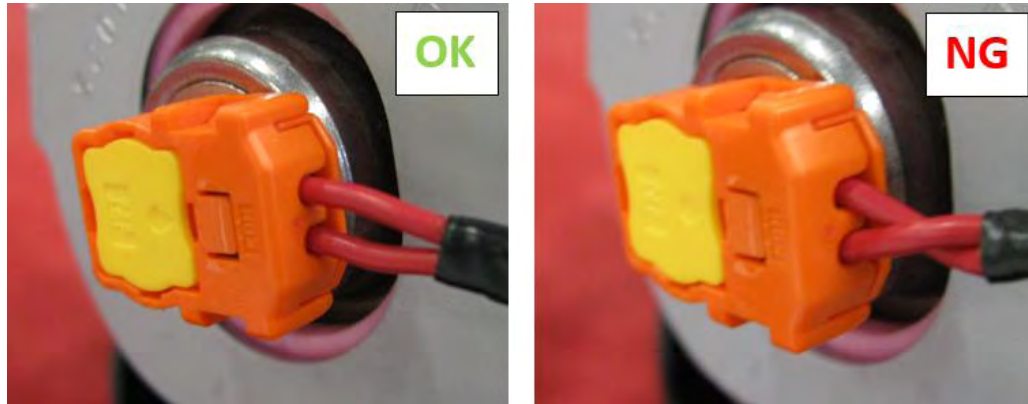
STEP 13- Reinstall the wiring harness retaining clip into its position on the mounting bracket.
IMPORTANT: Confirm the harness is not twisted at the inflator connector as shown below.

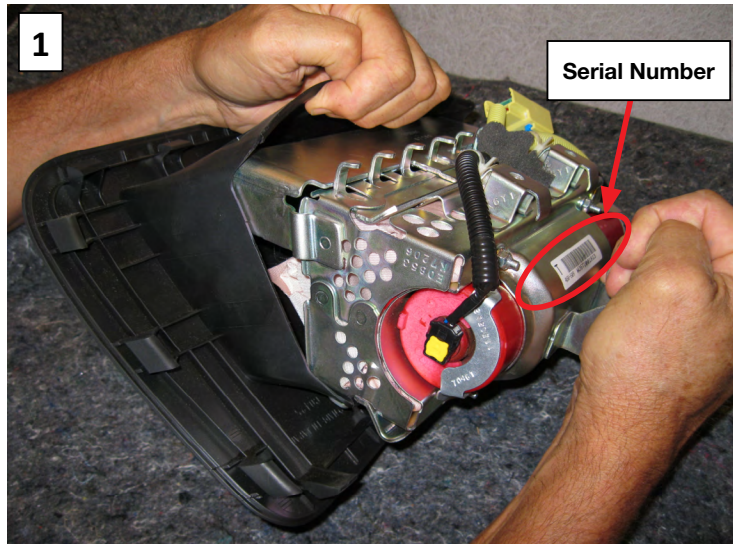
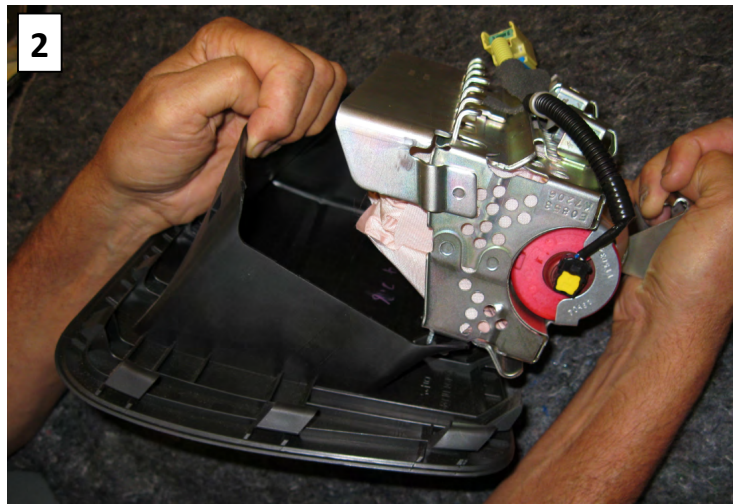
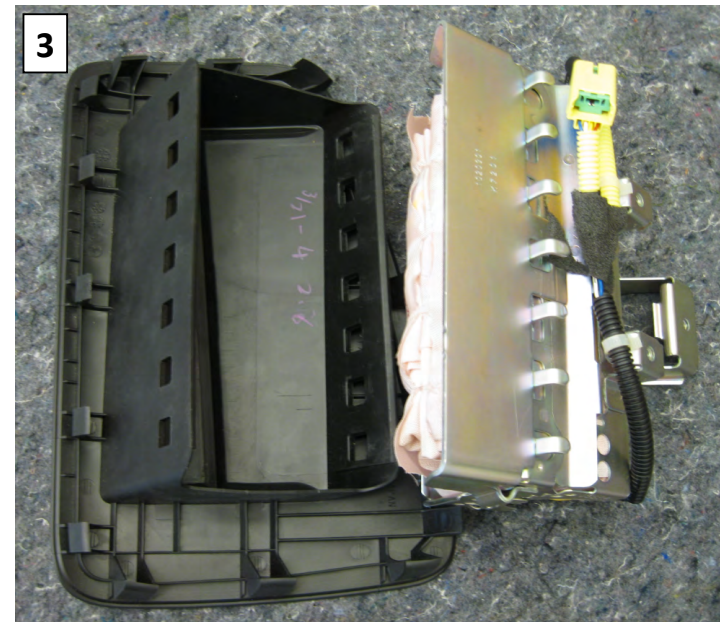
- Once all the harness-side retaining claws are released (EASILY done once the center claw is released), **CAREFULLY** separate the inflator module from the cover. After the harness-side of the module is free from the cover (2), simply rotate it to unhook the label-side retaining claws. Remove the cover completely as shown in (3) below.
