**PRODUCT CAMPAIGN BULLETIN**

**APPLICABILITY:** 2003-14 MY Legacy  
 2003-14 MY Outback  
 2003-06 MY Baja  
 2009-13 MY Forester  
 2004-11 MY Impreza  
 2004-14 MY WRX and STI

**NUMBERS:** TKA-20R  
 TKB-20R  
 TKC-20R

**SUBJECT:** Takata Front Passenger Airbag Module / Inflator “Like for Like” Recall

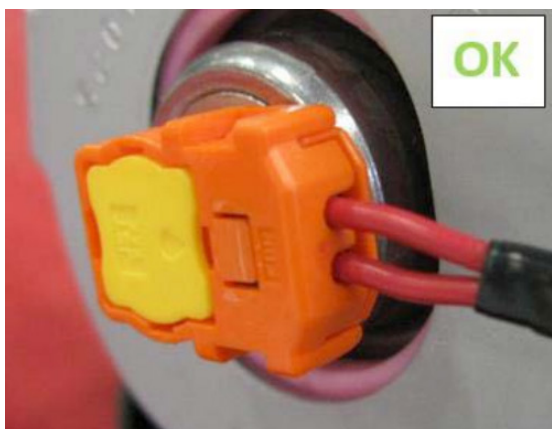
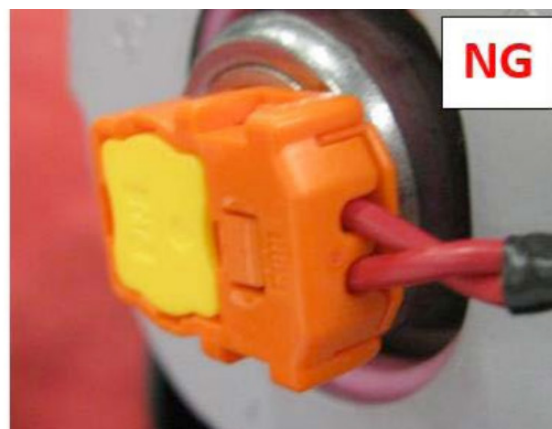
**BEFORE** connecting the harness to the inflator, make sure the harness is not twisted as shown below.

**STEP 16-** The new inflator wiring harness has 2 “sides” with 2-pin connectors on both ends. The side with the black harness tube goes with the black inflator connector and the other side (yellow harness tube) will connect to the orange connector. The end of the inflator aligned with the new Stopper Plate (A) will have a black harness connector while the connector on the opposite end of the inflator will be orange. This makes it impossible to install the harness backwards as the tangs (shown in Step 17) are also in different positions.

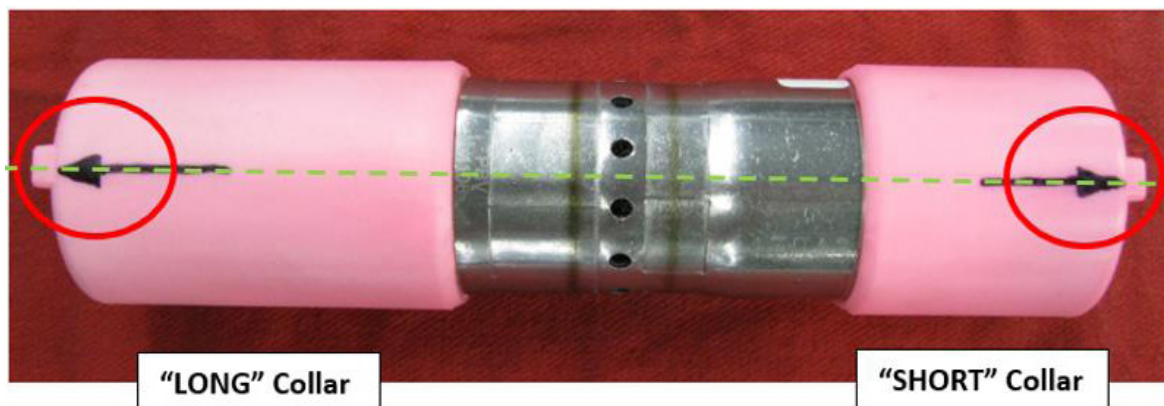
**NOTE:** The **Type 2** inflator is installed in the opposite direction of the original. This change puts the connector on the other end. The new harness has been extended approximately 2” to compensate.

**STEP 9-** Inspect the new **Type 2** inflator to confirm the locating protrusions on each of the pink collar portions are aligned as shown below. The “short” collar can be rotated as needed to align it with the protrusion on the “long” collar if necessary.

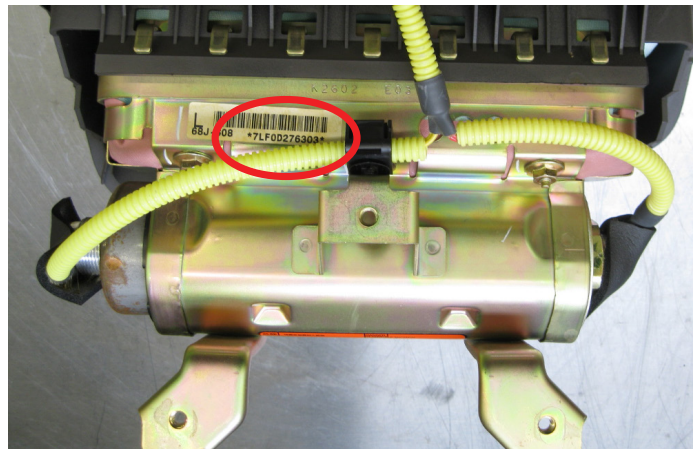
**Inflator WITHOUT Ammonium Nitrate- Serial Number Label Location (2003 Legacy, Outback and Baja models only): Record this 11-digit number for claims purposes.**

- These early production 2003 MY vehicles (77,000) were equipped with inflators which do not contain ammonium nitrate.
- These inflators which do not contain ammonium nitrate do not require replacement as part of any Subaru airbag recall.

If the serial number label is missing, illegible or if there is any uncertainty if the airbag module is affected by this Recall Campaign, follow the Counterfeit / Non-Genuine airbag inspection process provided above. Always take photos of the module showing the entire inflator along with an additional photo showing the area where the label should be as seen in the photos below. Next, submit a Quality Monitoring Report (QMR) requesting SOA review. A member of the Claims Team will contact the Retailer following review of the QMR submission with information on how to proceed.
