## PRODUCT CAMPAIGN BULLETIN

**APPLICABILITY:** 2003-14 MY Legacy  
 2003-14 MY Outback  
 2003-06 MY Baja  
 2009-13 MY Forester  
 2004-11 MY Impreza  
 2004-14 MY WRX and STI

**SUBJECT:** Takata Front Passenger Airbag Module /  
 Inflator “Like for Like” Recall

**NUMBERS:** TKA-20R  
 TKB-20R  
 TKC-20R

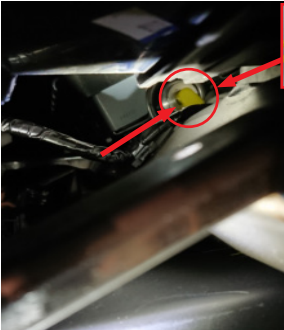
| Model Years | Carline | Part Number | Type | Procedure / How to Identify | ZF TRW End Collar Color | ZF TRW: OK - Do NOT replace the Inflator or Module Assembly. Process Claim for INSPECTION ONLY. | TAKATA: NG - Replace the Inflator or Module Assembly per the table. |
|---|---|---|---|---|---|---|---|
| 2010-14MY | LEGACY OUTBACK | 98279AJ06A | Module | 1) <b>CAREFULLY</b> remove the end panel of the IP on the passenger side.<br>2) Check <b>the harness connector color</b> of the inflator inside the IP.<br>• If the connector is <b>Black/Yellow</b> , it is a ZF TRW inflator.<br>• If the connector is <b>Solid Yellow</b> , it is a Takata inflator. | No End Collars Are Used | <div>Harness connector is a combination of Black and Yellow.</div> | <div>Harness connector is Solid Yellow.</div> |

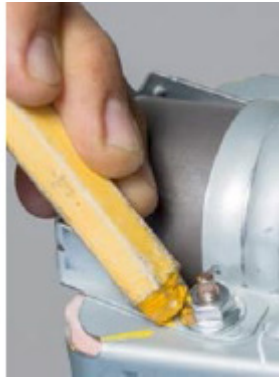
**STEP 15-** Reinstall the 4 **NEW** self-locking nuts. **SLOWLY** tighten (to prevent over-tightening) then torque the nuts to 31-38 inch-pounds. When complete, use a marker to indicate they have been fully tightened.

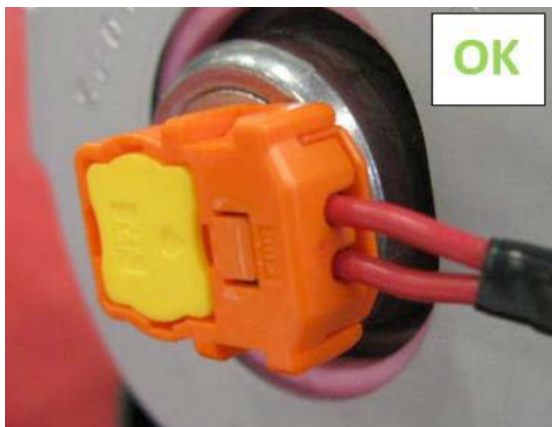
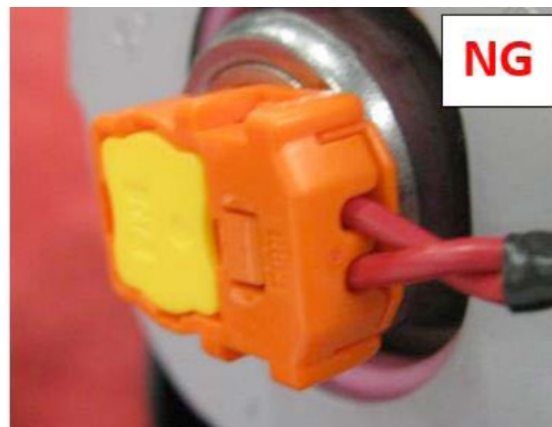
**BEFORE** connecting the harness to the inflator, make sure the harness is not twisted as shown below.

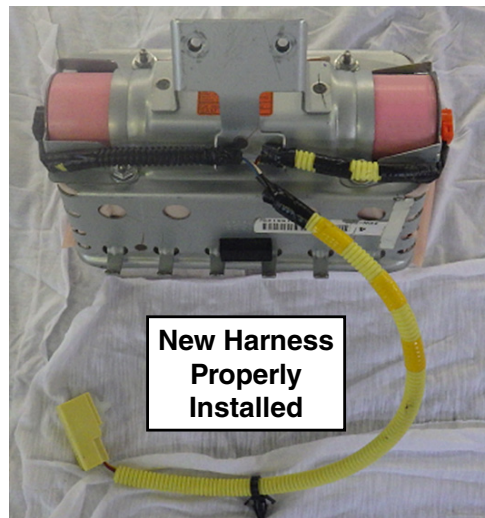
**VERY IMPORTANT:** After connecting the new harness to the inflator, **both sides MUST be routed as shown** in the “New Harness Properly Installed” photo below.

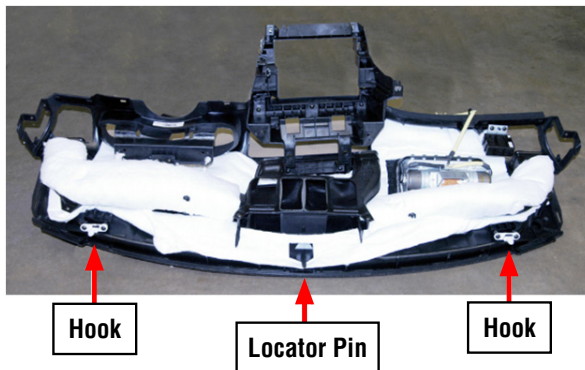
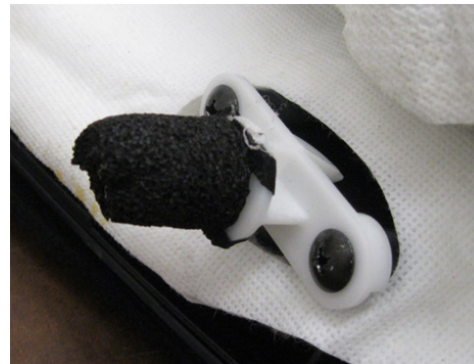
**TIP:** To eliminate a possible source of a rattling sound from the dash, wrap the 2 hooks and locator pin with non-woven material, p.n. SOA963W110 (or an equivalent self-adhesive foam) as shown below.

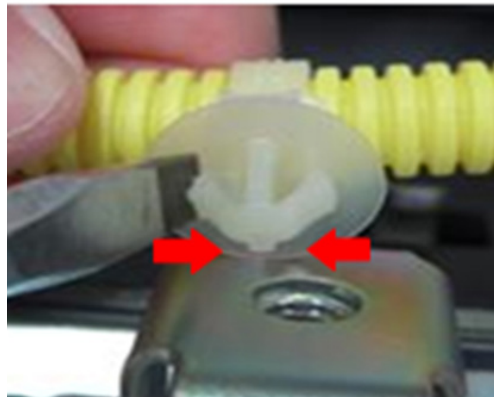
**STEP 2-** Peel the Sponge Tape and remove the harness clip from the retainer bracket by pushing the tangs inward with a flat-blade screwdriver as shown below. Always remove any Sponge Tape adhesive residue from the airbag mounting bracket using mild solvent on a clean shop cloth.  
**CAUTION:** Never use any silicone-based products for this purpose.

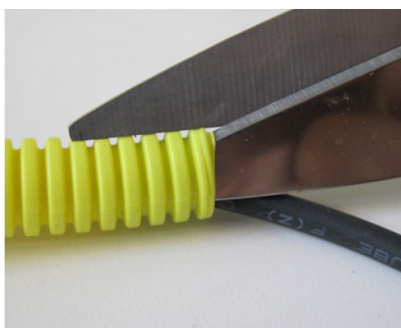
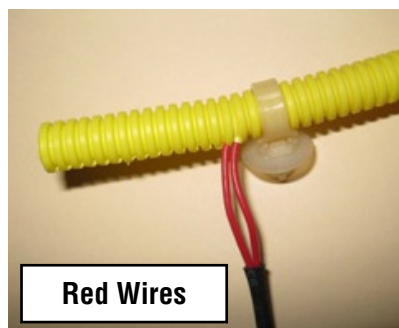
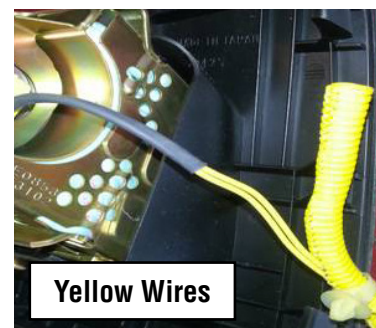
**STEP 3- CAREFULLY** cut the yellow harness cover enough (approximately 2 inches) to expose the 2 red (or yellow) wires inside and provide enough room to install the Electro-Tap (shorting) connector using a wire cutter or scissor (no knives or razors). **TAKE YOUR TIME AND BE CAREFUL TO NOT CUT THE 2 WIRES!**

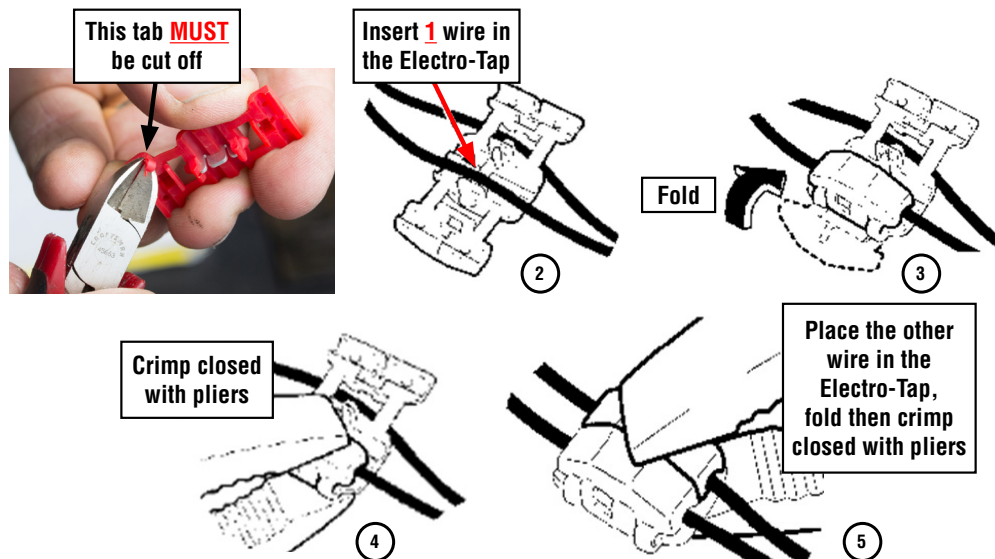
**STEP 4-** Short the 2 wires together by installing the Electro-Tap connector. The connector creates a short circuit which acts as a safeguard to prevent against static discharge that may deploy the removed inflator. The tab portion of the Electro-Tap connector **MUST** be cut off prior to use to insure a good short-circuit is made as shown in the illustration below. **Follow the sequence** below for installing the Electro-Tap connector. Use pliers to squeeze closed the two sections of the connector together, **one section at a time**.

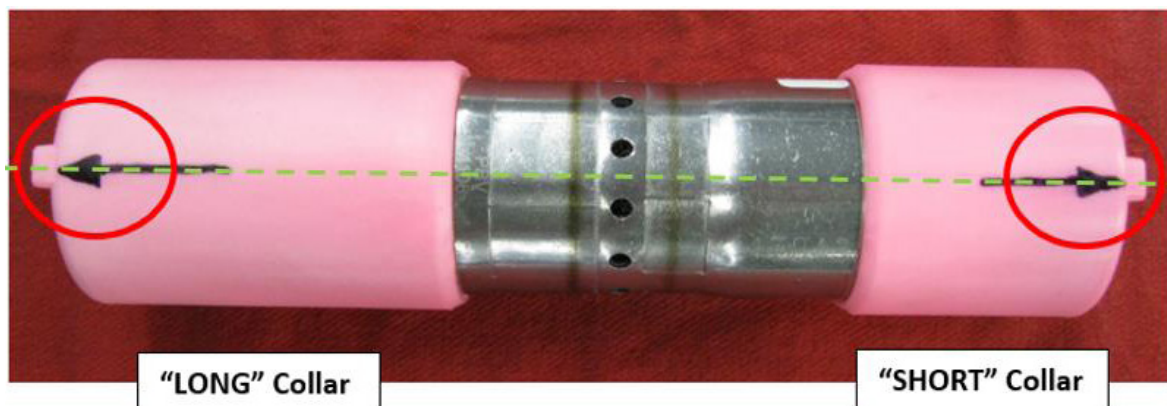
**STEP 9-** Inspect the new **Type 2** inflator to confirm the locating protrusions on each of the pink collar portions are aligned as shown below. The “short” collar can be rotated as needed to align it with the protrusion on the “long” collar if necessary.

**NOTE:** The **Type 2** inflator is installed in the opposite direction of the original. This change puts the connector on the other end. The new harness has been extended approximately 2” to compensate.

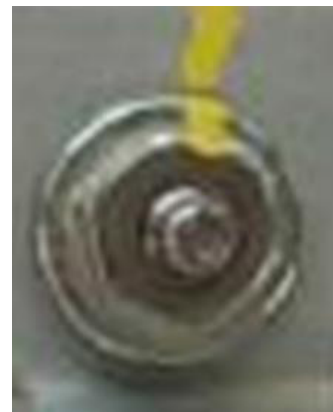
Remove the 2 nuts still installed on the mounting bracket and replace them with 2 **NEW** self-locking nuts. Once all 4 **NEW** nuts are in place, torque to 31 - 38 inch pounds in the new sequence shown below. Use a marker to mark the nuts after torquing indicating they have been fully tightened.

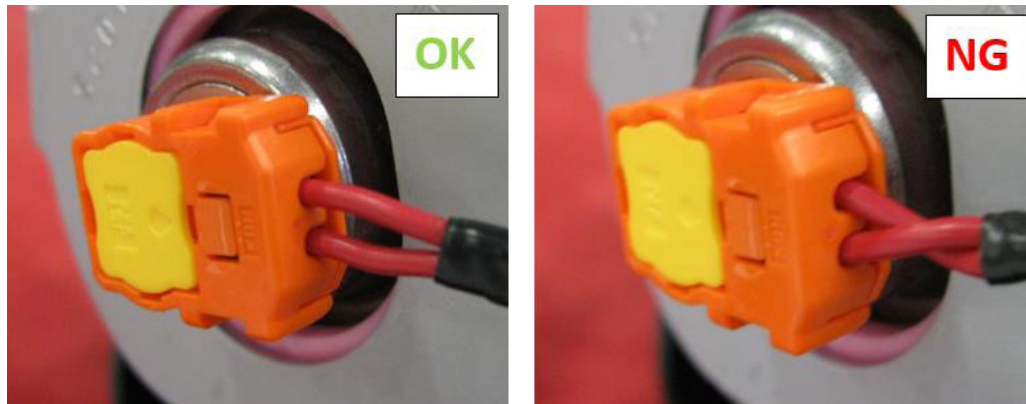
**STEP 13-** Reinstall the wiring harness retaining clip into its position on the mounting bracket.  
**IMPORTANT:** Confirm the harness is not twisted at the inflator connector as shown below.

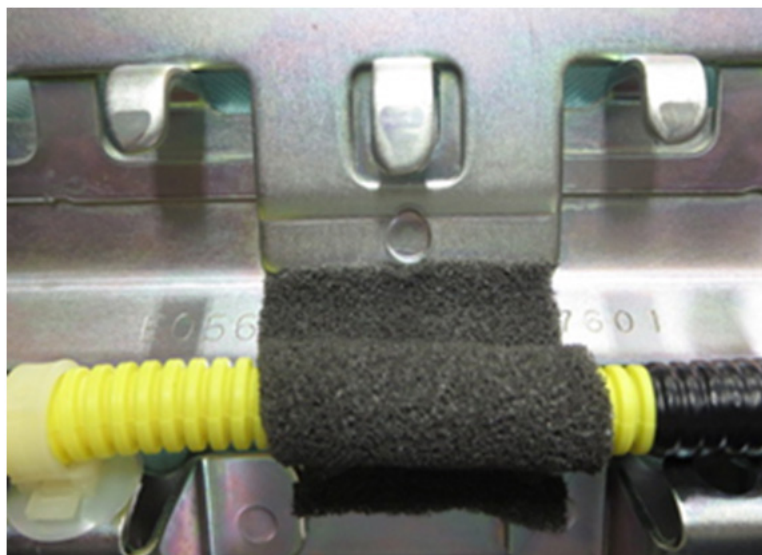
**STEP 14-** Peel the adhesive backing and install the new Sponge Tape onto the yellow harness tube first then adhere it to the airbag mounting bracket as shown in the illustrations below.

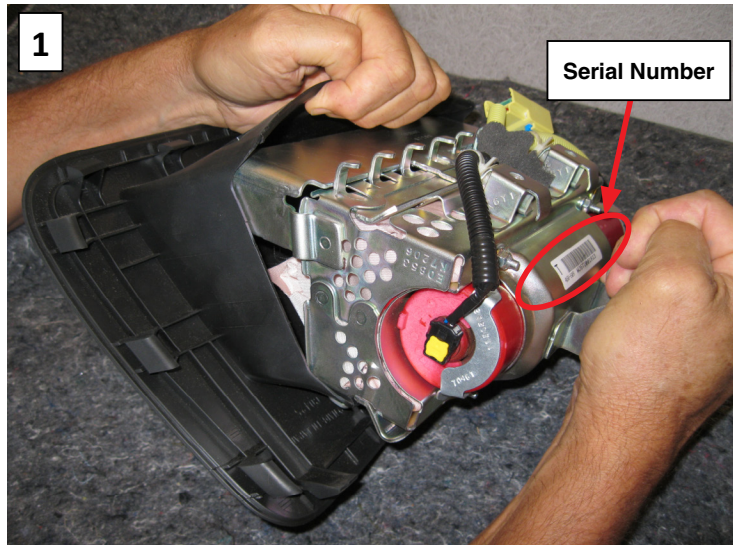
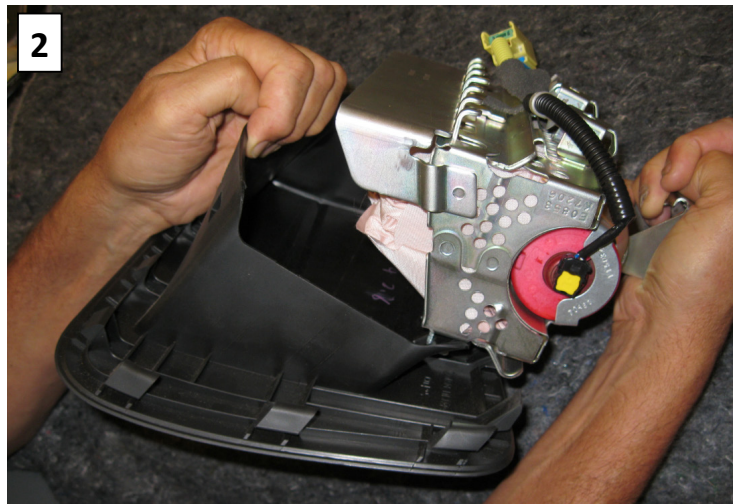
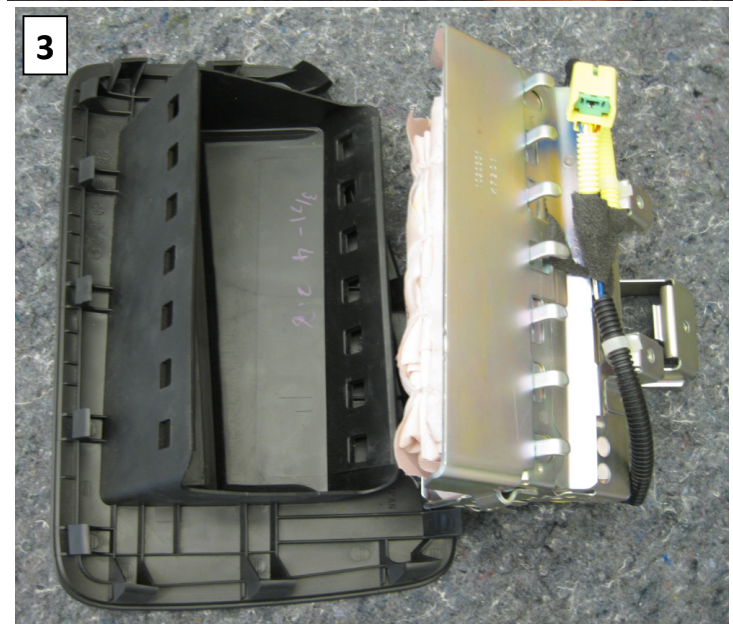
- Once all the harness-side retaining claws are released (EASILY done once the center claw is released), **CAREFULLY** separate the inflator module from the cover. After the harness-side of the module is free from the cover (2), simply rotate it to unhook the label-side retaining claws. Remove the cover completely as shown in (3) below.

- Inspect the claw openings on the outside and inside of the cover for damage. If any found to look like the NG example photo below, the cover must be replaced.
