PRODUCT CAMPAIGN BULLETIN

| <p>APPLICABILITY: 2003-14 MY Legacy 2003-14 MY Outback 2003-06 MY Baja 2009-13 MY Forester 2004-11 MY Impreza 2004-14 MY WRX and STI</p> <p>SUBJECT: Takata Front Passenger Airbag Module / Inflator “Like for Like” Recall</p> | <p>NUMBERS: TKA-20R TKB-20R TKC-20R</p> <p>DATE: 01/06/20</p> <p>REVISED: 12/28/22</p> <p>NHTSA ID: 20V001 20V002 20V003</p> |

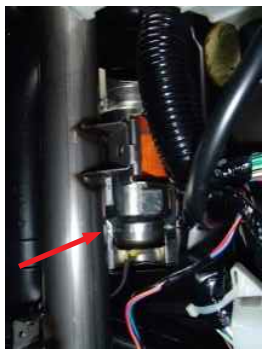
| Model Years | Carline | Part Number | Type | Procedure / How to Identify | ZF TRW End Collar Color | ZF TRW: OK - Do NOT replace the Inflator or Module Assembly. Process Claim for INSPECTION ONLY. | TAKATA: NG - Replace the Inflator or Module Assembly per the table. |
|---|---|---|---|---|---|---|---|
| 2004-05MY | IMPREGA WRX | 98279FE070 98279FE07A | Inflator | <ol style="list-style-type: none"> For these models, there is no need to remove any parts. Check the inflator collar from the bottom backside of the instrument panel (IP) on the passenger side. <ul style="list-style-type: none"> If the color of the collar is Pink, it is a ZF TRW inflator. If no collar is found, it is a Takata inflator. | Pink | | |

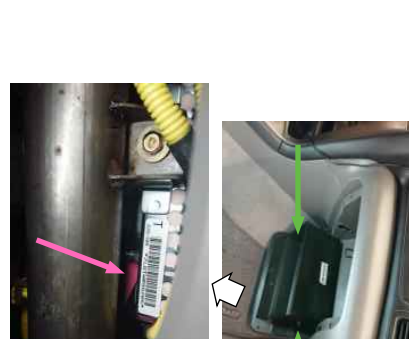
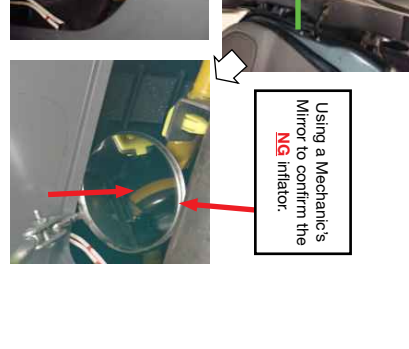
| Model Years | Carline | Part Number | Type | Procedure / How to Identify | ZF TRW End Collar Color | ZF TRW: OK - Do NOT replace the Inflator or Module Assembly. Process Claim for INSPECTION ONLY. | TAKATA: NG - Replace the Inflator or Module Assembly per the table. |
|---|---|---|---|---|---|---|---|
| 2003-06MY | Legacy Outback Baja | 98279AE04A 98279AE04B | Module | <p>IMPORTANT: For 2003MY ONLY see Appendix B on page 47 for more information.</p> <ol style="list-style-type: none"> Release the stoppers of the glovebox and open it fully. Check for the inflator collar from the bottom (TIP: use a Mechanic's mirror to make it easier). <ul style="list-style-type: none"> If the color of the collar is Pink, it is a ZF TRW inflator. If no collar is found, it is a Takata inflator. <p>TIP: In some cases, removal of the module / dash cover assembly from the IP may be easier and quicker.</p> | Pink | | <p>Using a Mechanic's Mirror to confirm the NG inflator.</p> |

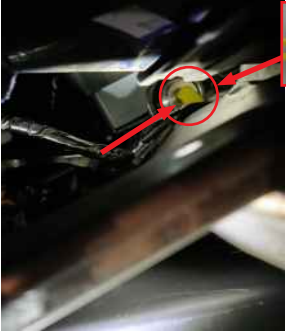
| Model Years | Carline | Part Number | Type | Procedure / How to Identify | ZF TRW End Collar Color | ZF TRW: OK - Do NOT replace the Inflator or Module Assembly. Process Claim for INSPECTION ONLY. | TAKATA: NG - Replace the Inflator or Module Assembly per the table. |
|---|---|---|---|---|---|--|---|
| 2010-14MY | LEGACY OUTBACK | 98279AJ06A | Module | <ol style="list-style-type: none"> CAREFULLY remove the end panel of the IP on the passenger side. Check the harness connector color of the inflator inside the IP. <ul style="list-style-type: none"> If the connector is Black/Yellow, it is a ZF TRW inflator. If the connector is Solid Yellow, it is a Takata inflator. | No End Collars Are Used | <p>Harness connector is a combination of Black and Yellow.</p> | <p>Harness connector is Solid Yellow.</p> |
