PRODUCT CAMPAIGN BULLETIN

<p>APPLICABILITY: 2003-14 MY Legacy 2003-14 MY Outback 2003-06 MY Baja 2009-13 MY Forester 2004-11 MY Impreza 2004-14 MY WRX and STI</p> <p>SUBJECT: Takata Front Passenger Airbag Module / Inflator “Like for Like” Recall</p>	<p>NUMBERS: TKA-20R TKB-20R TKC-20R</p> <p>DATE: 01/06/20</p> <p>REVISED: 12/28/23</p> <p>NHTSA ID: 20V001 20V002 20V003</p>
--	--

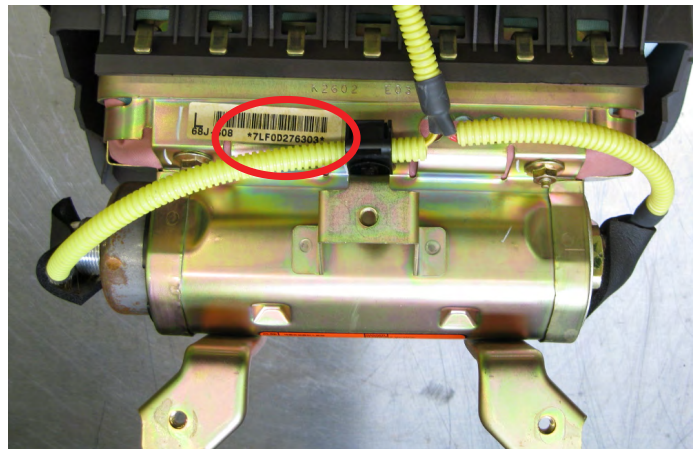
Inflator WITHOUT Ammonium Nitrate- Serial Number Label Location (2003 Legacy, Outback and Baja models only): Record this 11-digit number for claims purposes.

- These early production 2003 MY vehicles (77,000) were equipped with inflators which do not contain ammonium nitrate.
- These inflators which do not contain ammonium nitrate do not require replacement as part of any Subaru airbag recall.

If the serial number label is missing, illegible or if there is any uncertainty if the airbag module is affected by this Recall Campaign, follow the Counterfeit / Non-Genuine airbag inspection process provided above. Always take photos of the module showing the entire inflator along with an additional photo showing the area where the label should be as seen in the photos below. Next, submit a Quality Monitoring Report (QMR) requesting SOA review. A member of the Claims Team will contact the Retailer following review of the QMR submission with information on how to proceed.
