## PRODUCT CAMPAIGN BULLETIN

**SUBJECT:** Takata Front Passenger Airbag Module /  
 Inflator “Like for Like” Recall

**NUMBERS:** TKA-20R  
 TKB-20R  
 TKC-20R

**NHTSA ID:** 20V001  
 20V002  
 20V003

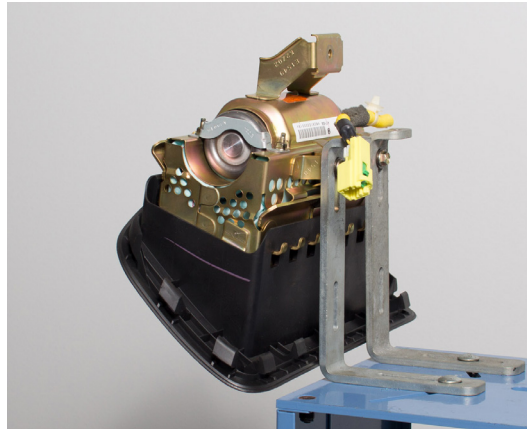
**IMPORTANT:** The removed airbag module must be mounted to the Airbag Deployment Fixture (part number J-39401-B) as shown in the photo below to better secure it during the inflator and wiring harness component replacement procedures. Always perform this work in an area away from others to reduce chances of inadvertent injury should any deployment occur. Take your surroundings into account to avoid possible hazards should inadvertent deployment occur or sources of static or other electricity that could potentially induce such a deployment.

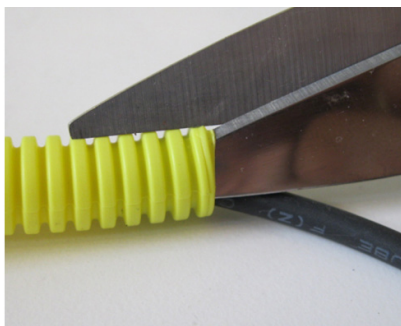
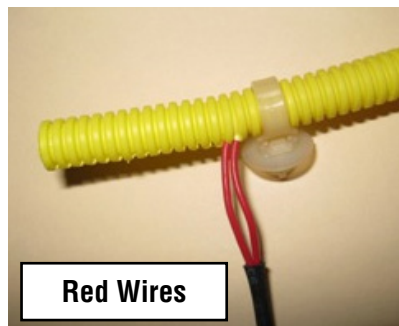
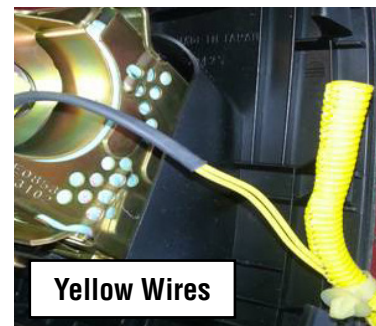
**STEP 3- CAREFULLY** cut the yellow harness cover enough (approximately 2 inches) to expose the 2 red (or yellow) wires inside and provide enough room to install the Electro-Tap (shorting) connector using a wire cutter or scissor (no knives or razors). **TAKE YOUR TIME AND BE CAREFUL TO NOT CUT THE 2 WIRES!**

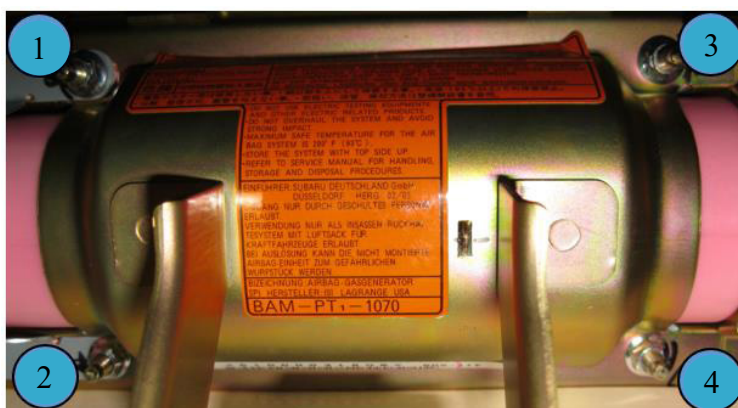
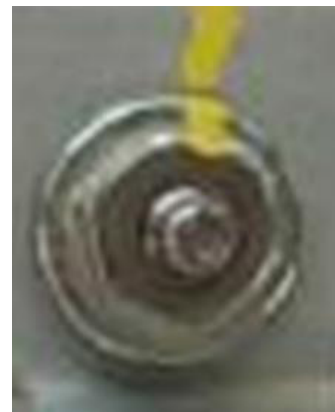
**Always hold the stopper plate tight against the inflator as shown when installing and tightening the NEW self-locking nuts. NEVER reuse the original nuts.**

Remove the 2 nuts still installed on the mounting bracket and replace them with 2 **NEW** self-locking nuts. Once all 4 **NEW** nuts are in place, torque to 31 - 38 inch pounds in the new sequence shown below. Use a marker to mark the nuts after torquing indicating they have been fully tightened.

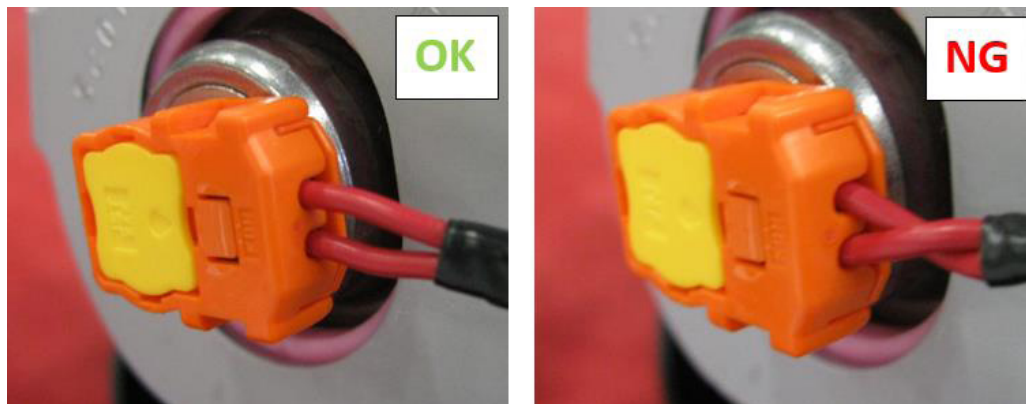
**STEP 13-** Reinstall the wiring harness retaining clip into its position on the mounting bracket.  
**IMPORTANT:** Confirm the harness is not twisted at the inflator connector as shown below.

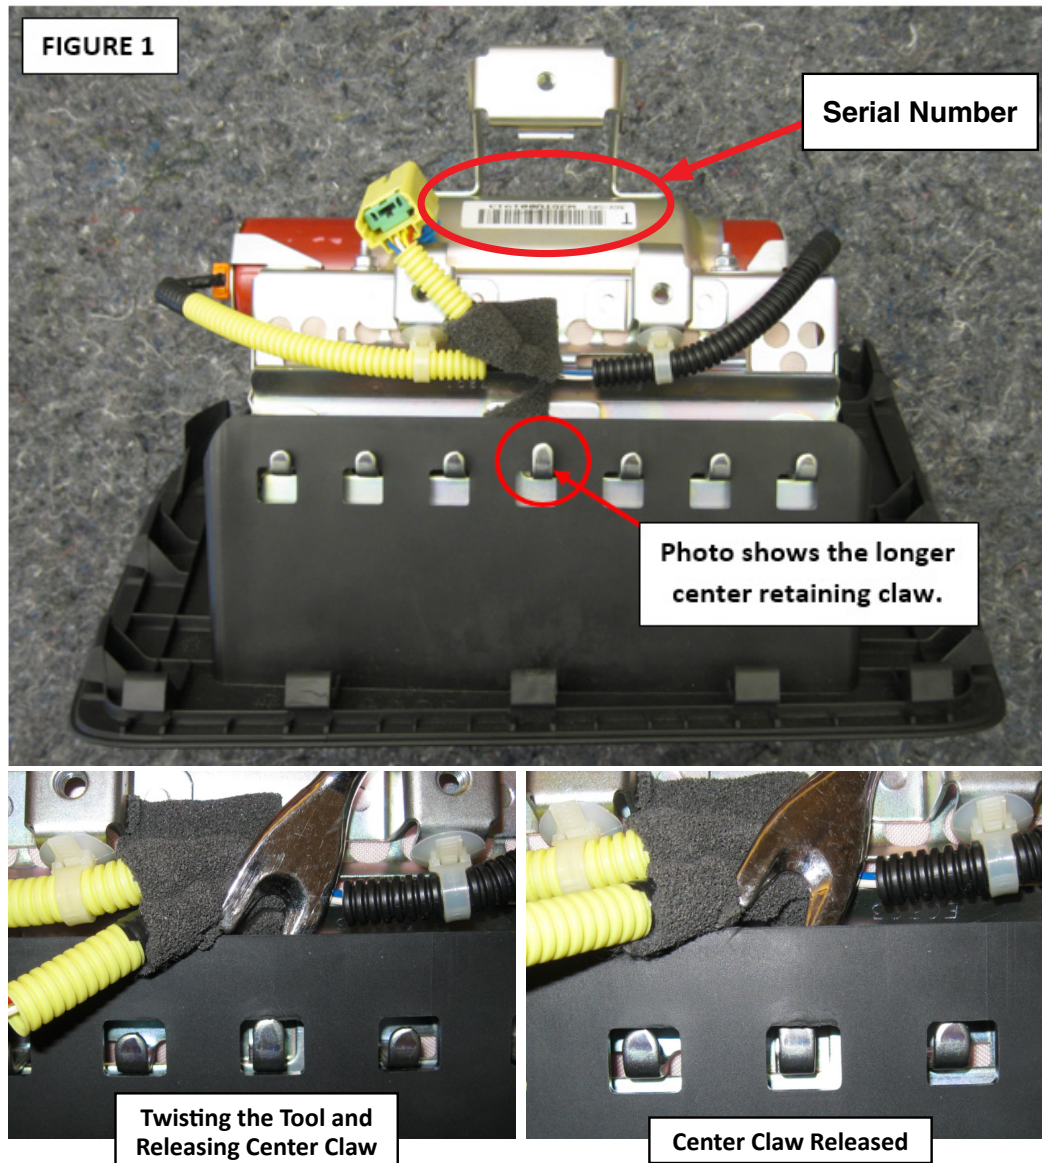
- Using a trim clip removal tool and starting on the harness-side of the module assembly as shown in photos and sequence below, **CAREFULLY** insert the tool and twist **ONLY AS MUCH AS IS REQUIRED** to release the slightly longer center retaining claw from the trim cover. Once released with the tool, the other 6 claws will release easily by hand.
- Rotate the inflator portion of the assembly outward from the cover to release the 7 label-side claws and separate the cover from the module. No tool is required as all the 7 label-side claws are the same size.
