SIB 65 04 20

**RECALL CAMPAIGN 20V-017: REPLACE DRIVER'S FRONT AIR BAG MODULE**

This Service Information Bulletin (Revision 3) replaces SI B65 04 20 **dated December 2022**.

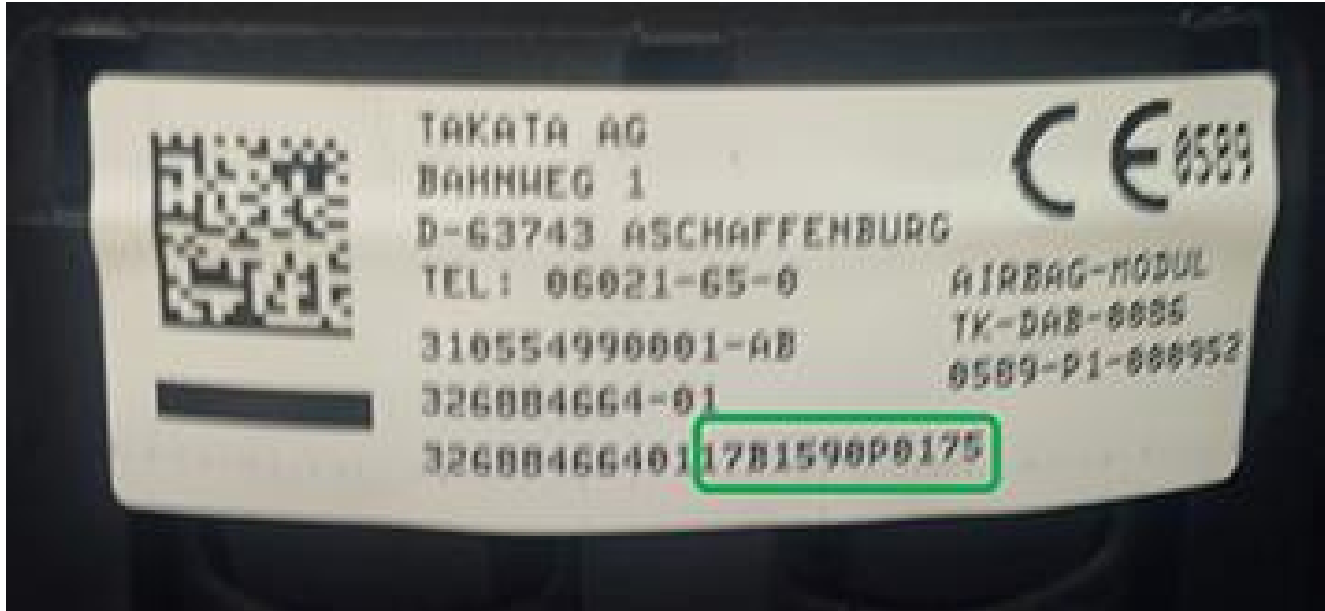
There are two different serial numbers that can be found. For this recall we only need the serial number on the label on the side of the air bag. . The serial number is identified below by the red box (1).

This is the last half of the number (after the part number) as shown below. The part number is identified below by the green box (2).

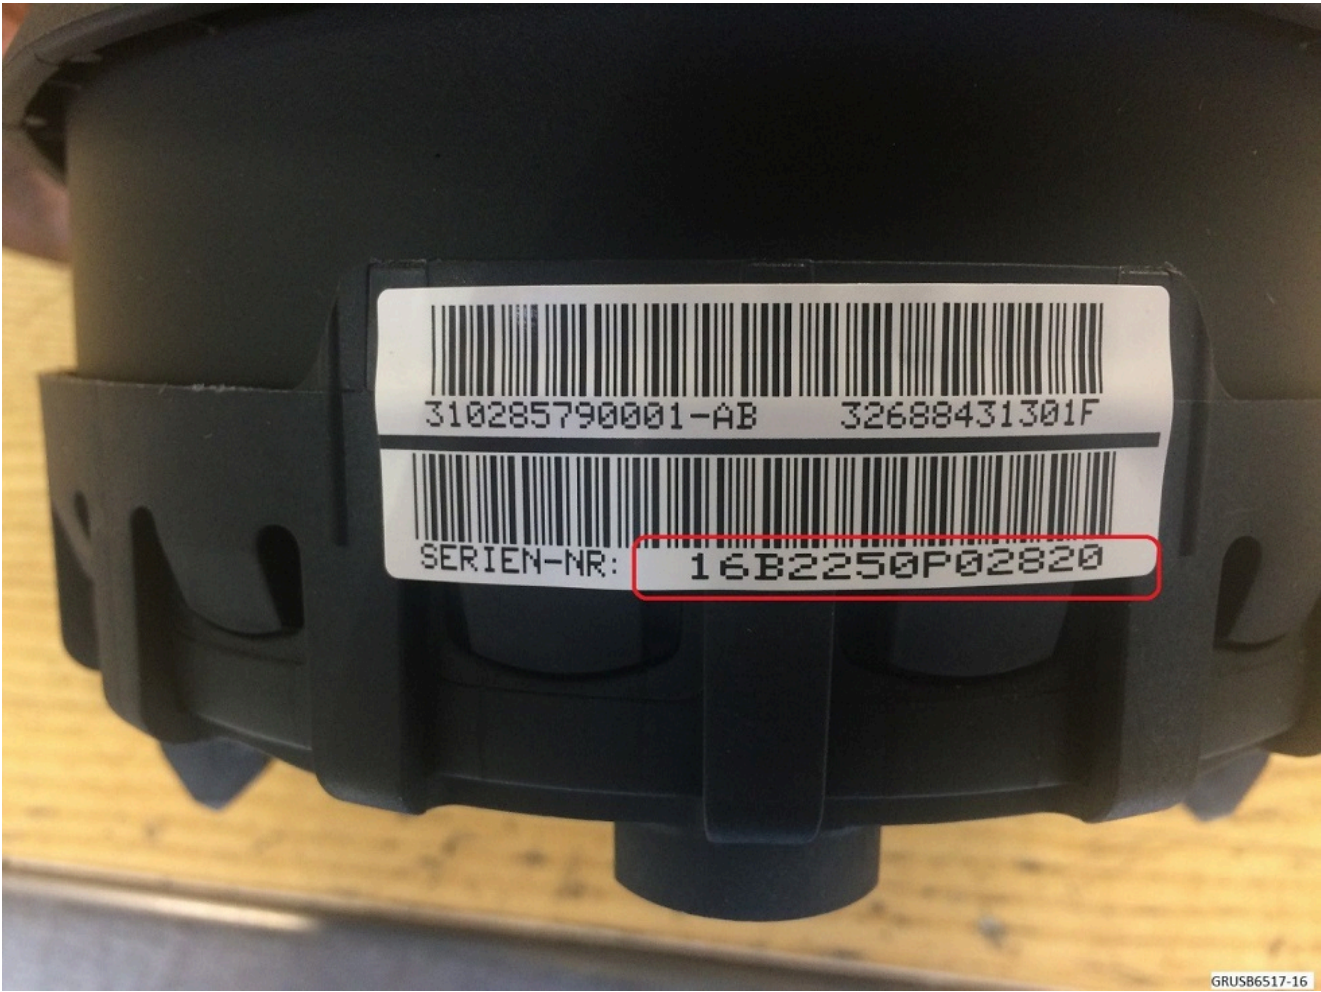
**OR** the serial number can also be found on the bottom of the label.

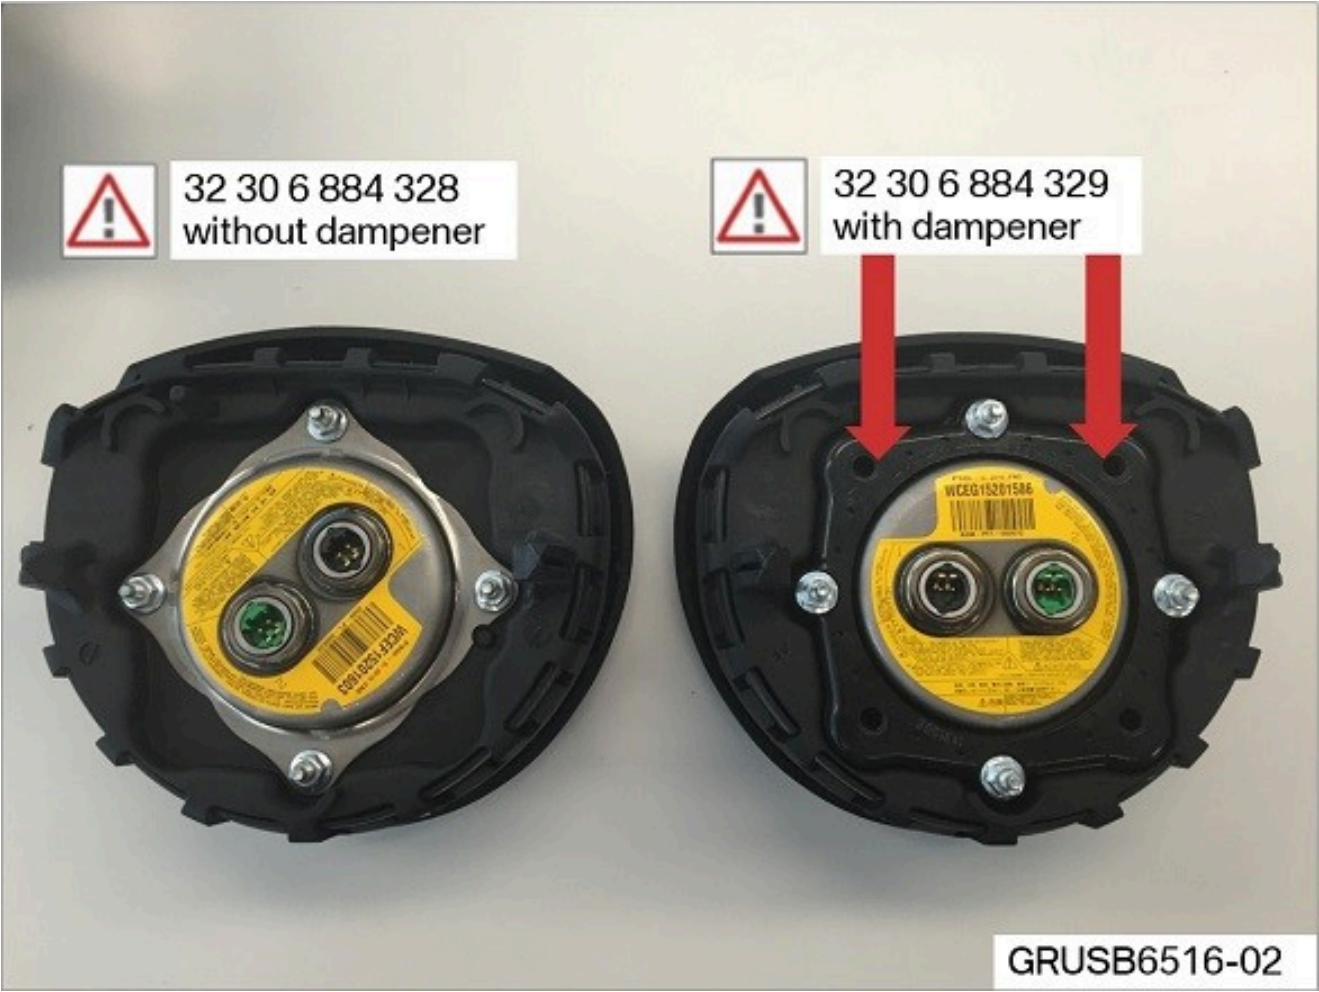
Note: **Original part coming out of the vehicle may not match the replacement part. This applies to vehicles originally equipped with or without a dampener. Refer to the photos below:**

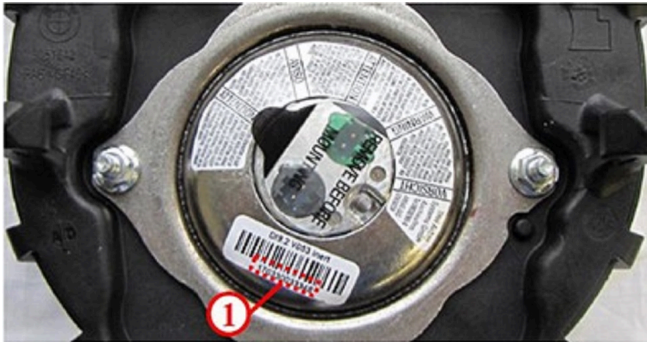
Serial Number location (1).

It is necessary to document which gas generator goes into which vehicle. Therefore, the technician is required to note on the repair order the serial number of the new gas generator. The serial number should also be entered into the warranty claims comment section. The serial number can be found on the gas generator below the barcode.
