SAFETY RECALL BULLETIN

SUBJECT:		No: SR-20-001REV
DRIVER SIDE TAKATA NADI INFLATOR – SAFETY RECALL CAMPAIGN		DATE: June 2021
		MODEL: 1998–2000 Montero
CIRCULATE TO:	<input type="checkbox"/> GENERAL MANAGER	<input checked="" type="checkbox"/> PARTS MANAGER
	<input checked="" type="checkbox"/> SERVICE ADVISOR	<input checked="" type="checkbox"/> SERVICE MANAGER
	<input checked="" type="checkbox"/> WARRANTY PROCESSOR	<input checked="" type="checkbox"/> SALES MANAGER
		<input checked="" type="checkbox"/> TECHNICIAN

This bulletin supersedes SR-20-001 issued February 2021, to update the Squib Harness Modification section of the Installation Process. Revisions are italicized and indicated by: ◀

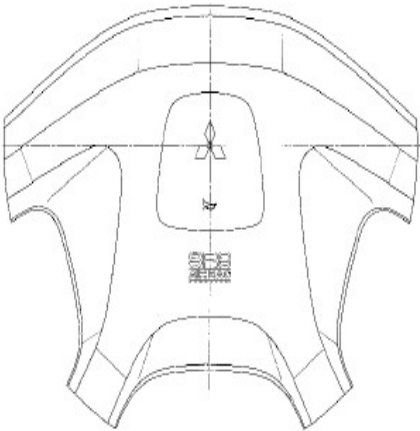
Applicable part	MR307479 (Airbag module)

<p>This work procedure describes replacement step of the inflator kit which is installed in this driver's airbag module.</p>
