Safety Recall Action Notice 574 Issue 1 - 03.2020

Subject: Ignition Switch Subharness Routing			
Bulletin Number	Models Affected	VIN Range	Markets Affected
574	Trophy, Trophy SE	From VIN 561284 to VIN 795295	All Markets

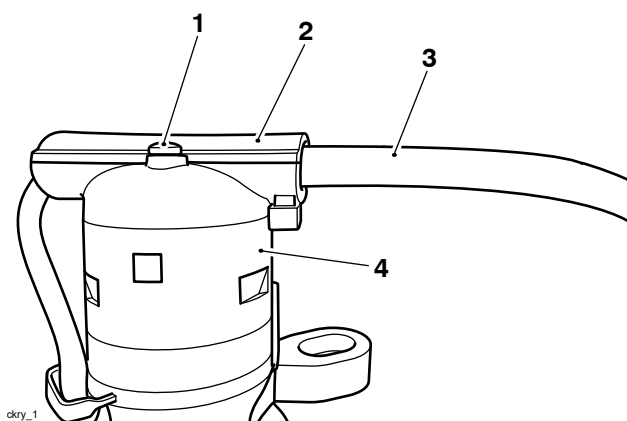
1. Fixing
2. Cover
3. PVC tube
4. Ignition switch

12. Remove the cover from the base of the ignition switch.

13. Trim the PVC tube to expose at least 90mm of the wires as they exit the ignition switch body.

14. Examine the exposed wiring for damage. If damage is observed undertake appropriate repairs or contact Triumph for further instruction

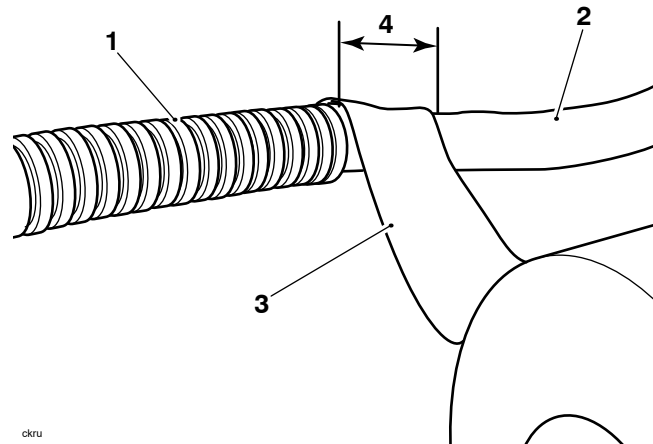
- 1. Conduit
- 2. PVC tube
- 3. Insulating tape
- 4. Tape width

16. Wrap the PVC tube with insulating tape. Starting a minimum of 20 mm from the end of the PVC tube wrap the insulating tape overlapping a minimum of half the tape's width.

17. Position the conduit to the PVC tube as shown below.

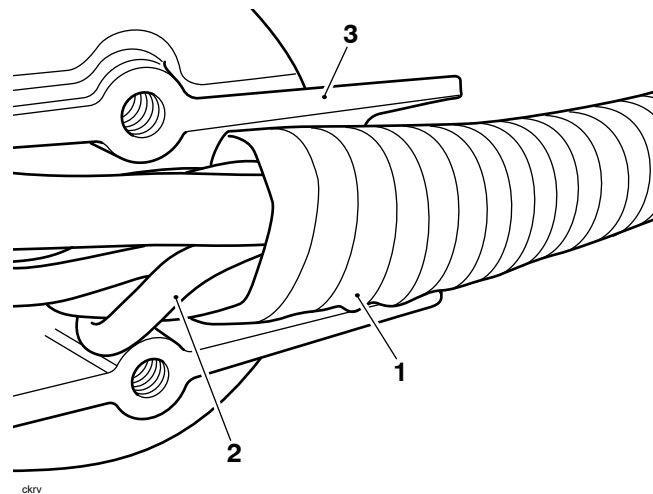
- 1. Insulating tape
- 2. Ignition switch wires
- 3. Ignition switch body

18. Continue to wrap the insulating tape until the conduit is fully covered. Cut the insulation tape.

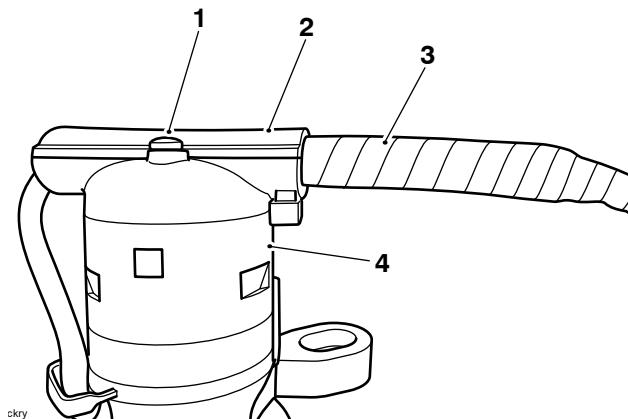
1. **Fixing**
2. **Cover**
3. **Conduit**
4. **Ignition switch**

21. Refit the plastic cover making sure it covers the exposed wires and newly added conduit.

22. Tighten the fixing to **0.25 Nm**.

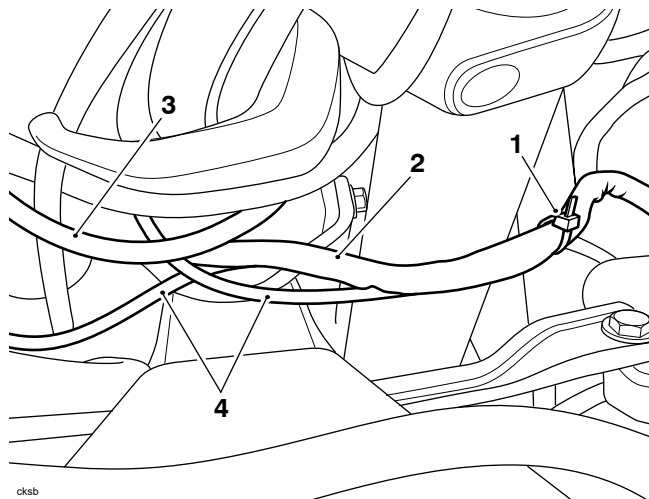
- 1. Cable tie
- 2. Ignition switch subharness
- 3. Brake hose
- 4. TES cables

28. Position the TES cables to the ignition switch subharness and secure with a cable tie.

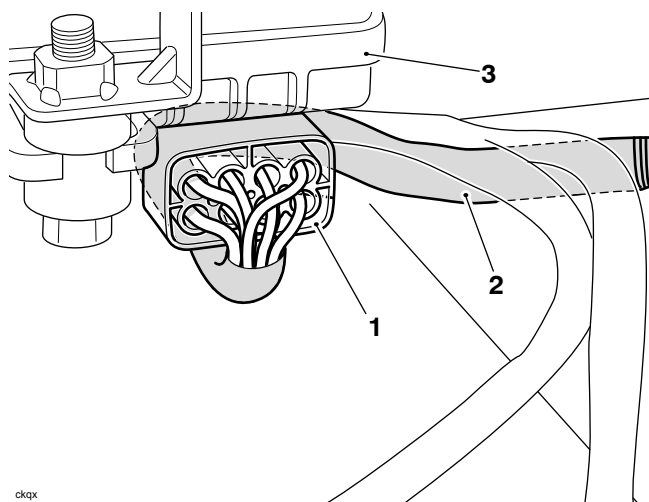
- 1. Ignition switch electrical connector
- 2. Ignition switch subharness
- 3. Immobiliser

29. Loop the ignition switch subharness so that the harness is positioned below the connector and then connect to the main harness electrical connector.
