SIB 27 01 20

RECALL 20V-185: REPLACING THE FLEX DISC AND INSPECTING THE TRANSFER CASE

F30 (3 Series Sedan)	F31 (3 Series Sports Wagon)	With xDrive and N47T diesel engine
----------------------	-----------------------------	------------------------------------

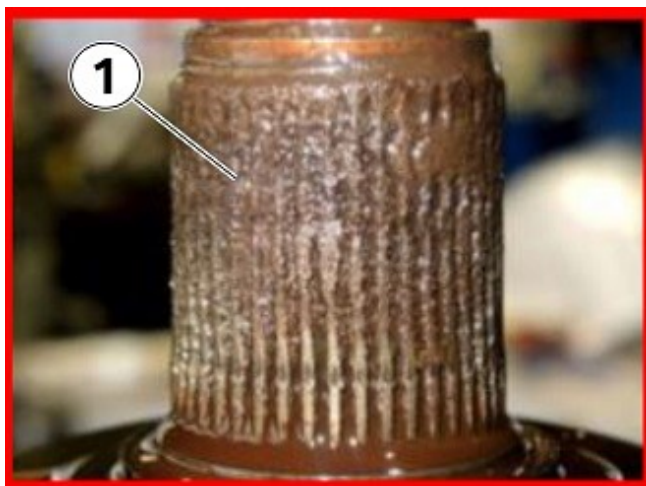
Flange and output shaft **with** friction rust damage (1). The transfer case will need to be replaced (with new flex disc).

NOTE: The transfer case needs to be replaced if either the flange or the output shaft are worn.

Follow Repair Instruction **27 10 020 Installing exchange transfer box (ATC 35L)**.
