SIB 27 01 20

RECALL 20V-185: REPLACING THE FLEX DISC AND INSPECTING THE TRANSFER CASE

F30 (3 Series Sedan)	F31 (3 Series Sports Wagon)	With xDrive and N47T diesel engine
----------------------	-----------------------------	------------------------------------

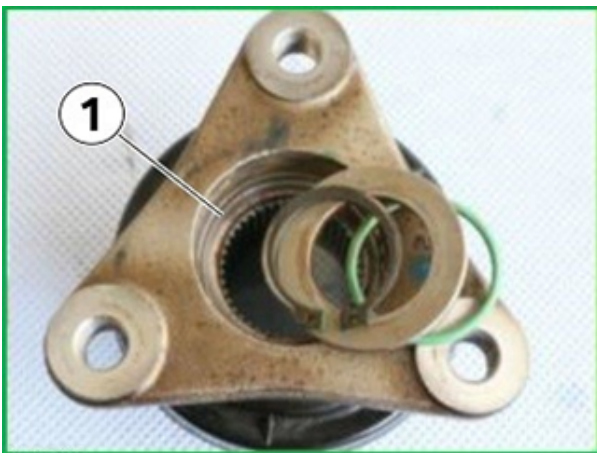
Typical output flanges without friction rust build up (1).

No further repair is necessary if there is no friction rust around the splines of the output flange.

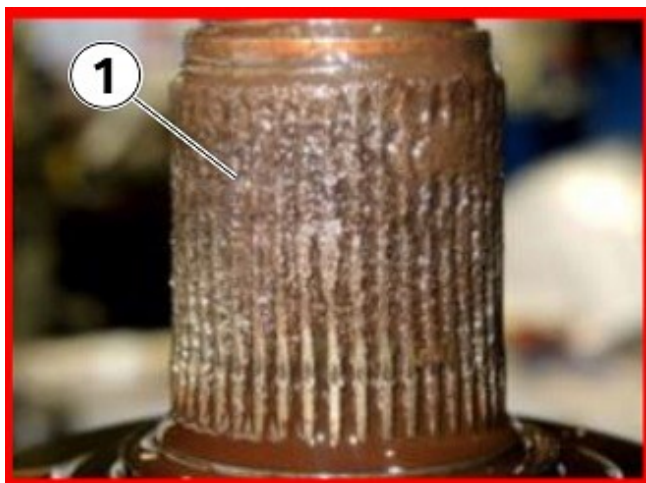
Flange and output shaft **with** friction rust damage (1). The transfer case will need to be replaced (with new flex disc).

NOTE: The transfer case needs to be replaced if either the flange or the output shaft are worn.

Follow Repair Instruction **27 10 020 Installing exchange transfer box (ATC 35L)**.
