Subject: Front Brake Hose Rework			
Field Change Program: Field Campaign	FCP Number: 481	Revision: A	Date: 06/24/2020
Coach Section: 04-Brakes & Air system	P/N: 04-20-1817		Type: Safety Recall

Ref. NHTSA Recall No.: 20V-233	Ref. Transport Canada Recall No.: 2020-179
--	--

1.0 Description

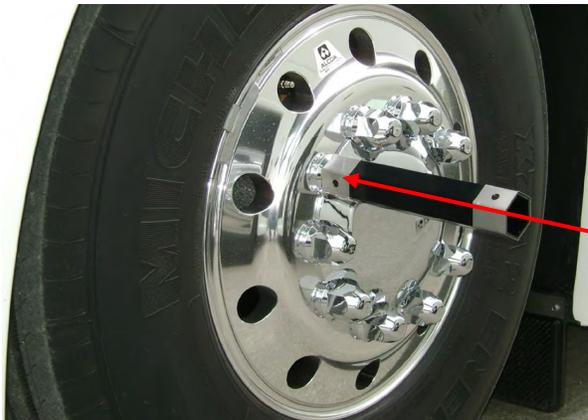
Remove and save the
hub nuts and hub cover

Remove and save the ten nuts on the hub cover of the front axle wheel. Save the hub cover

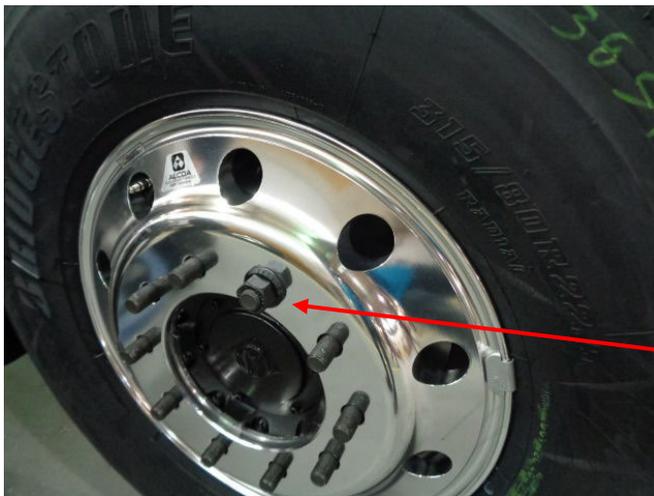
Remove and save the
flange nuts

Remove and save the ten flange nuts on the wheel. Remove and save the wheel.

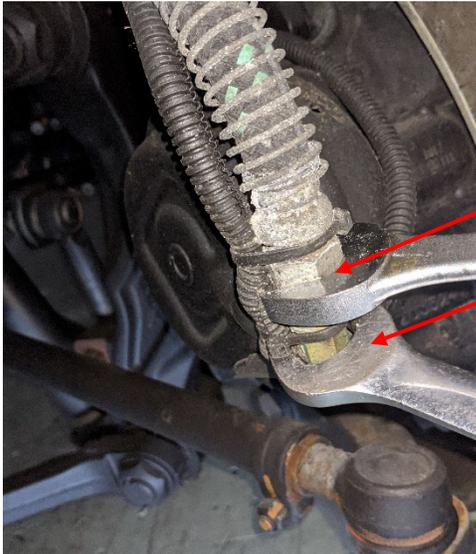
Disconnect the brake hose.

Hold the 90-degree fitting with a wrench

Disconnect the front brake hose on the wheel end by holding the 90-degree fitting on the front brake chamber tight with a wrench.

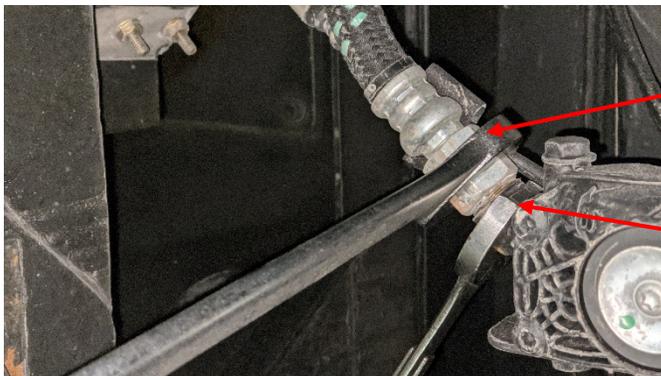
Remove and discard the brake hose.

Hold the fitting with a wrench

Disconnect the front brake hose on the other end by holding the fitting on the ABS front module relay valve tight with a wrench. Discard the brake hose.

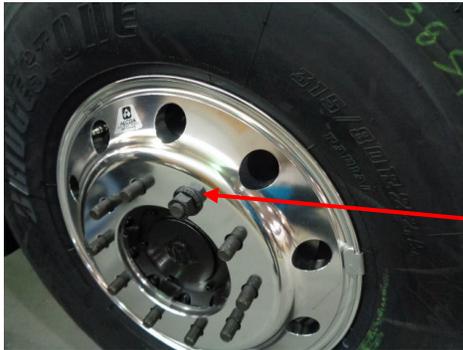
Install the wheel using flange nuts

Install the wheel using existing flange nuts and hand tighten the nuts.

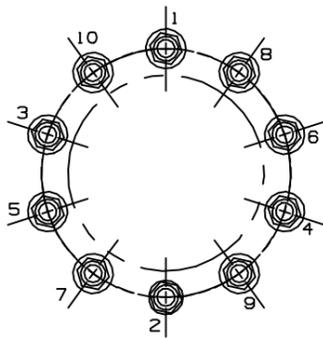
Sequence of the nuts to torque

Torque the nuts to 450-500 Ft-Lb in the sequence shown below.

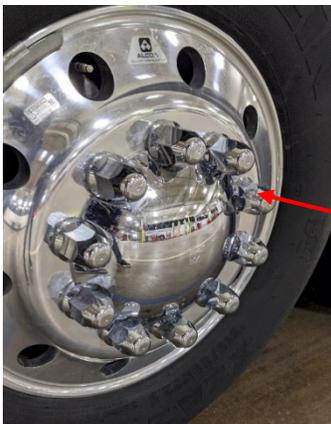
Install the hub cover using nut covers

Install the hub cover using the existing nut covers. Turn the nut covers approximately five full turns until the nut cover clamps the hub cover tightly against the wheel.
