**HYUNDAI**
Technical Service Bulletin

GROUP RECALL	NUMBER 20-01-023H
DATE MAY, 2020	MODEL(S) GENESIS COUPE (BK)

SUBJECT: 2016 GENESIS COUPE (BK)
DRIVER AIRBAG (RECALL CAMPAIGN 192)

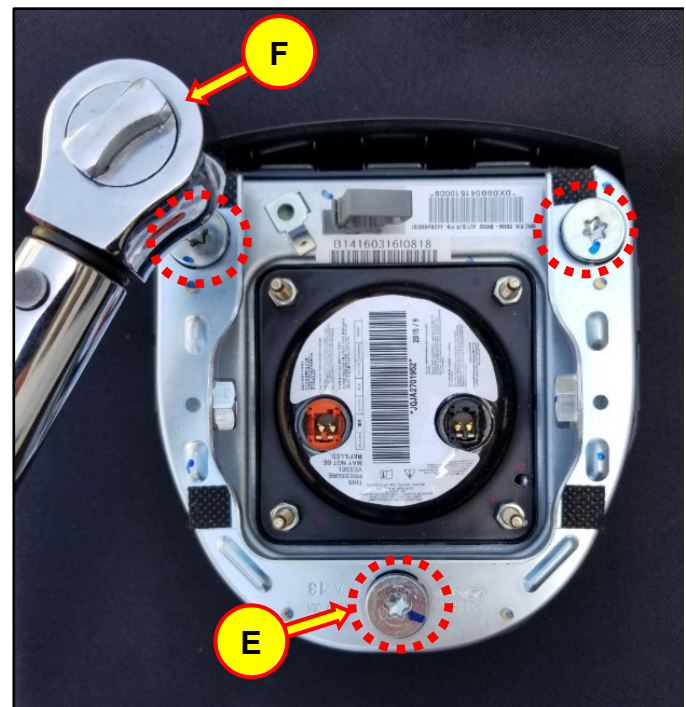
Certain Genesis Coupe vehicles are equipped with the driver airbag whose mounting bolts, which secures the driver airbag to the horn sub-assembly, may have been installed with insufficient torque during assembly. If insufficient torque was applied to the mounting bolts, the airbag may potentially detach from the steering wheel, increasing the risk of injury during a crash.

6. Tighten the mounting bolts (E) using the torque wrench (F).

Tightening Torque:

3.5 ~ 5.0N.m (0.4 ~ 0.5kgf.m, 2.6 ~ 3.7lb-ft)
