**HYUNDAI**  
**Technical Service Bulletin**

GROUP <b>RECALL</b>	NUMBER <b>20-01-046H</b>
DATE <b>December, 2020</b>	MODEL(S) <b>SANTA FE SPORT (AN)</b>

**SUBJECT:** ABS MODULE INSPECTION (RECALL CAMPAIGN 194)

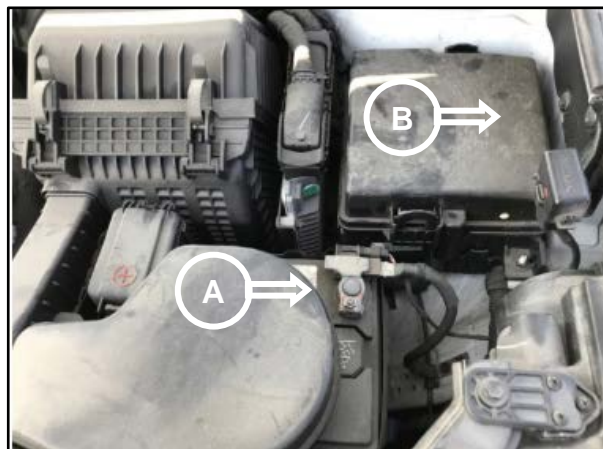
2. Disconnect the battery negative (-) terminal (A) and remove the junction box upper cover (B).

**Battery (-) Terminal Nut Tightening**

**Torque nut:**

**4.0~6.0 N.m (0.4~0.6 kgf.m, 3.0~4.4 lb-ft)**

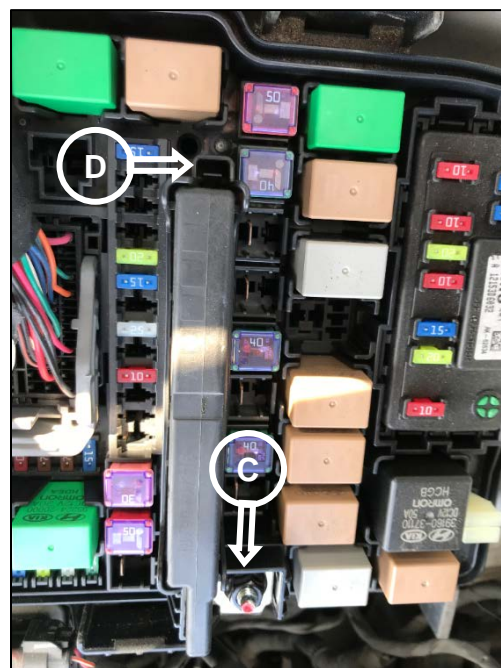
3. Remove the 10 mm nut (C) and lift the cable over the stud. Release the locking tab (D) and remove the multifuse.

**Tightening Torque:**

**9.8~11.7 Nm (1.0~1.2 kgf.m, 7.2~8.7 lb-ft)**

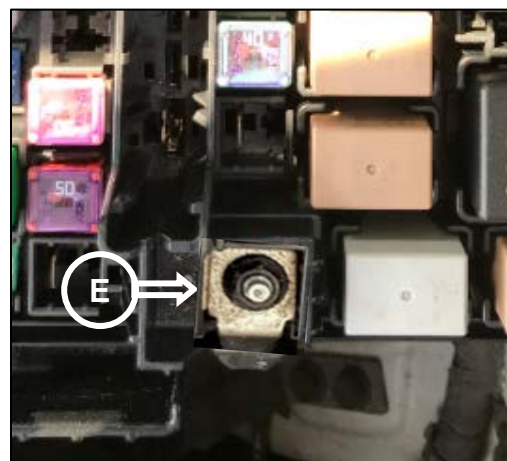
4. Place the junction box cable over the junction box stud (E), reinstall the nut and reconnect the battery negative (-) terminal.

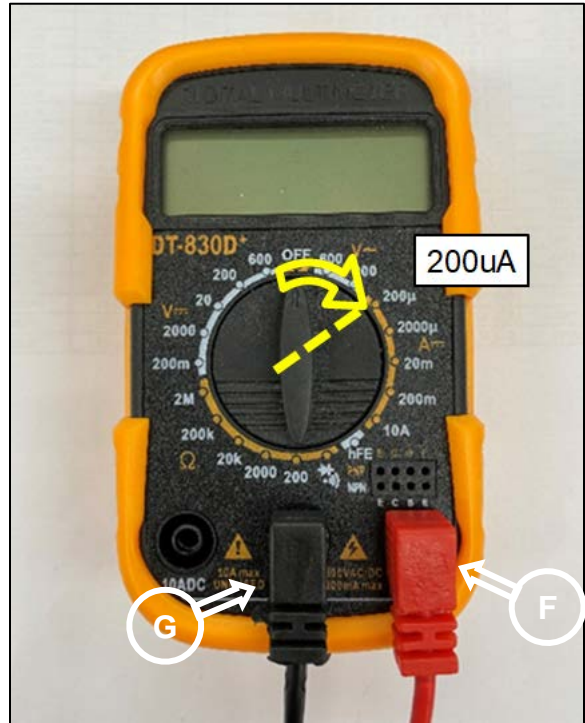
- Connect the red SST multimeter lead to VΩmA (F) and the black lead to COM (G). Turn the dial to 200uA.
