HYUNDAI Technical Service Bulletin

GROUP RECALL	NUMBER 20-01-040H
DATE October, 2020	MODEL(S) Tucson (TL)

SUBJECT: 2019-2021MY TUCSON (TL) ABS FUSE KIT INSTALLATION AND SOFTWARE UPDATE (RECALL CAMPAIGN 195)

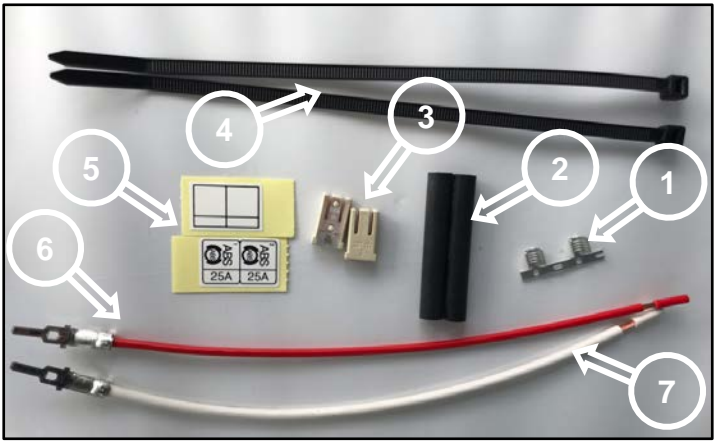
<p style="text-align: center;">91KIT-D325AQQH</p>	(1) U-Type Crimp Connector (2) Heat Shrink Tubing (3) 25A Fuses (4) Cable Ties (5) Labels (6) Red Lead Wire (7) White Lead Wire 1
