Safety Recall

Code: 40Q6

Subject Steering Knuckle(s) – STOP DRIVE

Release Date December 16, 2020

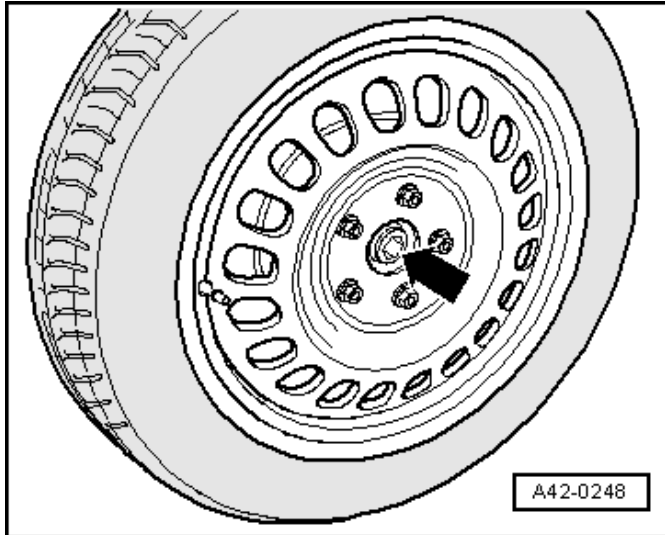
Loosen front drive axle bolt:

- Secure the front wheels from turning.
- Loosen the front axle bolt <arrow>.

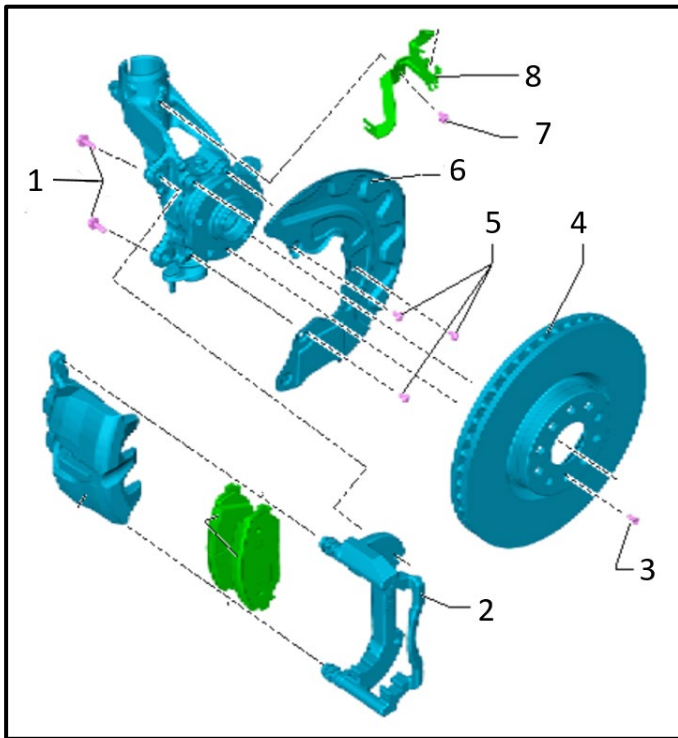
Remove brake components:

- Remove front wheel.
- Remove bolts <1> from the brake caliper carrier <2>.
- Remove brake caliper carrier <2> and secure it using wire to prevent damage to the brake hose.
- Remove bolt <3> and brake rotor <4>.
- Remove bolts <5> and backing plate <6>.
- Remove bolt <7> and secure bracket <8> out of the way.
- Free up wires from the wheel bearing housing.

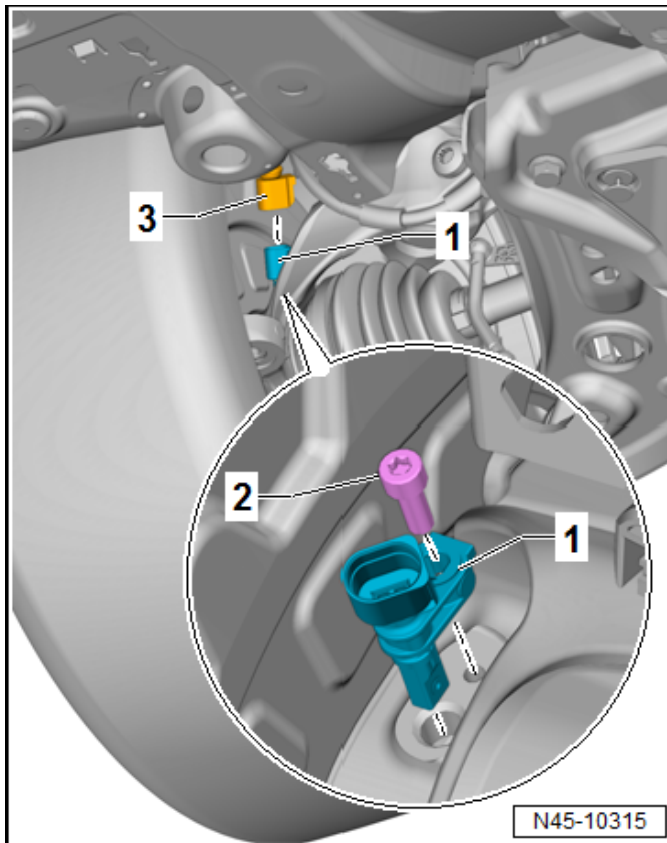
Remove ABS wheel speed sensor:

- Disconnect connector <3>.
- Remove bolt <2>.
- Remove ABS wheel speed sensor <1>.

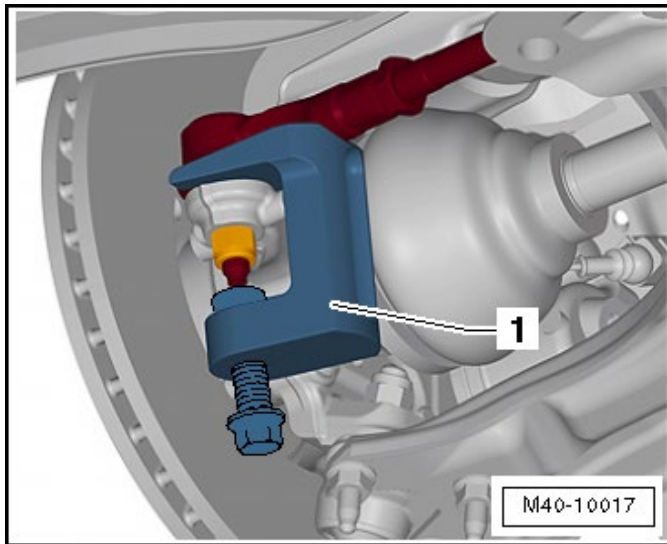
Remove tie rod end from wheel bearing housing:

- Loosen the nut from the tie rod end, but do not remove it yet.
- Install Puller – Ball Joint -T10187- <1> as shown.
- Tighten bolt using hand tools on -T10187- until tie rod end is pressed off the wheel bearing housing.

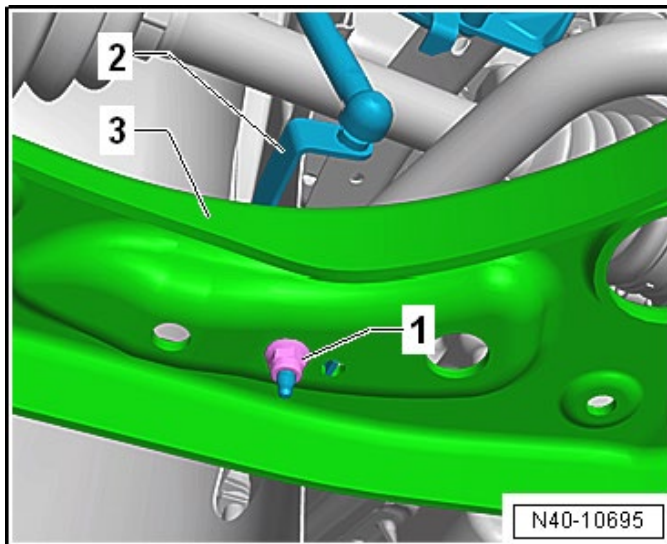
Remove level sensor bracket from control arm (if equipped):

- Remove nut <1>.
- Remove bracket <2> from control arm <3>.

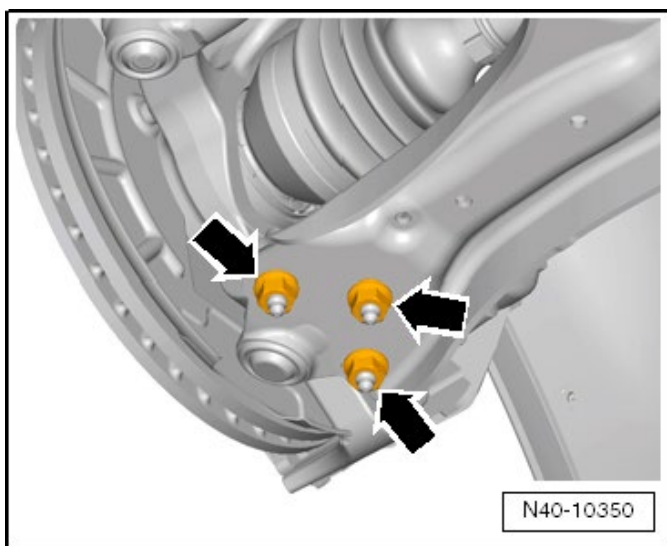
Remove wheel bearing housing from control arm:

- Remove nuts <arrows>.
- Press the drive axle outer joint out of the wheel bearing by hand.

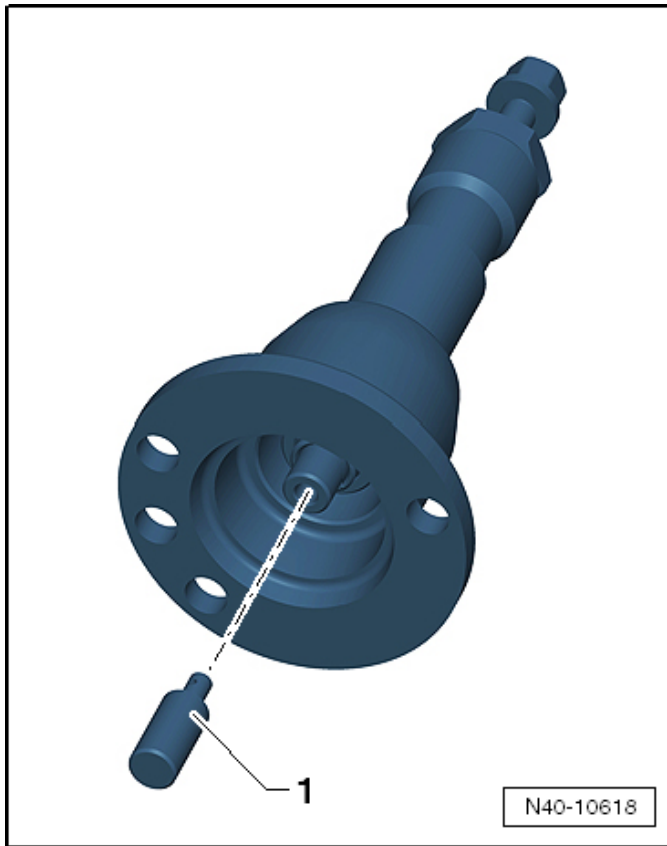
If the Drive Axle Cannot Be Pulled out of the Wheel Bearing, Then the Drive Axle Can Be Pushed out of the Wheel Bearing Using the Drive Shaft Remover -T10520A- as follows:

- Before using the -T10520A-, make sure that the thrust piece <1> is installed.

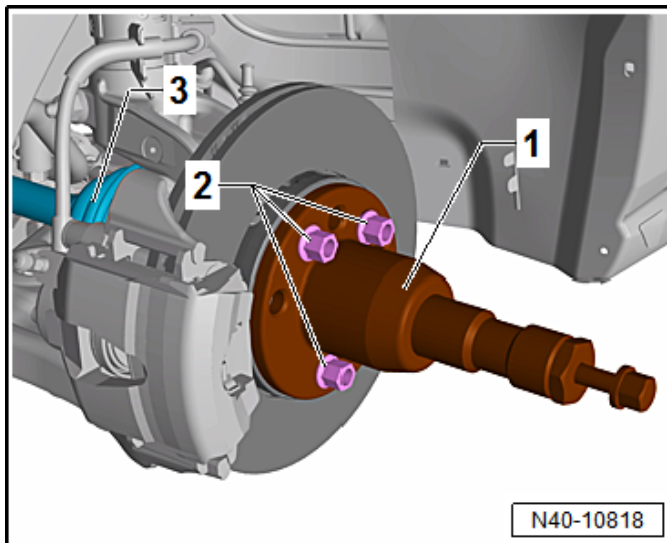
- Secure the -T10520A- <1> with three wheel bolts <2> on the wheel hub, so that the drive axle <3> can be pressed out.

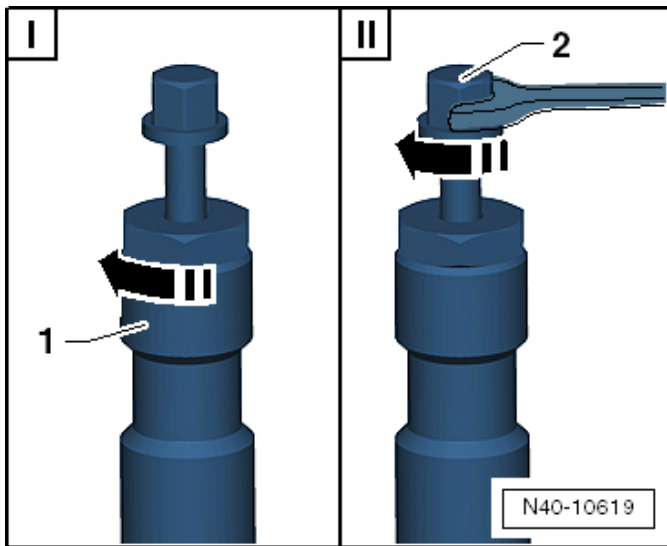
- Follow the specified sequence exactly.
 - I - Tighten the knurled nut <1> hand-tight.
 - II - Turn the bolt <2> using a wrench and press out the drive axle using the -T10520A-. DO NOT use power tools on bolt <2>.

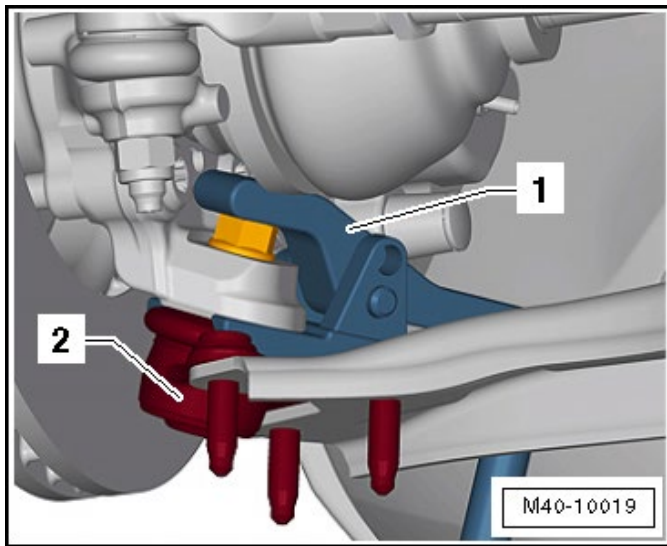
Remove ball joint:

- Loosen the nut on the ball joint <2> but do not remove it.
- Install Puller – Ball Joint -3287A- <1> as shown.
- Tighten bolt using hand tools on -3287A- until ball joint is pressed off the wheel bearing housing.
- Remove the ball joint nut and remove the ball joint.

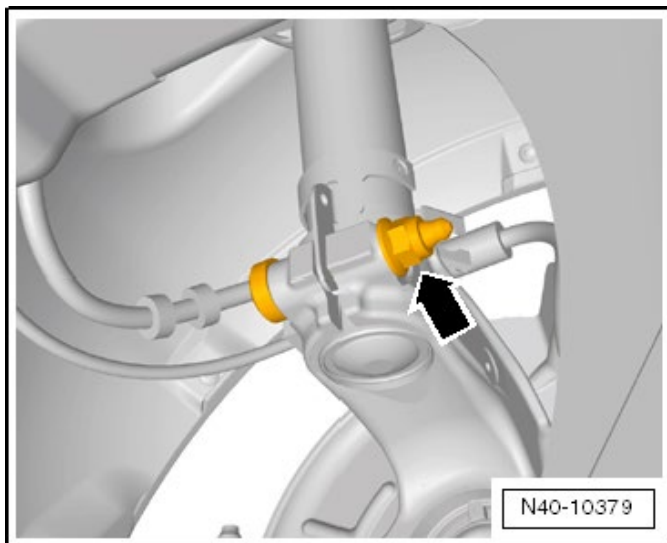
Remove wheel bearing housing:

- Place the -VAS6931- under the wheel bearing housing.
- Remove the threaded connection on the wheel bearing housing/suspension strut <arrow>.

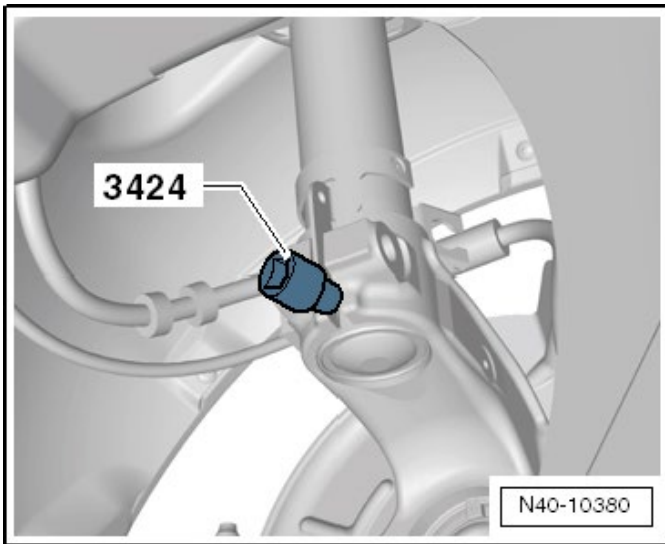
- Insert -3424- into the wheel bearing housing.

- Turn the ratchet 90° and remove it from the -3424-.
- Remove the wheel bearing housing downward from the suspension strut.

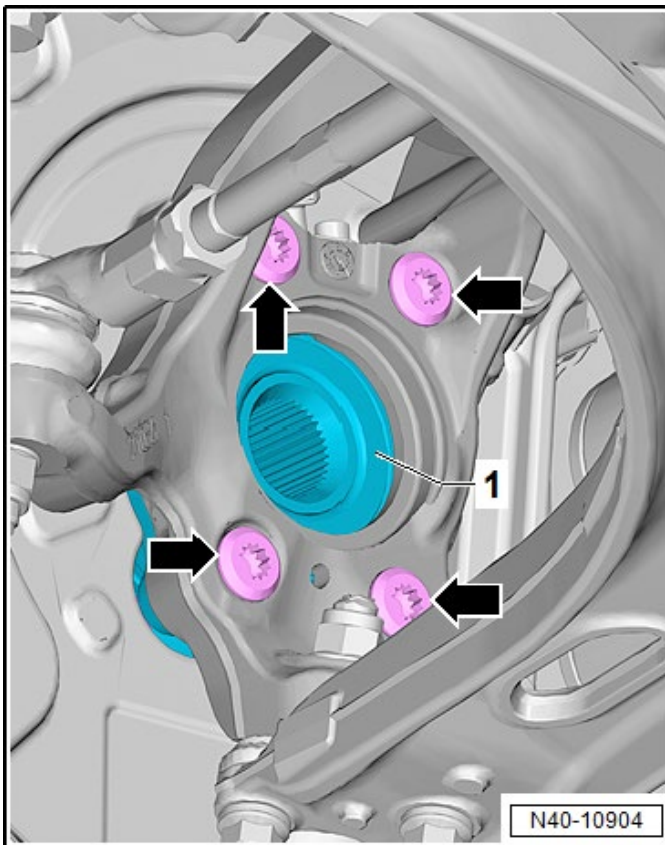
Install new wheel bearing into wheel bearing housing:

A new wheel bearing kit includes new mounting bolts <arrows> and a new drive axle bolt. If the new wheel bearing housing used during this repair comes with the wheel bearing pre-installed, a new drive axle bolt will be required.

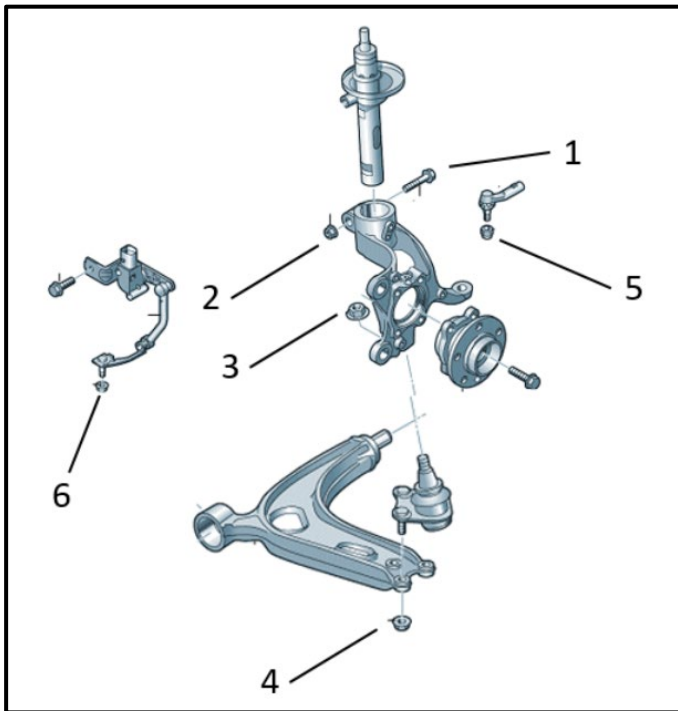
Install new wheel bearing housing:

- Installation is the reverse order of removal.
- Install new bolt <1> and new nut <2>.
 - The bolt tip must point in direction of travel.
- Remove -3424- after installing wheel bearing housing onto strut and installing new bolt and nut.
- Counter hold new bolt <1> and torque new nut <2> to 70 Nm + 180°.
- Counter hold ball joint stud. Install and torque new nut <3> to 60 Nm.

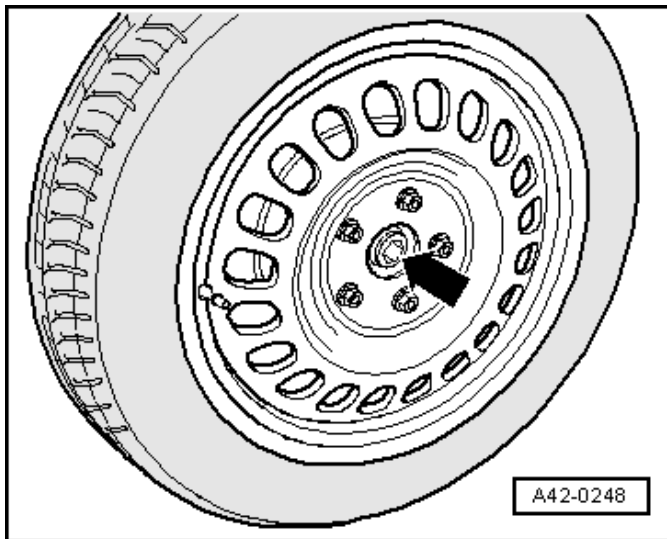
Install drive axle bolt:

- Press the brake pedal. A second technician will be needed.
- Tighten the twelve-point bolt to 200 Nm.
- Set the vehicle on its wheels.
- Tighten the twelve-point bolt an additional 90°.

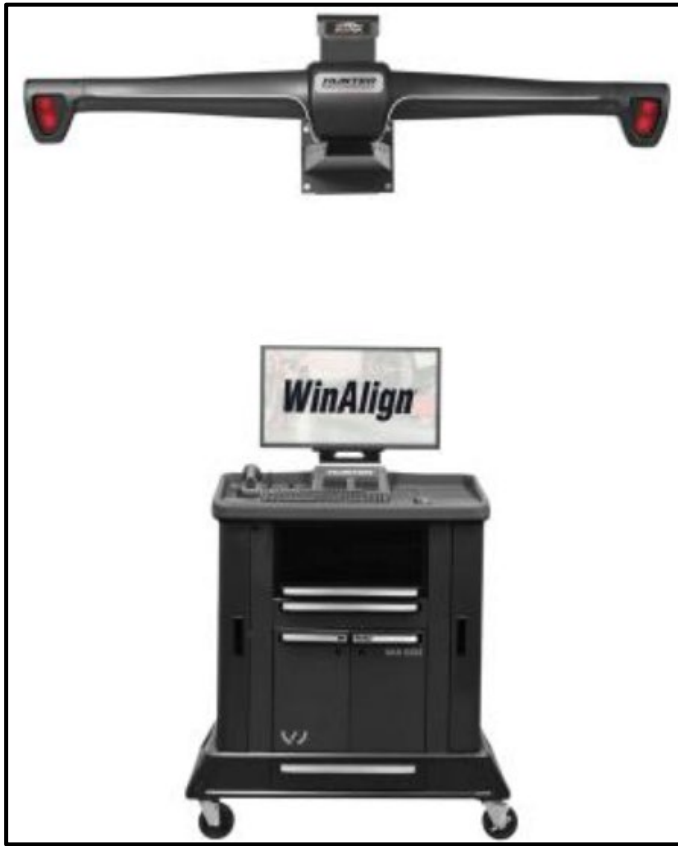
Perform four-wheel vehicle alignment:

- Follow the ELSA Repair Manual and wheel aligner equipment directions as needed.
- Was the rear axle toe adjusted?
 - If YES, proceed to the next step.
 - If NO, Proceed to Section D.

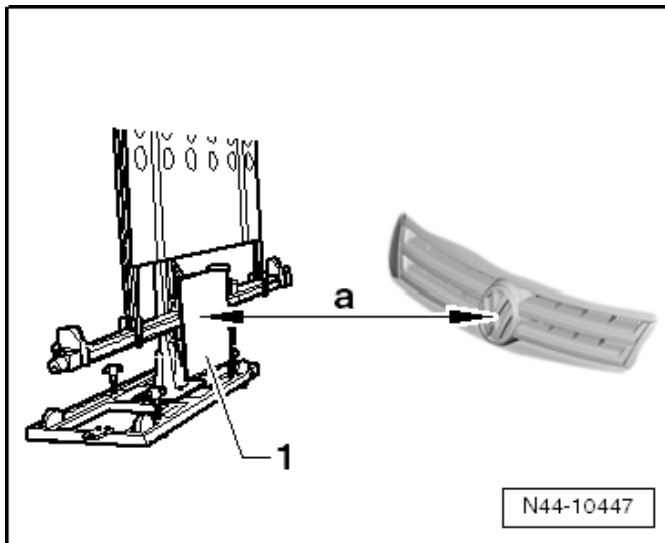
Calibrate driver assist systems depending on vehicle equipment:

- Calibrate *Adaptive Cruise Control (ACC)* only if rear axle toe required adjustment.
- Calibrate *Driver Assistance Systems Front Camera* only if rear axle toe required adjustment.
- Follow the ELSA repair manual procedures, GFF test plan directions and wheel aligner software directions as needed.
