TECHNICAL INSTRUCTIONS
FOR
20TA17
STEERING COLUMN ISSUE MAY AFFECT AIRBAG PERFORMANCE
CERTAIN 2020 – 2021 AVALON
CERTAIN 2020 AVALON HYBRID

A component of the steering column on the subject vehicles may have been damaged during assembly. This can potentially affect the performance of the driver airbag when it deploys. This may cause the vehicles not to meet certain federal safety requirements and can result in an increased risk of injury during a crash necessitating airbag deployment.

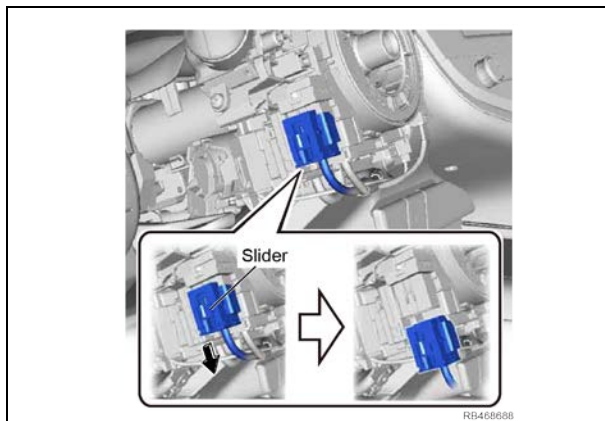
- (i) Slide the slider to release the lock, and then disconnect the airbag connector

When disconnecting any airbag connector, take care not to damage the airbag wire harness.

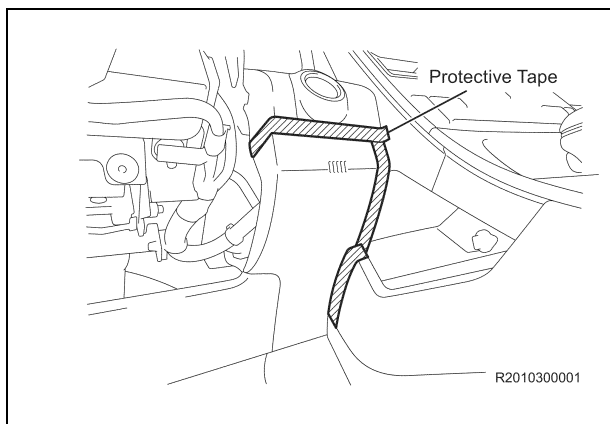
- (i) TIP: apply protective tape to the position indicated in the illustration to prevent damage to the LOWER NO. 2 INSTRUMENT FINISH PANEL.

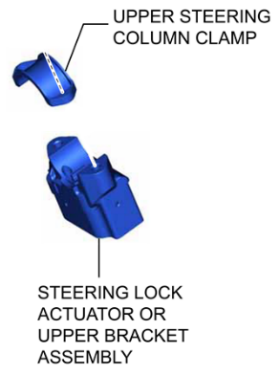
DO NOT DAMAGE STEERING LOCK ACTUATOR

The steering lock actuator will be re-used for this repair. Please take care not to damage it during removal.

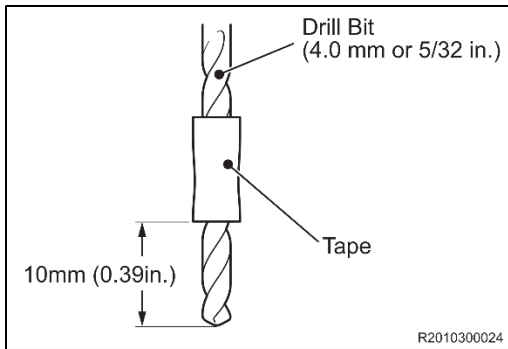
A 4.0 mm (5/32) drill bit is recommended.

- (i) Tape the drill bit at 10 mm from the tip as a stopper
