IMPORTANT SAFETY RECALL

Re: Safety Recall - Smart-Steer 2.0 Self-Steer Axle

Recall 21E-019

Subject: SMART-STEER 2.0 Bolt-On Steer Arm Reinforcement Welds

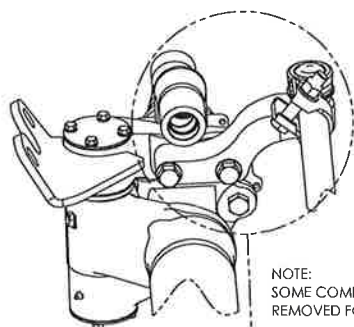
DETAIL A
SCALE 1 : 4

Based on feedback from our customers, Dexter Heavy Duty has become aware that under certain loading conditions, the 8-7/8" steer arm setup on the SMART-STEER 2.0 axle is prone to shearing the attaching steer arm bolts. This will lead to a failure in the steer arm assembly.

1. Visually inspect steer arm bolts and washers for mechanical tightness and replace if necessary.
2. Ensure the steer arm bolts are torqued to 400 Ft. Lbs.
3. Place welds as shown on page three of this bulletin. If you would like a copy of engineering drawing 750049, please contact one of the service technicians listed below.
