## PRODUCT CAMPAIGN BULLETIN

**APPLICABILITY:** 2019-20MY Ascent  
 2020-21MY Legacy 2.4L (turbo models)  
 2020-21MY Outback 2.4L (turbo models)

**NUMBER:** WRK-21/22R  
**DATE:** 07/05/22  
**REVISED:** 12/29/22

**SUBJECT:** CVT Chain Guide Breakage

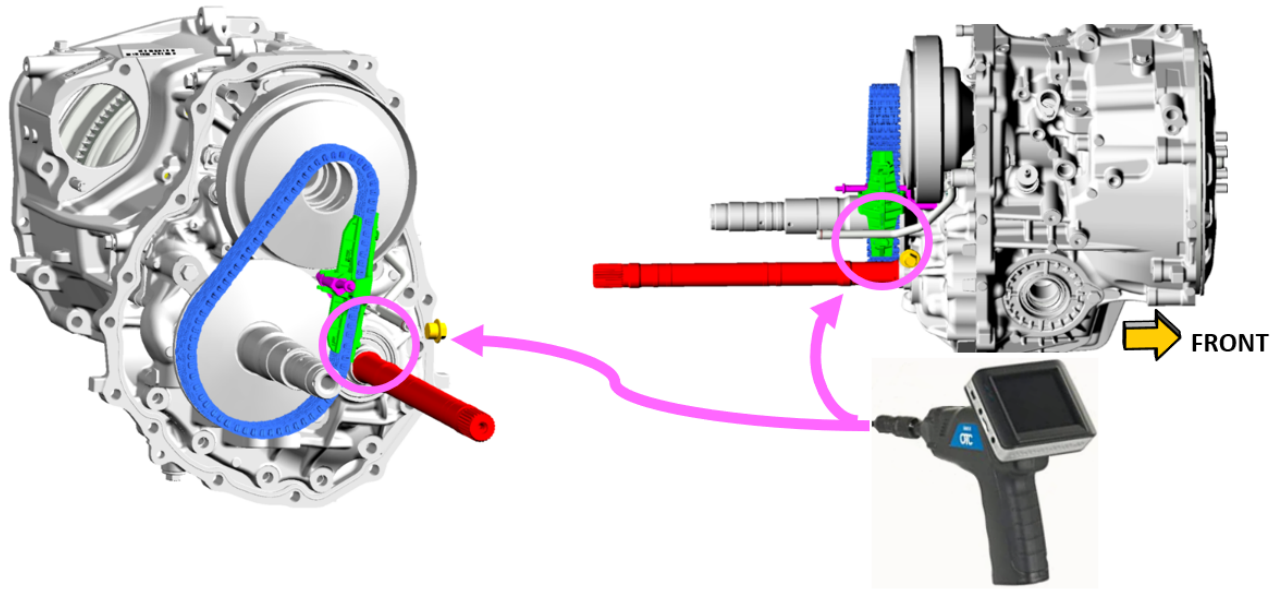
**STEP 3E:** Inspect the position of the lower end of the chain guide rail and the drive pinion shaft.

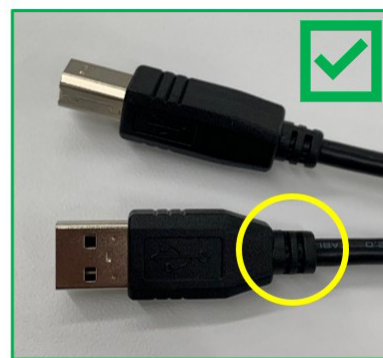
Exposed Wiring &  
Incorrect Cable

Confirm the PC being use for reprogramming is connected to a known good power source. Turn off any screen saver settings. Make sure the PC is not in power saving mode and is set to the normal power mode. Always inspect the DST-I/DST-010 and PC cables prior to programing. Confirm the cables are CORRECT and there is no exposed wiring, corroded connections, or loose fitment. See the example images below.

Correct Cable
