August 10, 2022

**SUBJECT: NEW VEHICLE DEMONSTRATION / DELIVERY HOLD -**

**Safety Recall 21S56 – Supplement #7**

Certain 2021 - 2022 Model Year F-150 Vehicles Equipped with Crew Cab, 145" Wheelbase, 4x4, 302a & Above Option Package, and One-Piece Aluminum Driveshaft Loose/Sagging Underbody Insulators

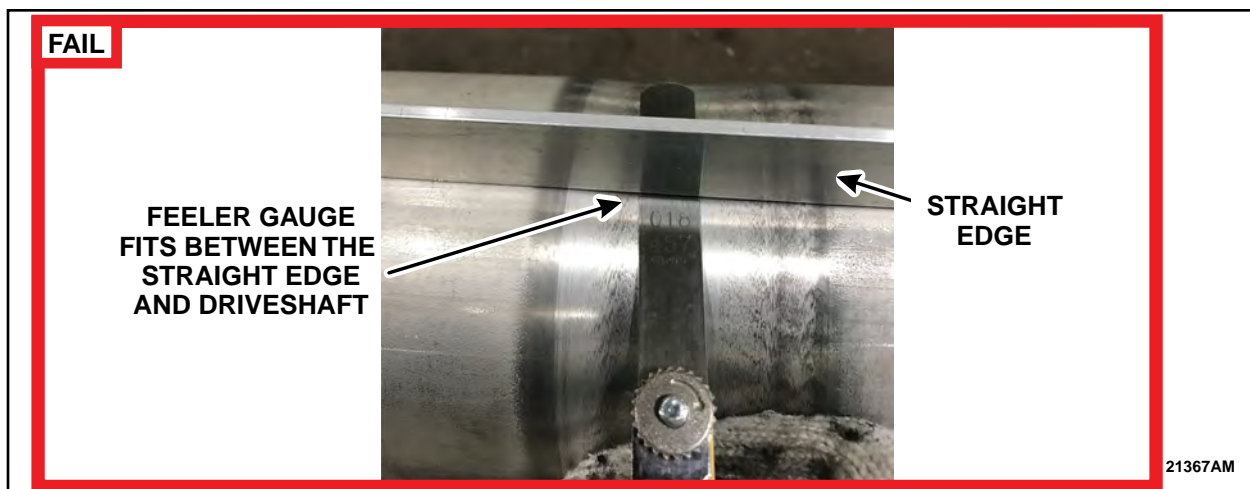
FIGURE 4

11. Place a straight edge along the driveshaft over the wear mark and attempt to fit a 0.018in (0.45mm) feeler gauge between the flat edge and the wear mark. Can the feeler gauge fit between the straight edge and anywhere along the wear mark? See Figures 3 and 4.

Yes – Does not pass inspection. Contact the SSSC and provide a picture of the driveshaft with the feeler gauge fitting between the straight edge and wear mark. Once approved, rear driveshaft replacement will be required, but do not install at this time. Proceed to step 14.

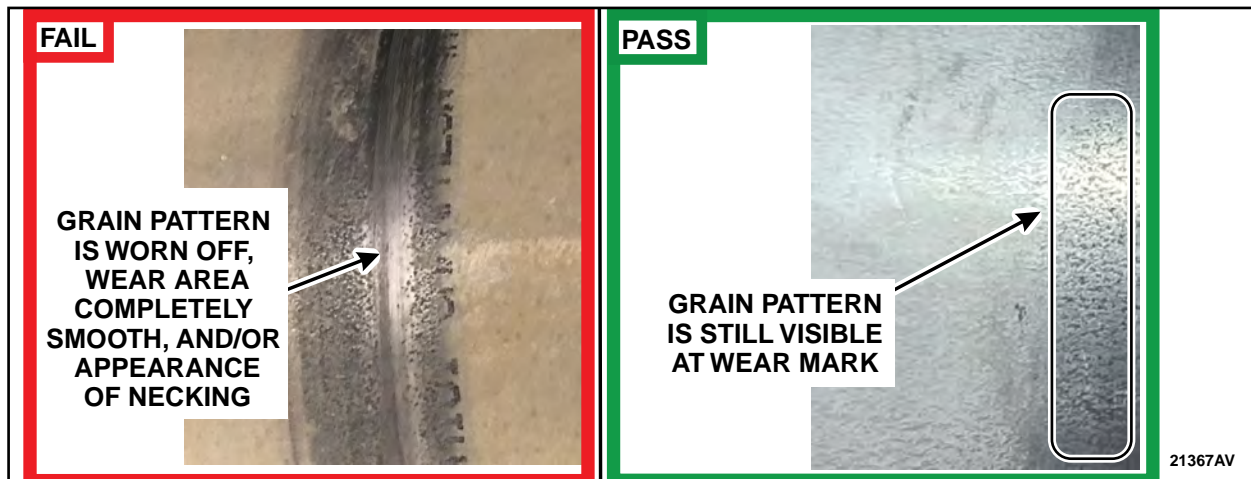
FIGURE 9

10. Inspect the marks found on Zone 2. Is the aluminum tube surface grain pattern worn off, completely smooth, or have an appearance of necking? See Figures 6 through 9.

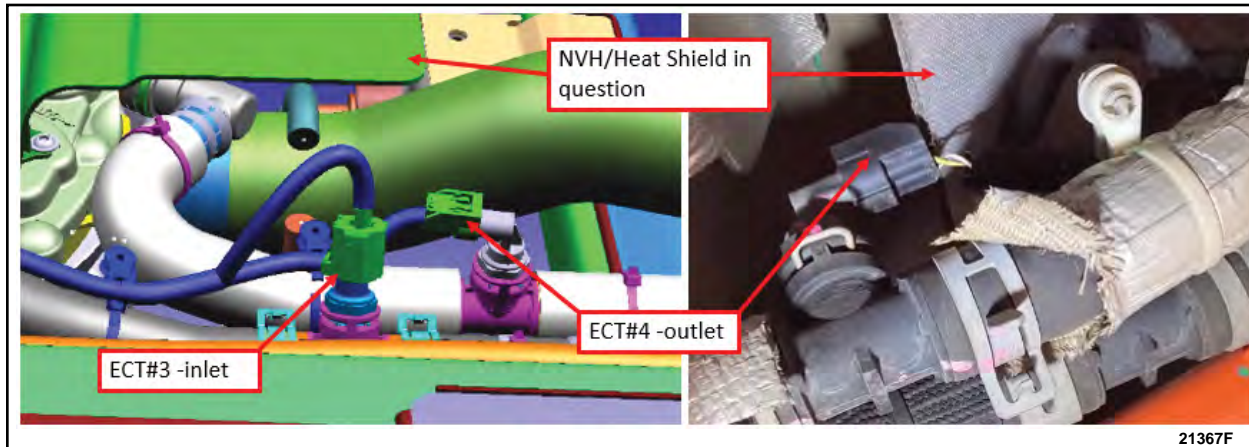
FIGURE 10

10. Inspect the front Engine Coolant Temperature (ECT) sensor connectors for any damage caused by the passenger side insulator. Is there any damage? See Figure 10.

Yes – Does not pass inspection. Contact the SSSC and provide a picture of the damage for proper technical instructions and part numbers, then proceed to step 11.

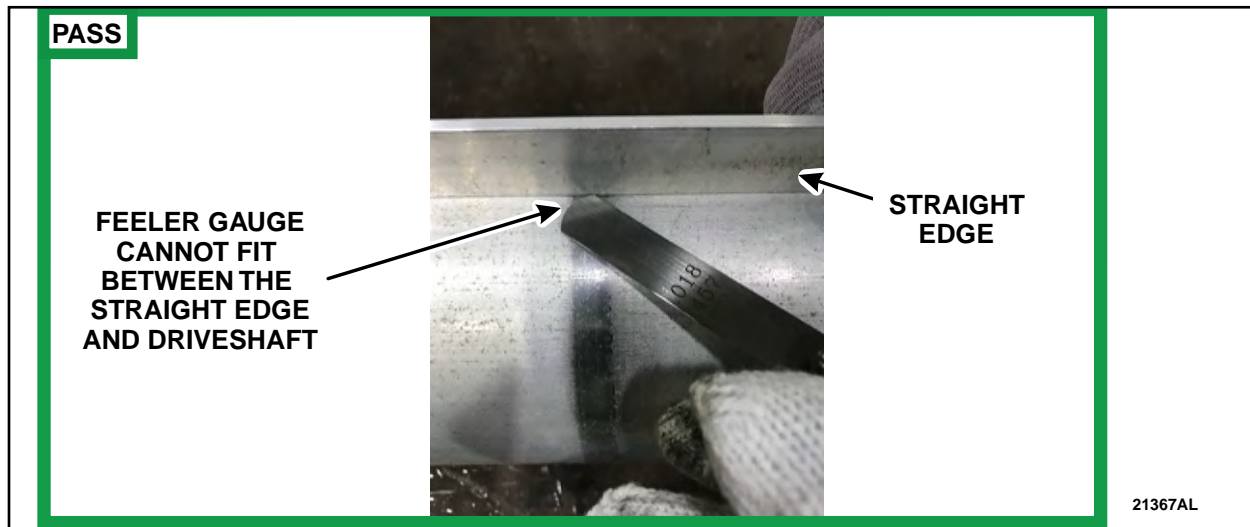
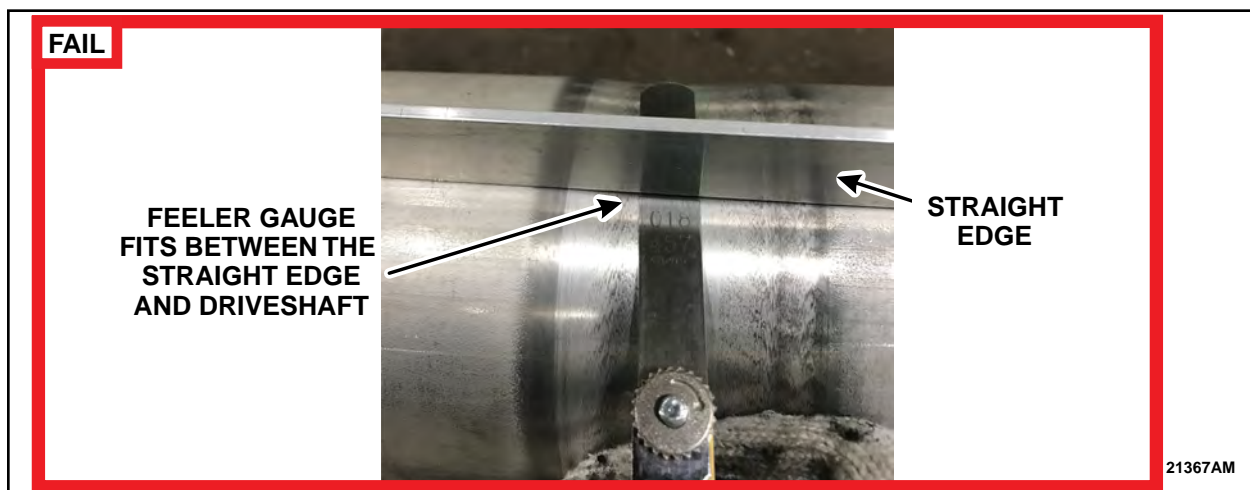
FIGURE 3

9. Place a straight edge along the driveshaft over the wear mark and attempt to fit a 0.018in (0.45mm) feeler gauge between the flat edge and the wear mark. Can the feeler gauge fit between the straight edge and anywhere along the wear mark? See Figures 3 and 4.

Yes – Does not pass inspection. Contact the SSSC and provide a picture of the driveshaft with the feeler gauge fitting between the straight edge and wear mark. Once approved, rear driveshaft replacement will be required, but do not install at this time. Proceed to step 12.
