**SUBJECT: NEW VEHICLE DEMONSTRATION / DELIVERY HOLD -**

**Safety Recall 21S56 – Supplement #6**

Certain 2021 - 2022 Model Year F-150 Vehicles Equipped with Crew Cab, 145" Wheelbase, 4x4, 302a & Above Option Package, and One-Piece Aluminum Driveshaft Loose/Sagging Underbody Insulators

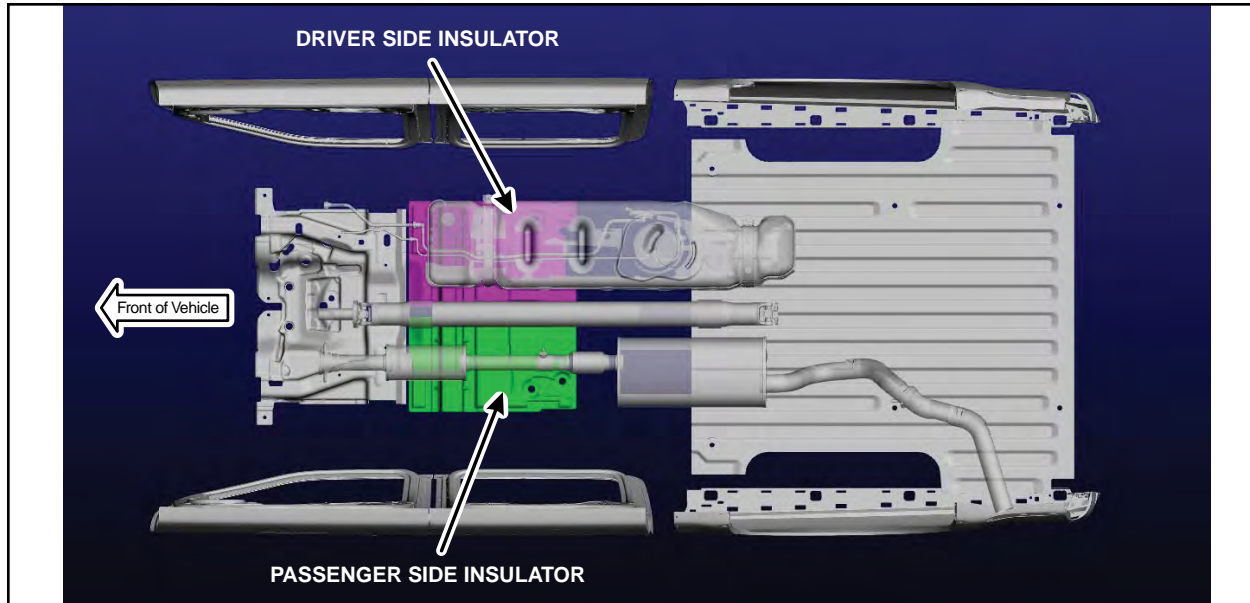
**FIGURE 1**

**NOTE:** The passenger side insulator is located directly above the exhaust.

**NOTE:** Insulators are highlighted for illustration purposes only.

Dearborn Truck Plant Build Date - Design change that removed underbody insulators from production

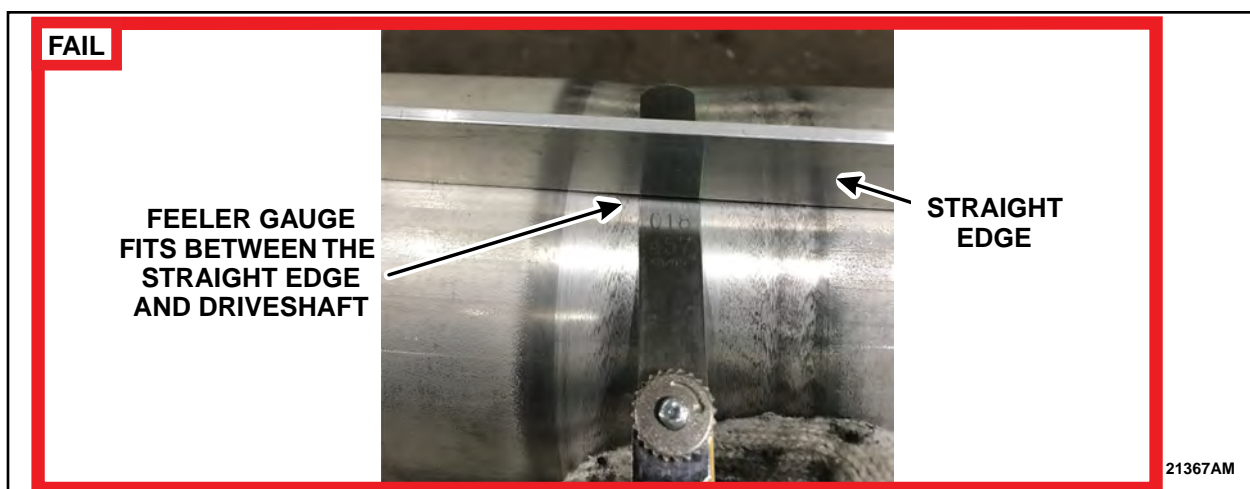
FIGURE 4

11. Place a straight edge along the driveshaft over the wear mark and attempt to fit a 0.018in (0.45mm) feeler gauge between the flat edge and the wear mark. Can the feeler gauge fit between the straight edge and anywhere along the wear mark? See Figures 3 and 4.

Yes – Does not pass inspection. Contact the SSSC and provide a picture of the driveshaft with the feeler gauge fitting between the straight edge and wear mark. Once approved, rear driveshaft replacement will be required, but do not install at this time. Proceed to step 14.

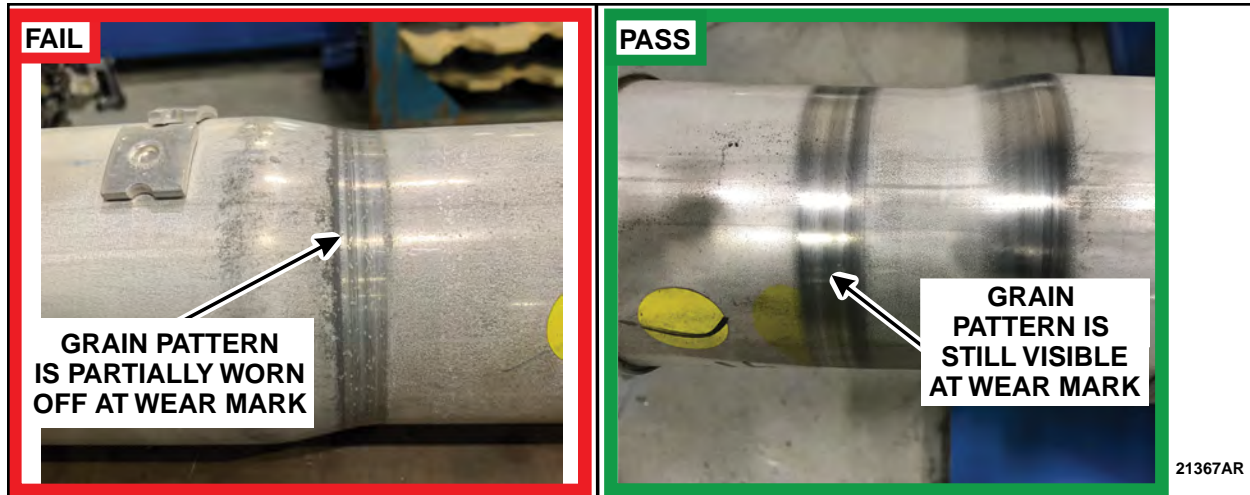
FIGURE 7

13. Inspect the marks found on Zone 2. Is the aluminum tube surface grain pattern worn off, completely smooth, or have an appearance of necking? See Figures 6 through 9.

Yes – Does not pass inspection. Contact the SSSC and provide a picture of the driveshaft with the grain pattern worn off. Be sure to show a clear image of the grain pattern missing. Once approved, rear driveshaft replacement will be required, but do not install at this time. Proceed to step 14.

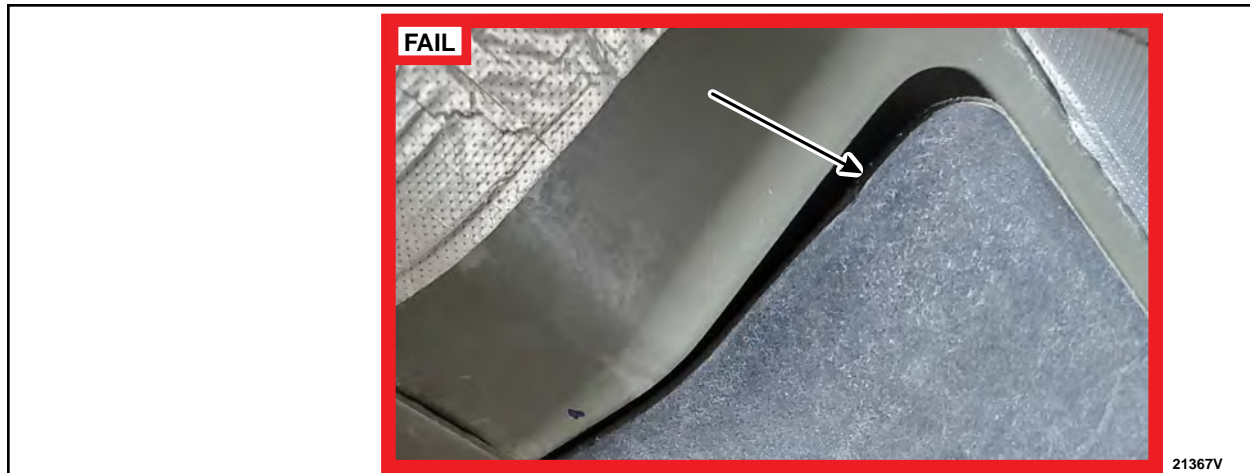
**FIGURE 10**

14. Inspect the driver side insulator for any edges hanging down or touching the fuel tank. Is the insulator hanging down or touching the fuel tank? See Figure 10.

Yes – Does not pass inspection. Proceed to step 15.

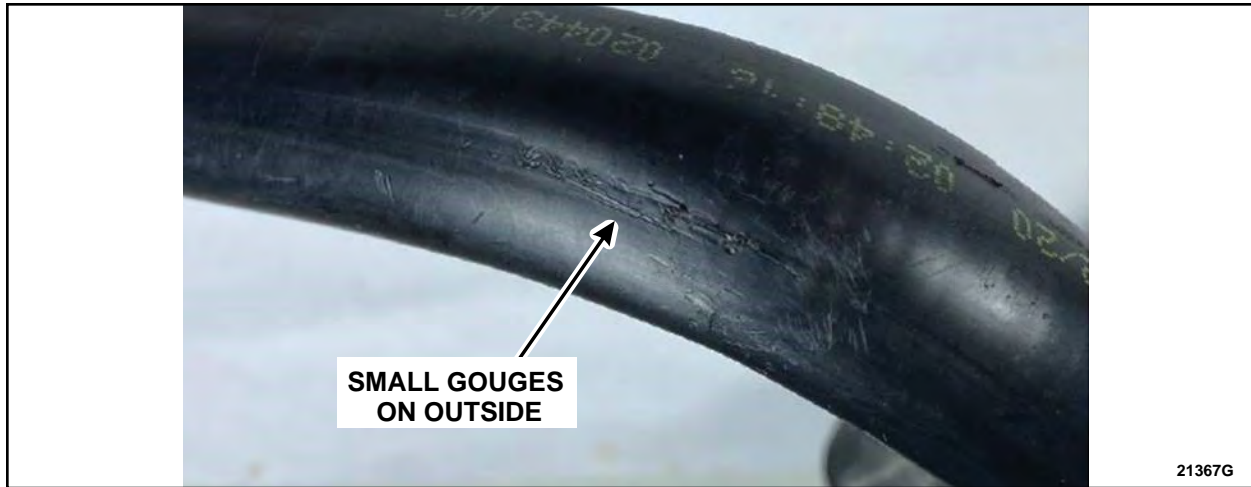
FIGURE 12

16. Inspect the vapor line for any damage caused by the driver side insulator. Is there any damage to the line? See Figures 11 through 13.

SMALL GOUGES  
ON OUTSIDE

Yes – Does not pass inspection. Replace the damaged line. Please follow WSM procedures in Section 310-01, then proceed to step 17.

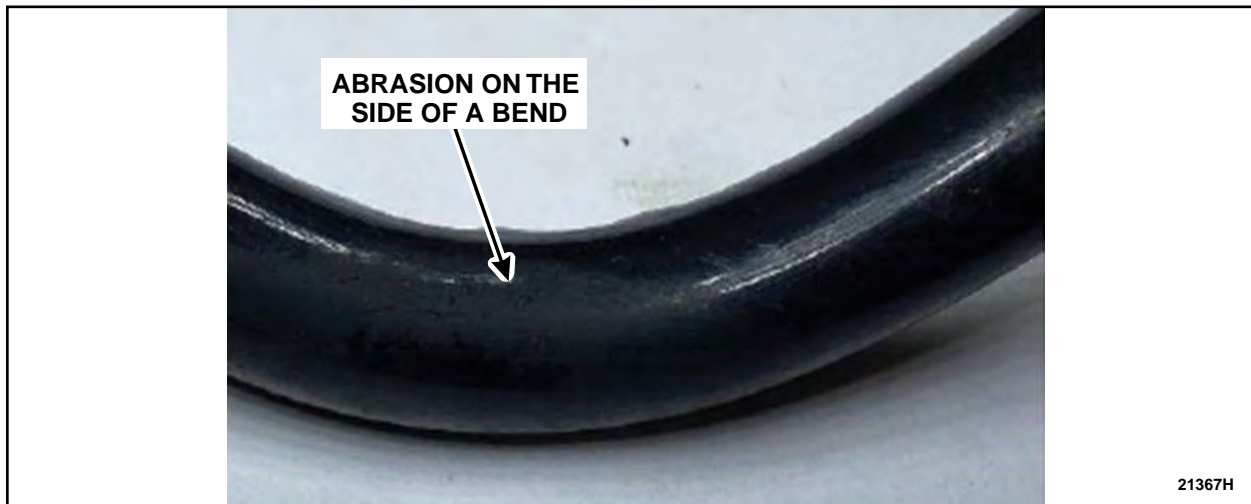
FIGURE 13

ABRASION ON THE  
SIDE OF A BEND

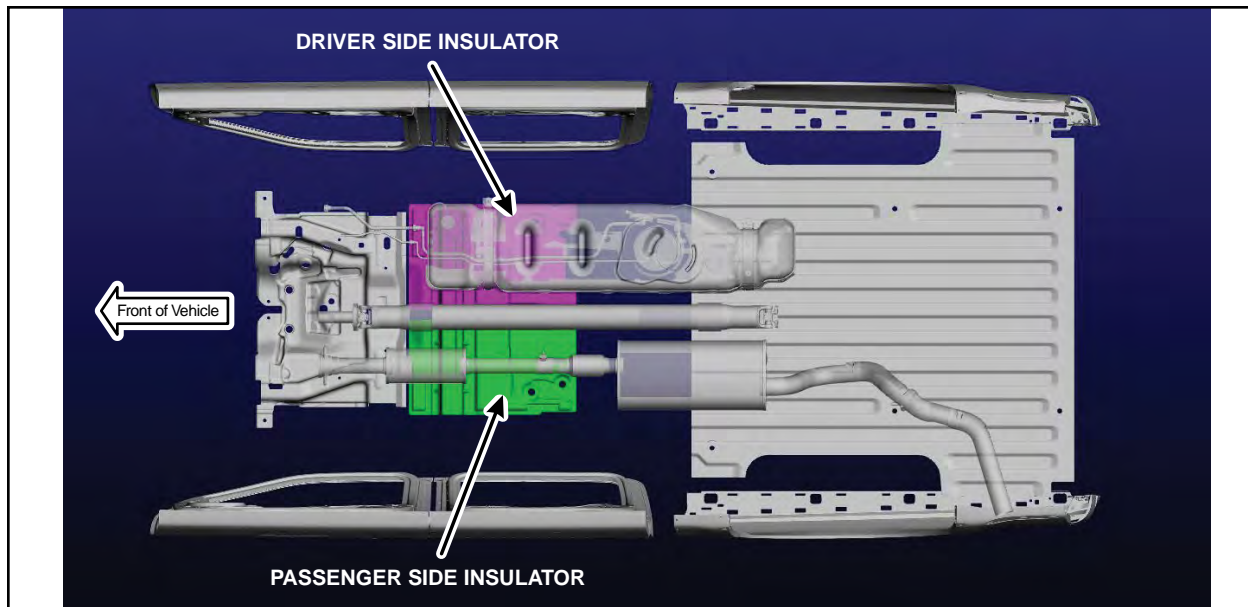
**FIGURE 1**

**NOTE:** Insulators are highlighted for illustration purposes only.

Dearborn Truck Plant Build Date - Design change that removed underbody insulators from production

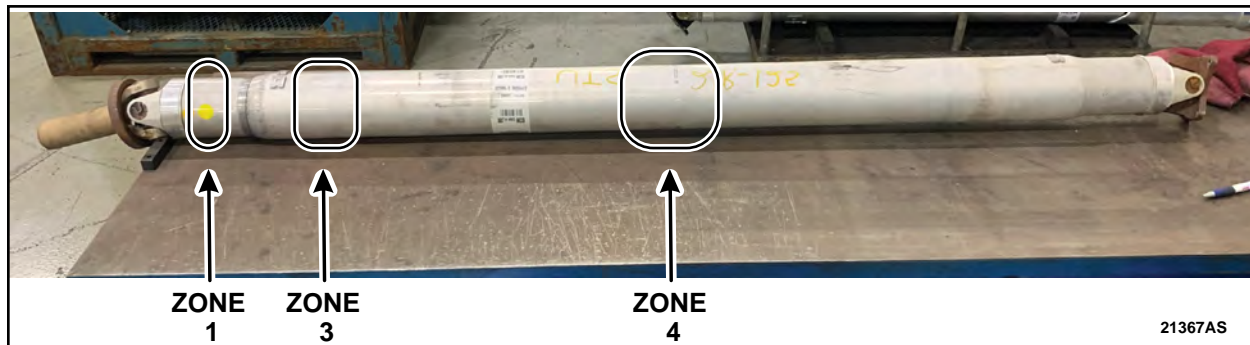
**FIGURE 2**

6. Inspect Zones 1, 3 and 4 of the rear driveshaft for any marks caused by the front and/or rear edges of the passenger side insulator. Are there any marks present in Zones 1, 3 or 4? See Figure 2.

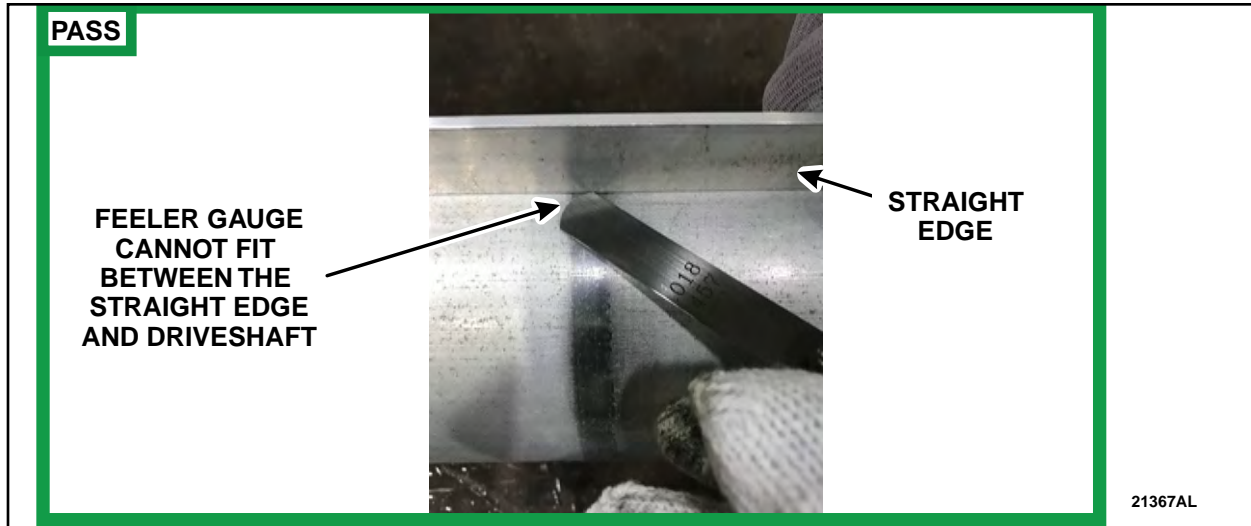
FIGURE 3

8. Place a straight edge along the driveshaft over the wear mark and attempt to fit a 0.018in (0.45mm) feeler gauge between the flat edge and the wear mark. Can the feeler gauge fit between the straight edge and anywhere along the wear mark? See Figures 3 and 4.

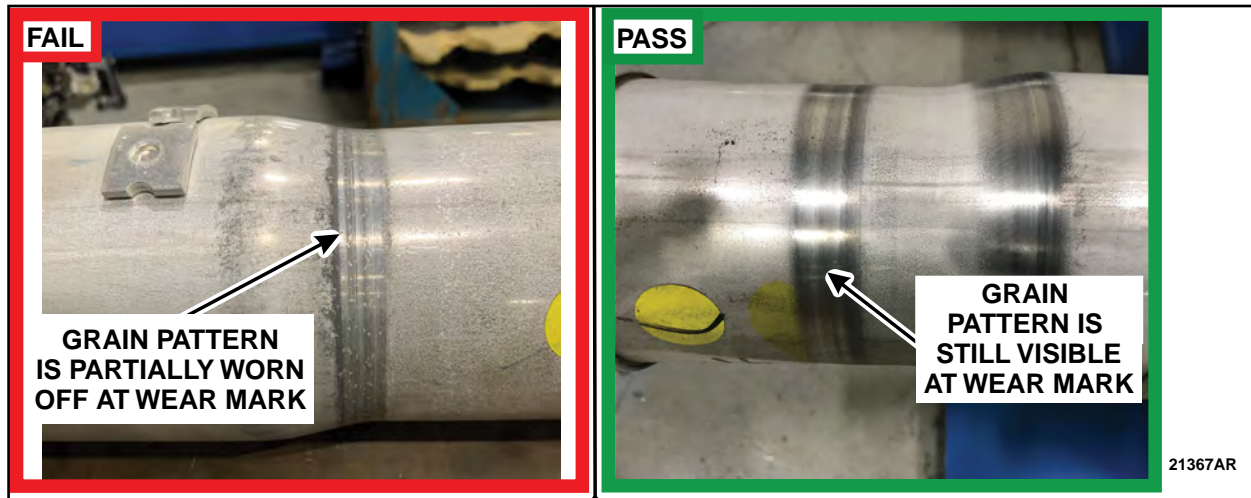
FIGURE 7

10. Inspect the marks found on Zone 2. Is the aluminum tube surface grain pattern worn off, completely smooth, or have an appearance of necking? See Figures 6 through 9.

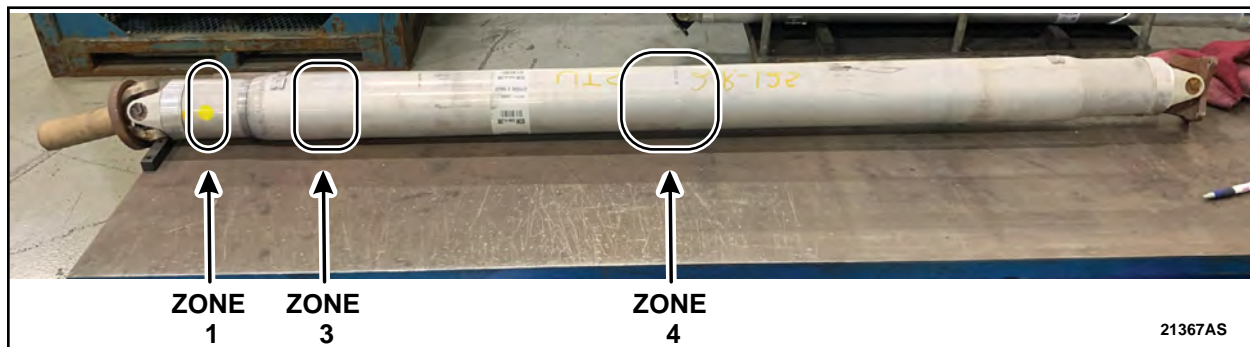
**FIGURE 2**

5. Inspect Zones 1, 3 and 4 of the rear driveshaft for any marks caused by the front and/or rear edges of the passenger side insulator. Are there any marks present in Zones 1, 3 or 4? See Figure 2.

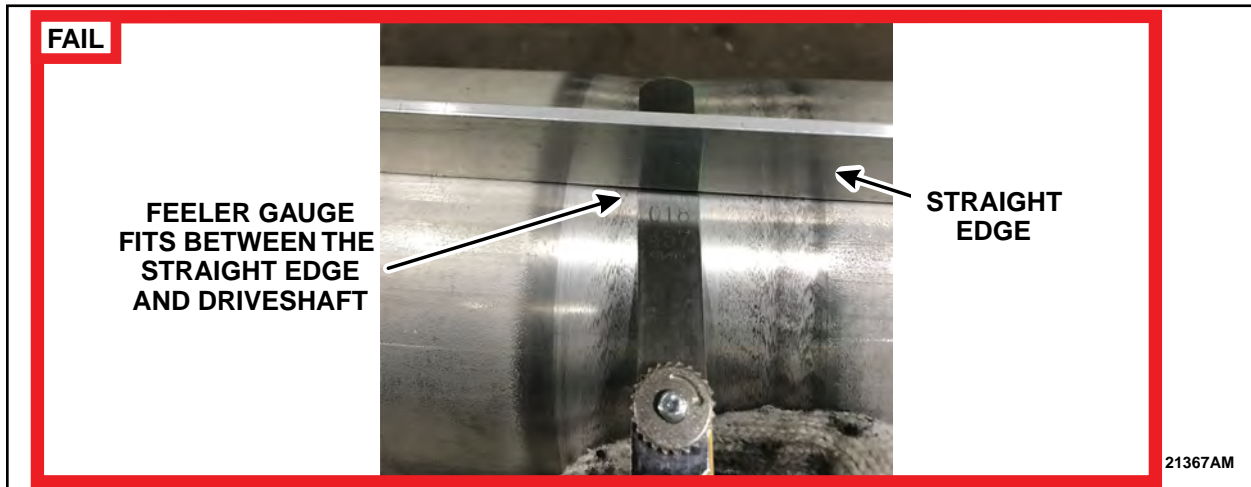
FIGURE 3

7. Place a straight edge along the driveshaft over the wear mark and attempt to fit a 0.018in (0.45mm) feeler gauge between the flat edge and the wear mark. Can the feeler gauge fit between the straight edge and anywhere along the wear mark? See Figures 3 and 4.

Yes – Does not pass inspection. Contact the SSSC and provide a picture of the driveshaft with the feeler gauge fitting between the straight edge and wear mark. Once approved, rear driveshaft replacement will be required, but do not install at this time. Proceed to step 10.

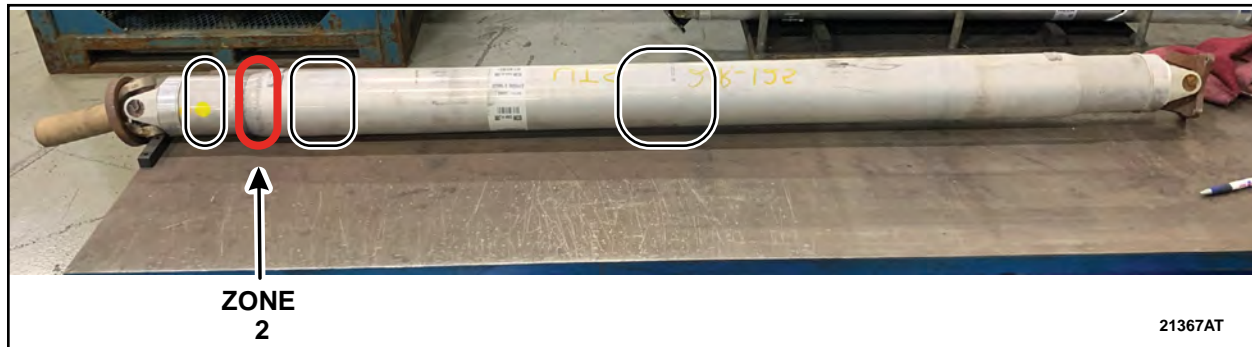
FIGURE 5

8. Inspect Zone 2 (transition from larger tube diameter to smaller diameter section) of the driveshaft tube for any marks caused by the front edge of the passenger side insulator. Are there any marks present? See Figure 5.

Yes – Does not pass inspection. Proceed to step 9.

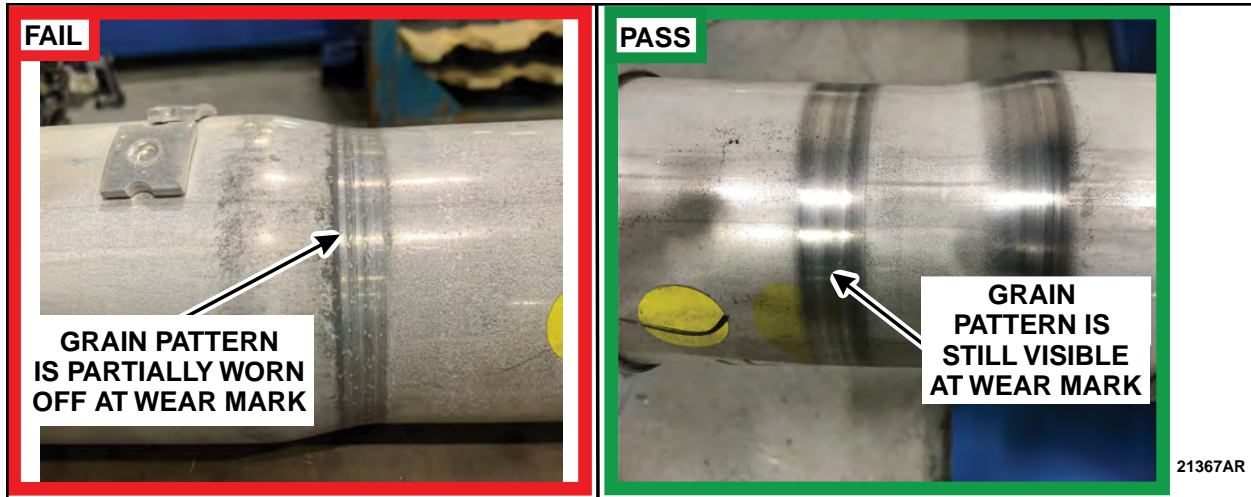
FIGURE 7

9. Inspect the marks found on Zone 2. Is the aluminum tube surface grain pattern worn off, completely smooth, or have an appearance of necking? See Figures 6 through 9.

Yes – Does not pass inspection. Contact the SSSC and provide a picture of the driveshaft with the grain pattern worn off. Be sure to show a clear image of the grain pattern missing. Once approved, rear driveshaft replacement will be required, but do not install at this time. Proceed to step 10.

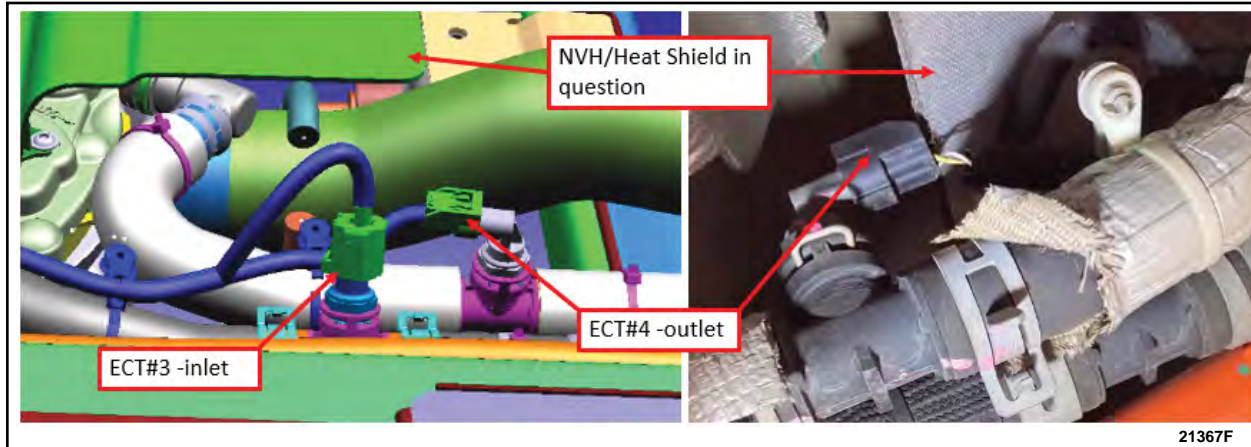
FIGURE 10

10. Inspect the front Engine Coolant Temperature (ECT) sensor connectors for any damage caused by the passenger side insulator. Is there any damage? See Figure 10.

Yes – Does not pass inspection. Contact the SSSC and provide a picture of the damage for proper technical instructions and part numbers, then proceed to step 11.

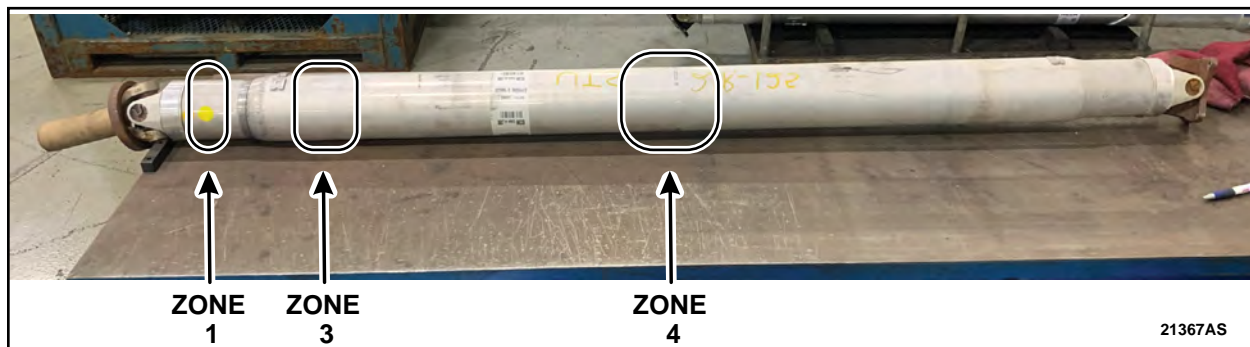
**FIGURE 2**

- Inspect Zones 1, 3 and 4 of the rear driveshaft for any marks caused by the front and/or rear edges of the passenger side insulator. Are there any marks present in Zones 1, 3 or 4? See Figure 2.

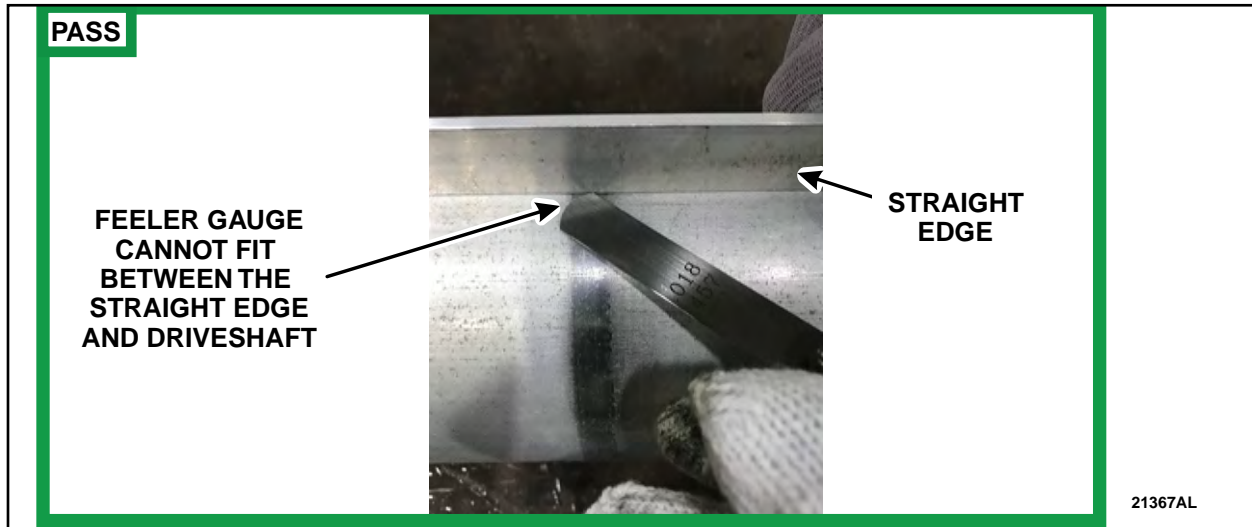
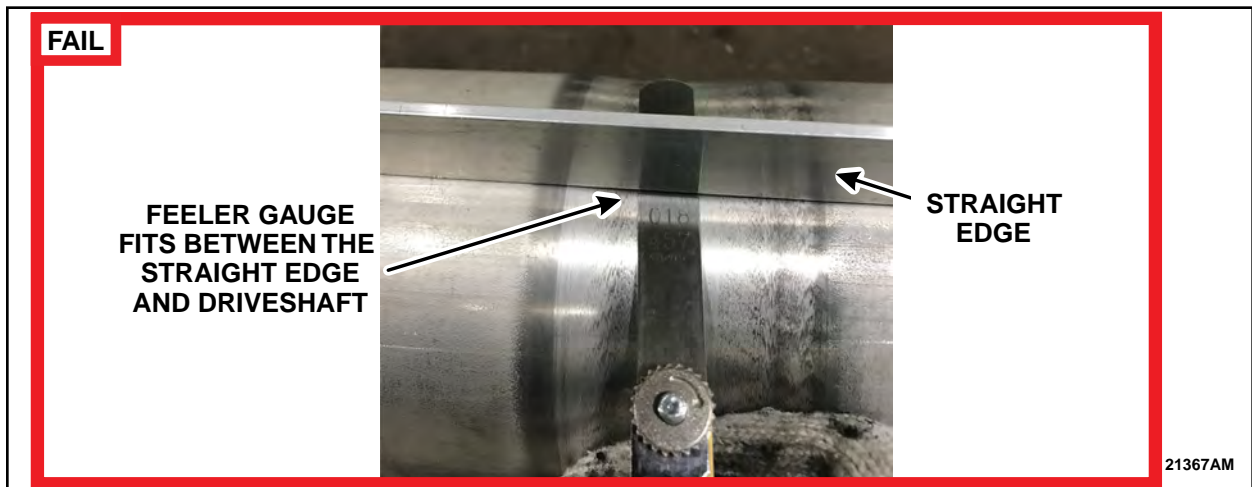
9. Place a straight edge along the driveshaft over the wear mark and attempt to fit a 0.018in (0.45mm) feeler gauge between the flat edge and the wear mark. Can the feeler gauge fit between the straight edge and anywhere along the wear mark? See Figures 3 and 4.

Yes – Does not pass inspection. Contact the SSSC and provide a picture of the driveshaft with the feeler gauge fitting between the straight edge and wear mark. Once approved, rear driveshaft replacement will be required, but do not install at this time. Proceed to step 12.

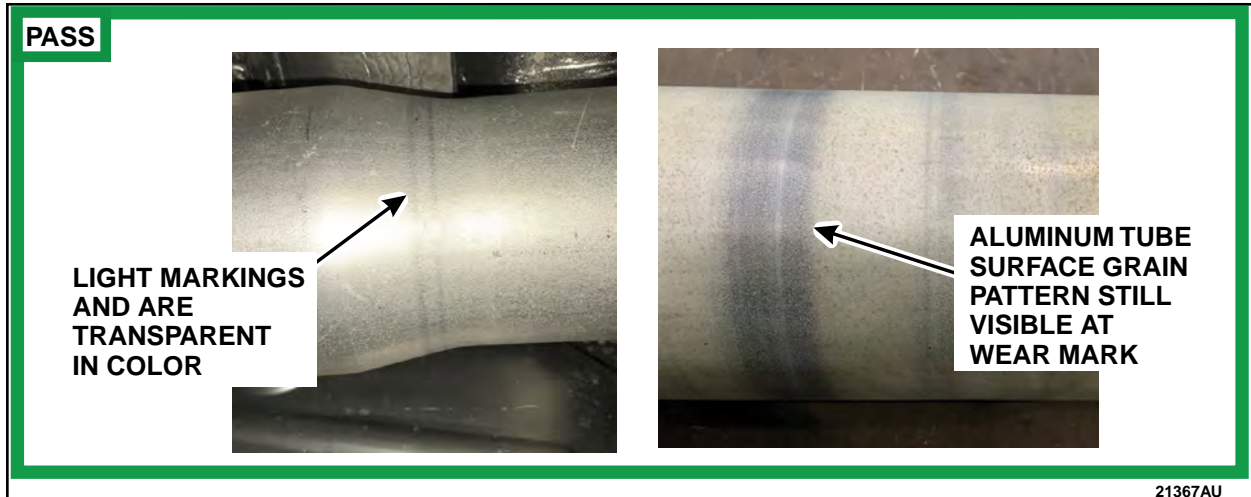
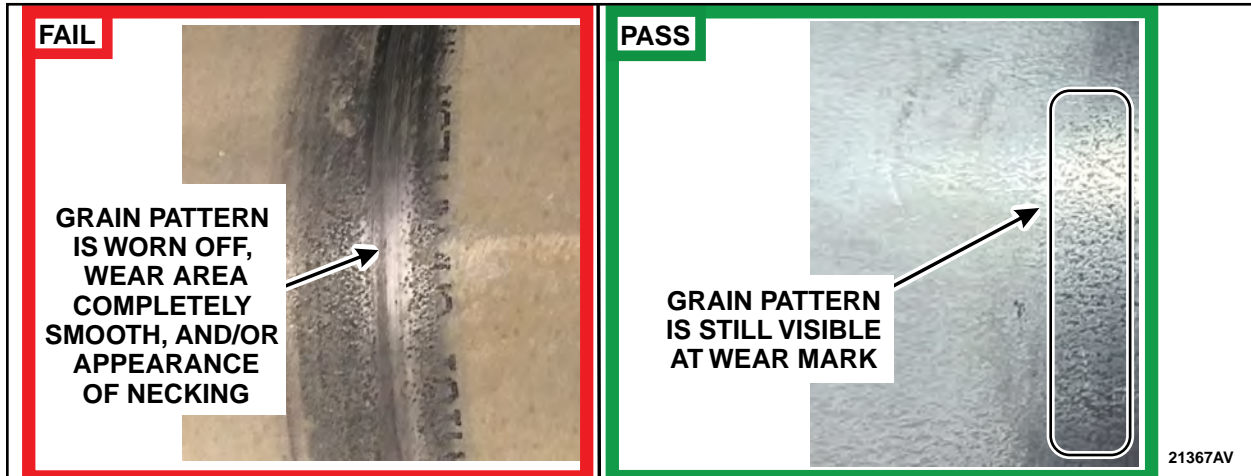
11. Inspect the marks found on Zone 2. Is the aluminum tube surface grain pattern worn off, completely smooth, or have an appearance of necking? See Figures 6 through 9.

Yes – Does not pass inspection. Contact the SSSC and provide a picture of the driveshaft with the grain pattern worn off. Be sure to show a clear image of the grain pattern missing. Once approved, rear driveshaft replacement will be required, but do not install at this time. Proceed to step 12.
