February 7, 2022

**SUBJECT: NEW VEHICLE DEMONSTRATION / DELIVERY HOLD -
 Safety Recall 21S56 – Supplement #2**

Certain 2021 - 2022 Model Year F-150 Vehicles Equipped with Crew Cab, 145”
 Wheelbase, 4x4, 302a & Above Option Package, and One-Piece Aluminum Driveshaft
 Loose/Sagging Underbody Insulators

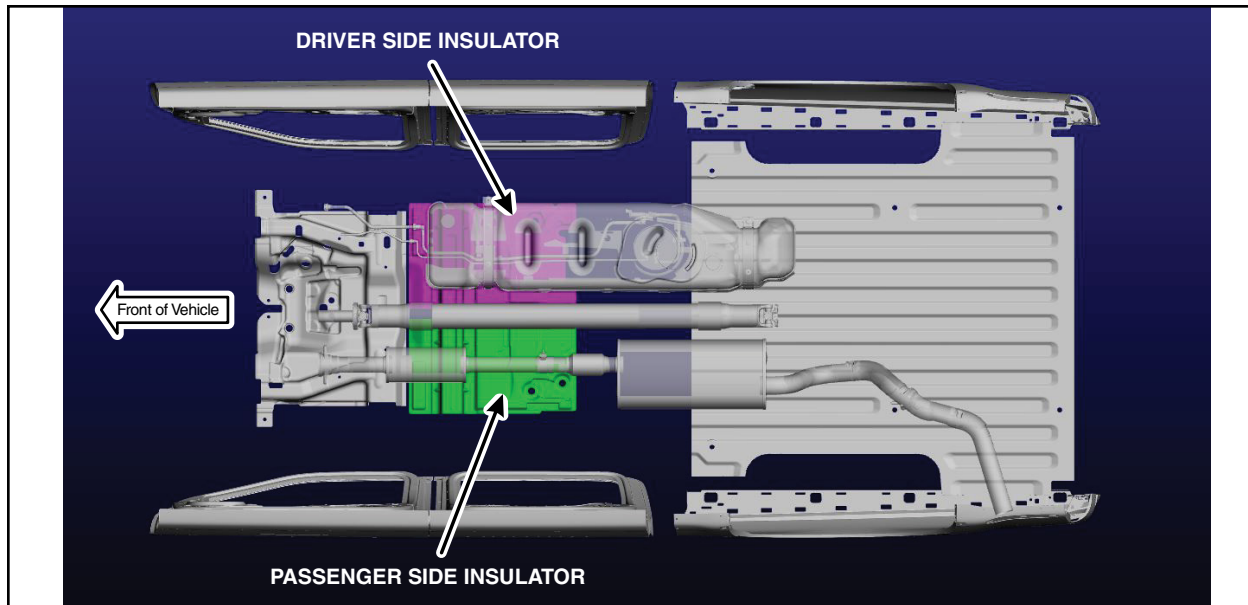
FIGURE 1

NOTE: The passenger side insulator is located directly above the exhaust.

Dearborn Truck Plant **Build Date** - Design change that removed underbody insulators from production
