**SUBJECT: NEW VEHICLE DEMONSTRATION / DELIVERY HOLD -  
 Safety Recall 21S56 – Supplement #5**

Certain 2021 - 2022 Model Year F-150 Vehicles Equipped with Crew Cab, 145" Wheelbase, 4x4, 302a & Above Option Package, and One-Piece Aluminum Driveshaft Loose/Sagging Underbody Insulators

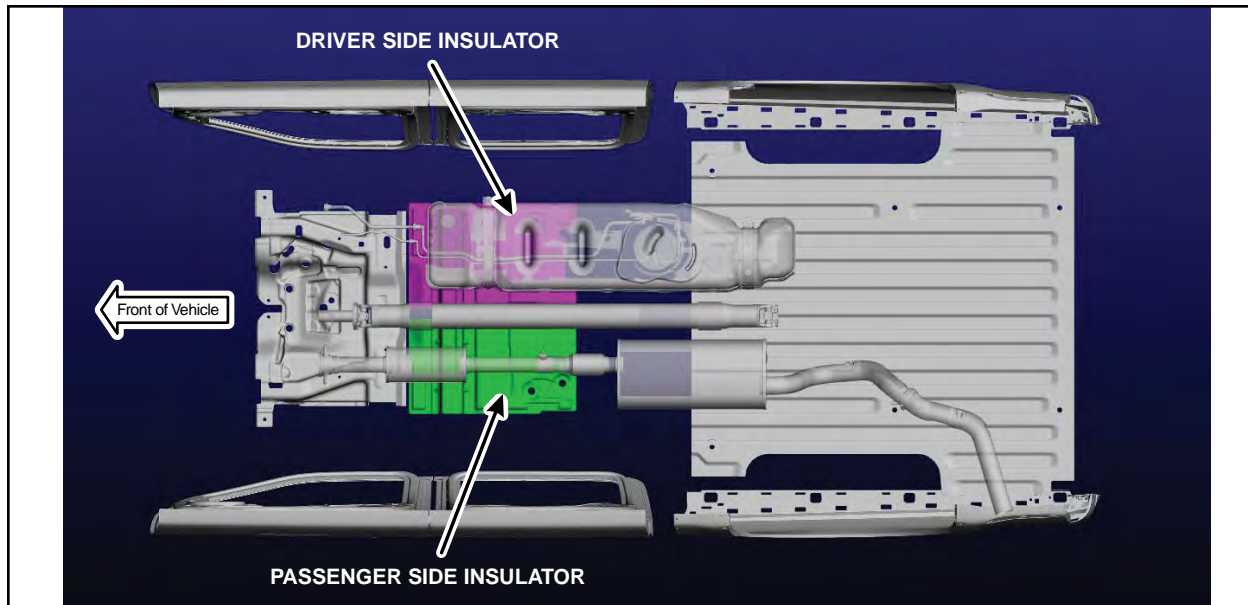
**FIGURE 1**

**NOTE:** The passenger side insulator is located directly above the exhaust.

Dearborn Truck Plant Build Date - Design change that removed underbody insulators from production

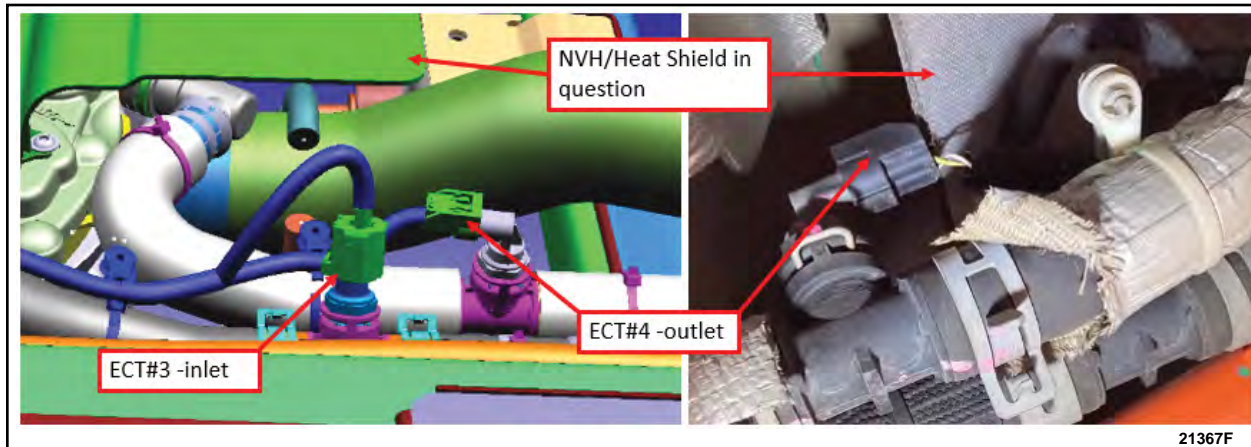
FIGURE 10

10. Inspect the front Engine Coolant Temperature (ECT) sensor connectors for any damage caused by the passenger side insulator. Is there any damage? See Figure 10.

Yes – Does not pass inspection. Contact the SSSC and provide a picture of the damage for proper technical instructions and part numbers, then proceed to step 11.

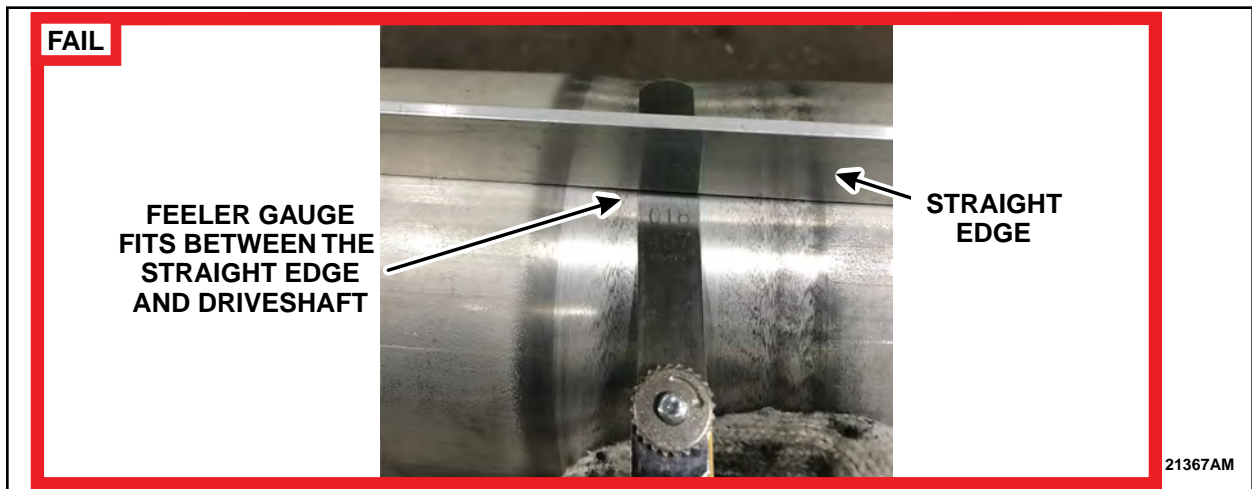
FIGURE 3

9. Place a straight edge along the driveshaft over the wear mark and attempt to fit a 0.018in (0.45mm) feeler gauge between the flat edge and the wear mark. Can the feeler gauge fit between the straight edge and anywhere along the wear mark? See Figures 3 and 4.

Yes – Does not pass inspection. Contact the SSSC and provide a picture of the driveshaft with the feeler gauge fitting between the straight edge and wear mark. Once approved, rear driveshaft replacement will be required, but do not install at this time. Proceed to step 12.
