IMPORTANT SAFETY RECALL NOTICE – SMART-STEER 2.0 Self-Steer Axle

Re: Safety Recall - Smart-Steer 2.0 Self-Steer Axle

SERVICE BULLETIN #009R

Subject: SMART-STEER 2.0 Bolt-On Steer Arm Reinforcement Welds

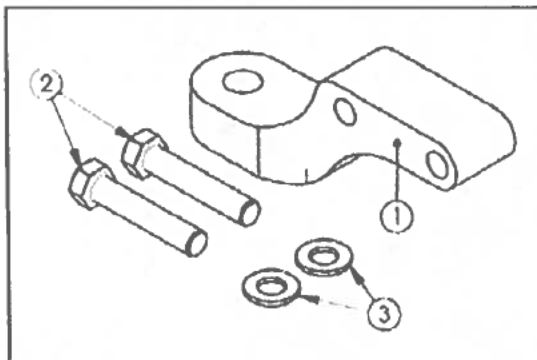
702732-01 BOLT-ON STEER ARM SERVICE KIT (-8-7/8") LH OR RH

Upon inspection; if the steer arm bolts or steer arm are worn or damaged, below is the replacement steer arm kit for these models.
