Technical Service Bulletin: TSB210113 Released Date: 27-Jul-2021

Fuel Rail Assembly Inspection and Repair Procedure: External Fuel Leaks

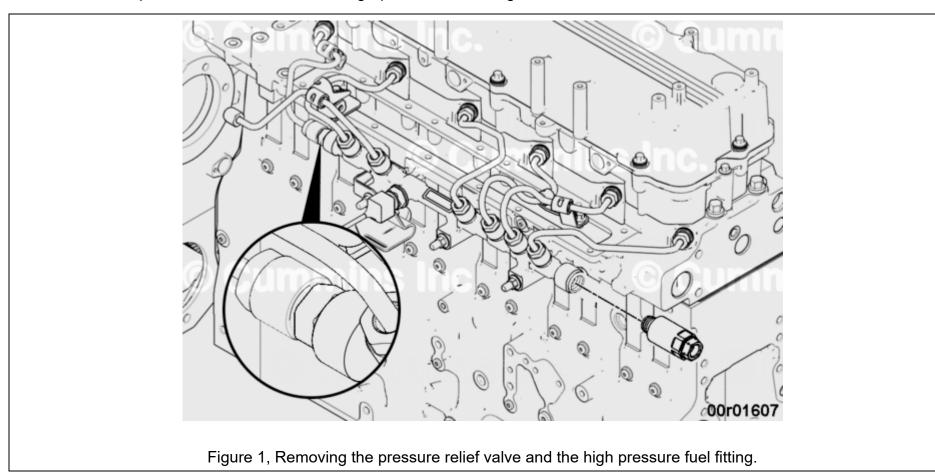
• Remove the pressure relief valve and the high-pressure fuel fitting from the fuel rail.

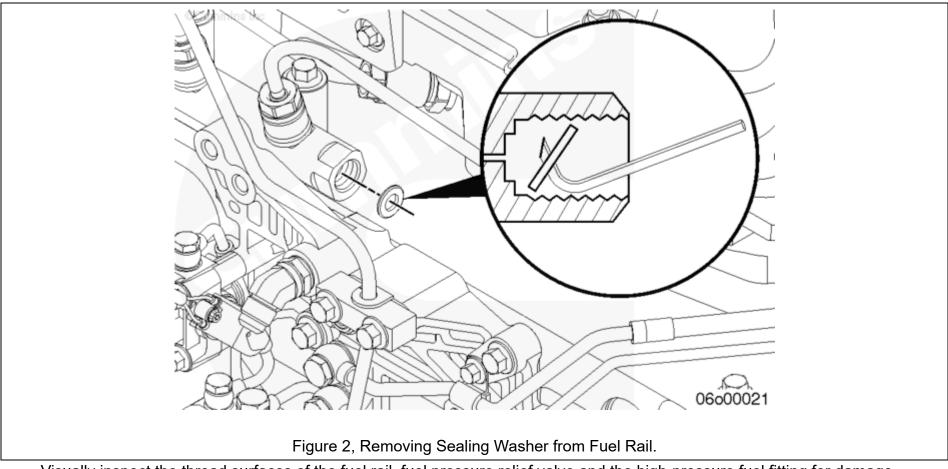
- A special tool **must** be created for the removal of the sealing washers by grinding a 45 degree angle on the short leg of a 1/8-inch or 3/16-inch Allen wrench, so that the wrench is no longer than 13 mm [½ in] long (measured from the outside of the long leg.)
- This tool acts as a mini heel bar to pry out the sealing washer without damaging the back of the hole.
- Use the modified Allen wrench to pry out the old sealing washer from the threaded hole in the fuel rail. Considerable force is required to remove the sealing washer.

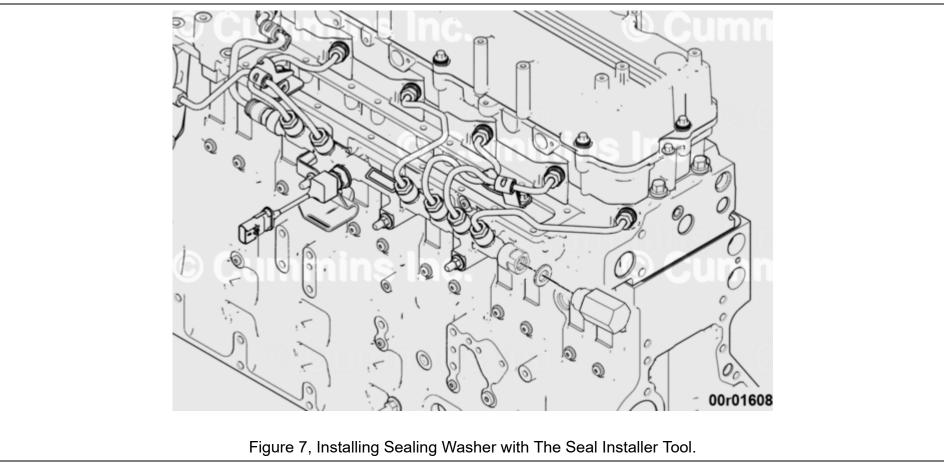
- 2. Install a new sealing washer on the pressure relief valve bore in the fuel rail. Use assembly lubricant, Part Number 3163087, or equivalent, on the threads and the face of the seal installer tool. Use seal installer tool, Part Number 5573487, to seat the sealing washer fully in the fuel rail bore.
- 3. Torque the seal installer tool.

Torque Value: 81 n·m [60 ft-lb]
