Technical Service Bulletin: TSB210146
 Released Date: 13-Sep-2021

Safety Campaign #4495 RBAB Lift Cable Crimp Issue

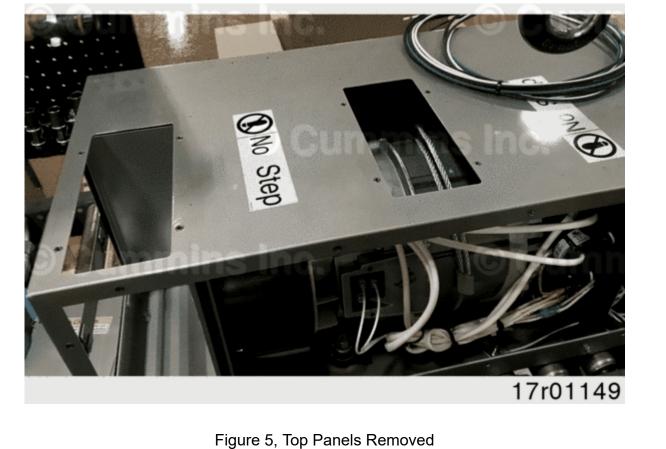
If the unit has one of the serial numbers listed below, the unit needs to be inspected for uncrimped cable ferrules. If the cable ferrules do not have a marking on them to show it has been crimped, (see arrows in Figure 1 below) the cable needs to be replaced.

Note: If cable has no crimp marking, continue to follow the steps below and replace the cable. If cable is marked (and properly crimped), no repair is required. Replace enclosure panel.
