**Safety Recall 4621B – 2020-2021 CX-30 Power Liftgate May Partially Lower Unexpectedly**

**REPAIR PROCEDURE**  
**Recall Campaign 4621B**

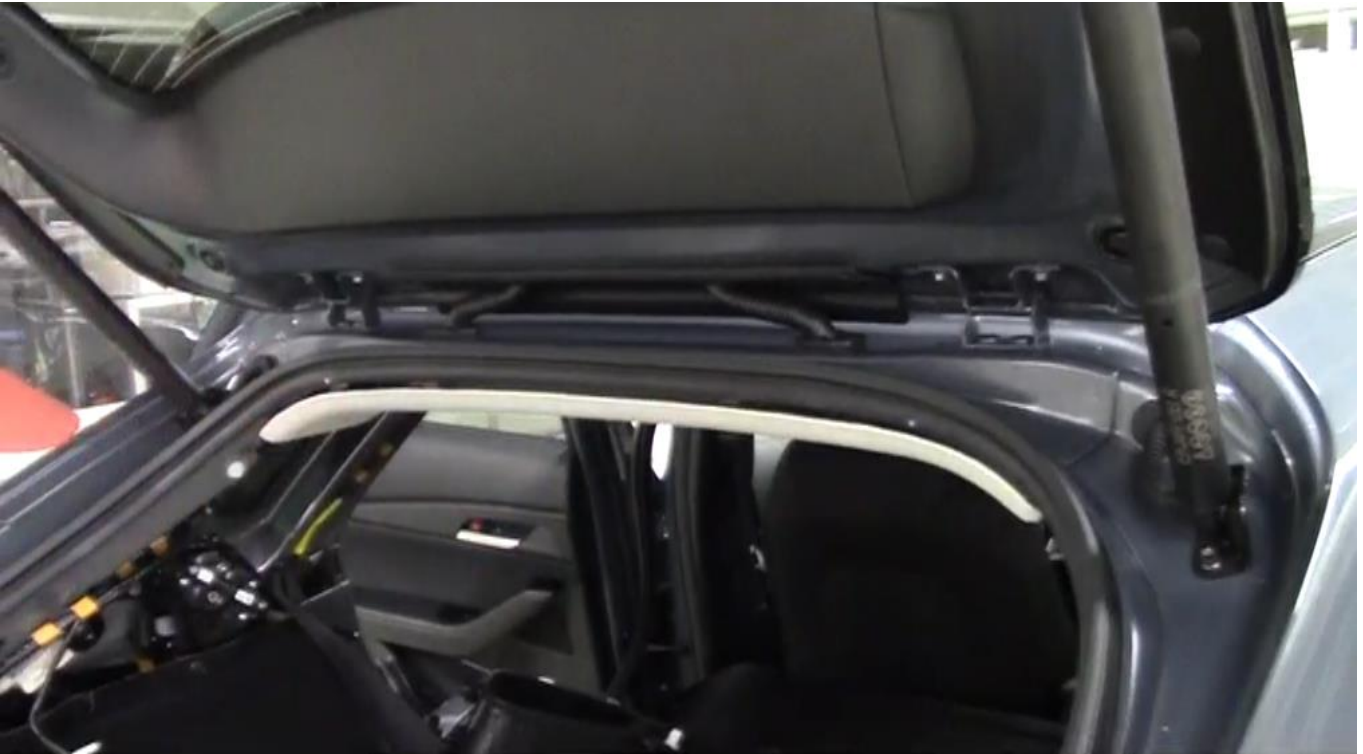
Detached top ceiling at its rear end

**Caution: The headliner must not be lowered more than 5.0 cm or 1.97 inches between the headliner and weatherstrip seam for this next step!** If you exceed 5.0 cm or 1.97 inch, the headliner will deform, break, or wrinkle. Damage to the headliner is not covered under this recall or warranty.
