**UPDATED June 7, 2024 – Using M-MDS to reprogram vehicle and added labor ops**

## Safety Recall 4621B – PLG Reprogramming and replacement

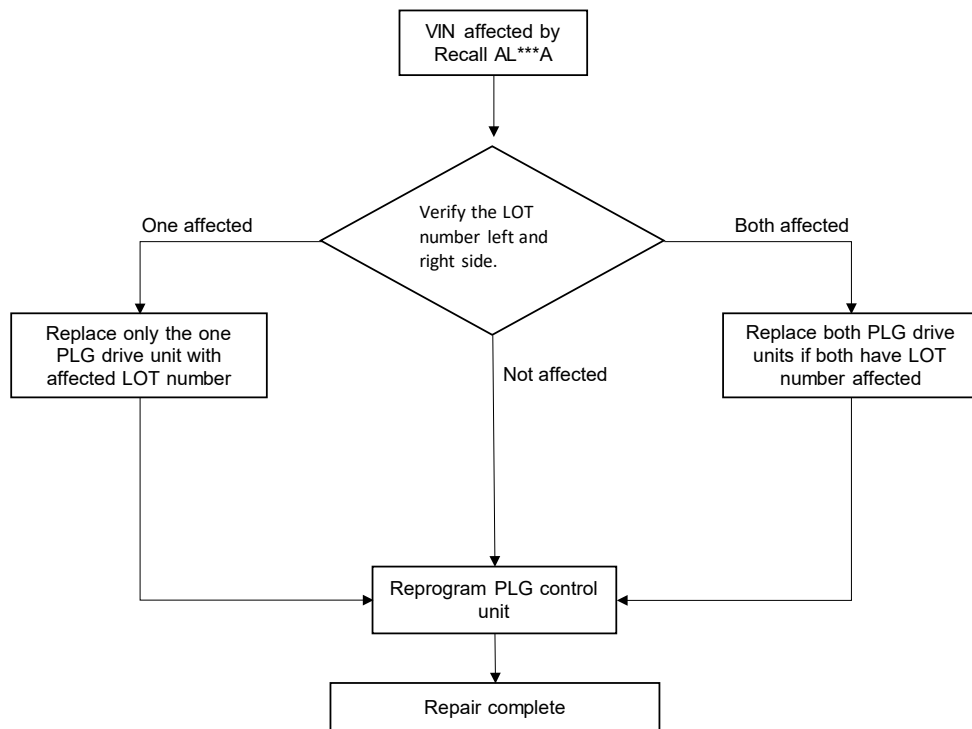
## A. Flowchart

Follow the procedure to reprogram the module first before replacing any affected liftgate

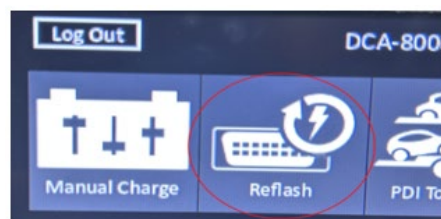
During reprogramming, connect battery charger to the vehicle to stabilize voltage fluctuation. If missing, it may cause damage to ECUs due to decreasing voltage.

7<sup>th</sup> generation vehicle will control to turn on headlight forcibly during reprogramming due to change CAN communication. **Please use the "Reflash" setting in the charger, which will keep the voltage stable. The setting voltage must be between 12 -13V.**
