Campaign code:
L734-R.01.21

Campaign Name:
Replacement of engine hood hinge screws

Model:
Aventador SVJ Coupé

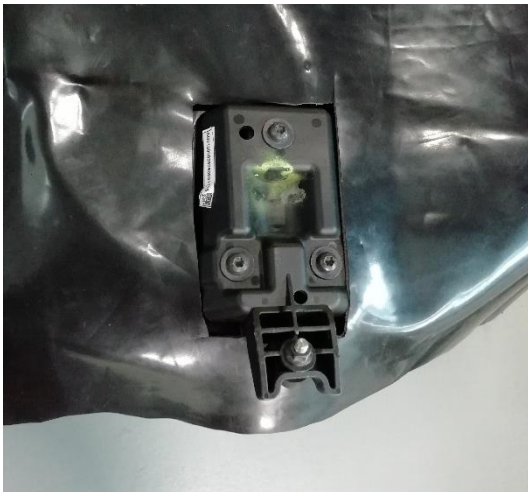
Danger of damaging the hood and composite material.

Place the hood on an adequate work surface and protect the work area.

Always follow the removal and tightening sequence indicated below.

5. Perform the same procedure (from point 1 to point 4) for screws number 2 and number 3, remembering to replace them one at a time and paying attention to not exceed the tightening torque.
