GROUP	MODEL
Safety Recall Campaign	2020-2021MY Soul (SK3) and 2021MY Seltos (SP2) w/2.0L Nu MPI engine
NUMBER	DATE
SC209	June 2021

ENGINE VIBRATION INSPECTION AND REPLACEMENT (SC209)

This bulletin provides information to perform an engine vibration inspection and, if necessary, replace the engine long block on some 2020-2021MY Soul (SK3) produced from November 24, 2018 through October 24, 2020 and some 2021MY Seltos (SP2) produced from November 20, 2019 through October 15, 2020 vehicles equipped with 2.0L Nu MPI (Atkinson) Engine. The piston oil rings in the affected vehicles may have been improperly heat-treated during production, resulting in excessive oil ring hardness. Excessive oil ring hardness can lead to chipping of the piston oil ring's outer periphery and scuffing of the engine cylinder bore. A scuffed cylinder bore can lead to increased oil consumption which will eventually result in abnormal noise from the engine and/or illumination of the oil pressure warning lamp. If the vehicle is continually operated in this condition, connecting rod bearing seizure can occur. A seized connecting rod bearing can result in engine damage, thereby increasing the risk of an engine sta

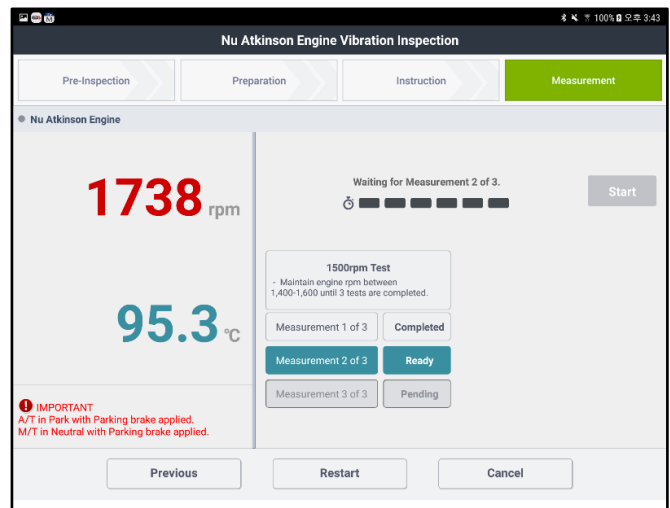
The successful measurements will display "Completed" on the screen.

PASS: If the measured engine vibration test has a normal condition, capture the screen image/screenshot for record keeping and attach to the warranty claim using Attachment Type - 'XX': Other. Select 'Finish'.

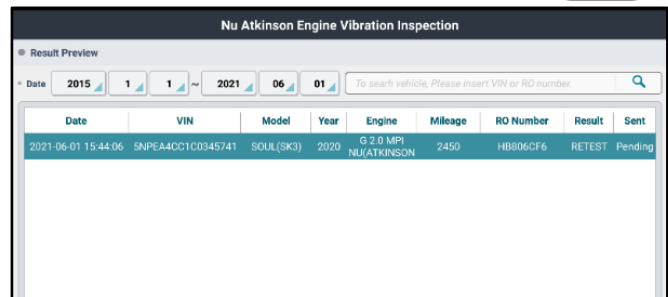
10b. **NO PASS:** If the measured engine vibration test is abnormal capture the screen image/screenshot for record keeping and attach to the warranty claim using Attachment Type - 'XX': Other. → **Open a Techline case online for further instructions.**

Select 'Finish' and replace the engine long block by referring to the "Engine Mechanical System → Engine And Transaxle Assembly → Repair procedures" chapter in the applicable Shop Manual on KGIS. Refer to page 7 information.
