L62X-R.02.21

Rear View Camera not available - Kombi update

Model:Huracán 4WD, Huracán 2WD, Huracán Performante,
Huracán EVO**Model year:**

As a result of continuous product monitoring, Automobili Lamborghini S.p.A. has determined that some vehicles were manufactured with a software bug within the infotainment system which when subjected to temperatures below 41 degrees Fahrenheit and after a long sleep may some-times generate a fault that renders the rear view (back-up) camera inoperable until the next power latch.

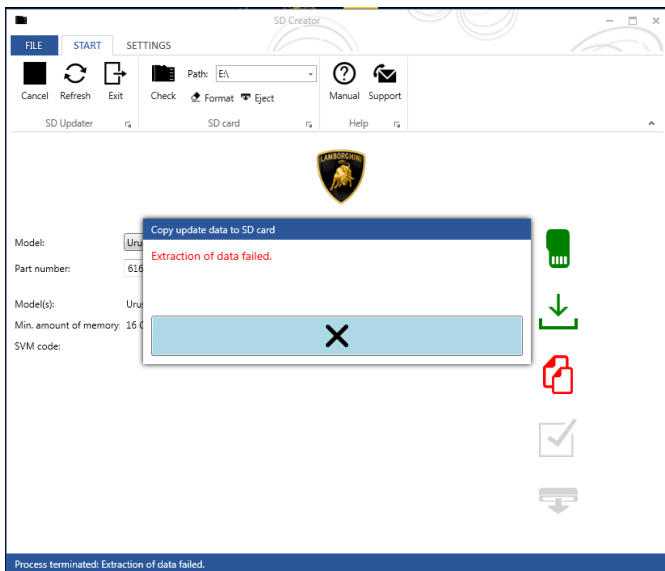
If the error shown in the following image occurs in the download from SD Creator, perform the instructions at the end of this document, in Trouble shooting section.

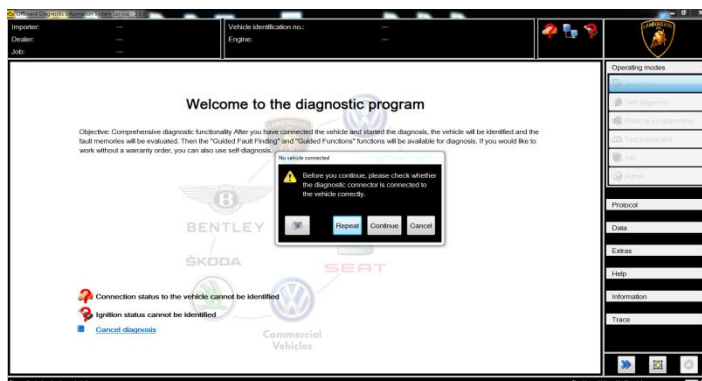
- If an error is displayed that regards the hardware interface, and the "connection to vehicle" and "key state" icons appear as shown in the figure below:

- Click "Cancel";
- Repeat installation of the interface VAS5054/6154/6154A for the instructions in procedure (*) "VCI Manager v2.0", selecting the right-hand "Extras" menu in ODIS and clicking on the "Diagnostic interface" button.

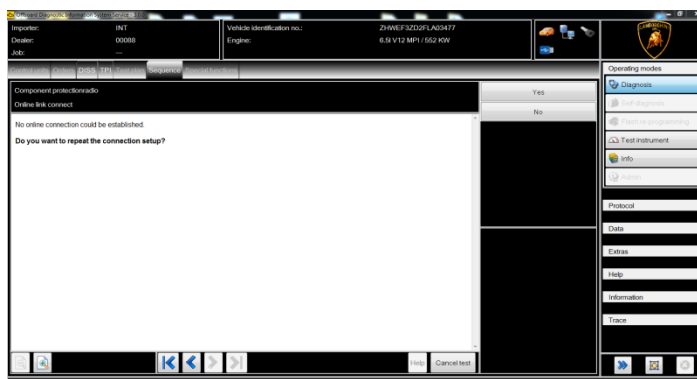
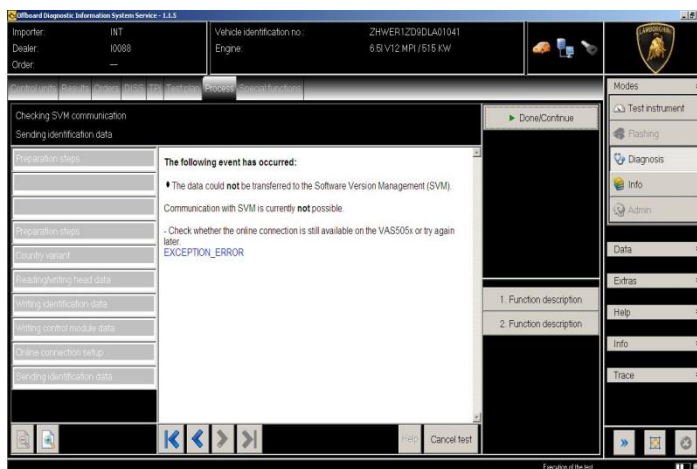
- If one of the following connection errors is displayed like in the following example screenshots:

- It is not possible to connect to the central server; check that your laptop is correctly connected to the Internet and retry by clicking on "Yes" or "Done/continue", as appropriate.

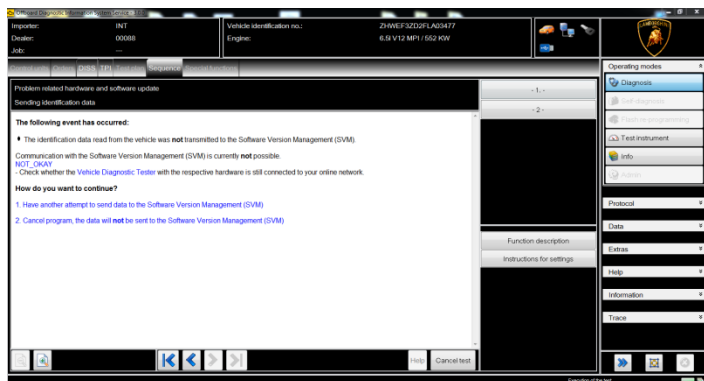
iv. If the connection is dropped during the course of the target/actual comparison during the SVM procedure:

- It is not possible to connect to the central server; check that your laptop is correctly connected to the Internet and retry by clicking on "1".

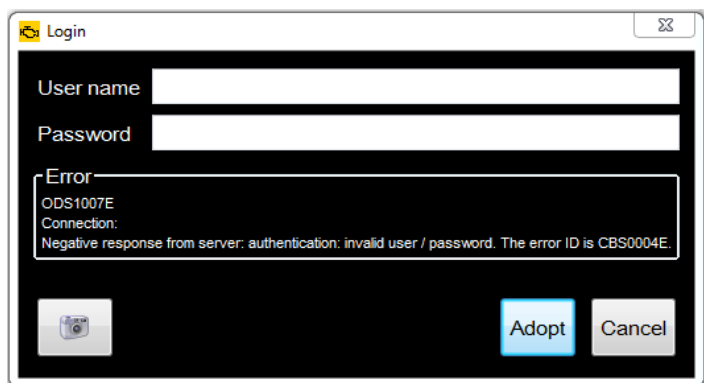
v. If the authentication error as shown in the following screenshot is displayed (error code: ODS1007E):

- Ensure you have a valid GeKo user account
- Ensure that the "GeKo" label is printed on the token you are using
- Ensure you have entered the correct password
- Click on "Cancel" and run the application test (see document "ODIS_ControlloCon-nessione_Server_SVM_2.0" (*)).

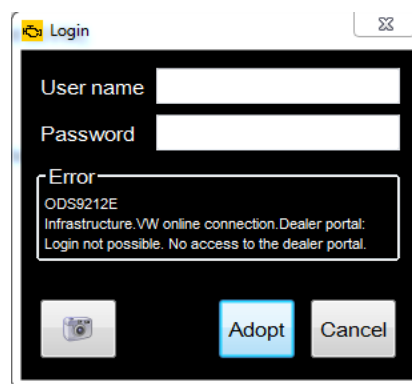
vi. If the infrastructure error as shown in the following screenshot is displayed (error code: ODS9212E):

- Ensure you have a valid GeKo user account
- Ensure that the "GeKo" label is printed on the token you are using
- Check that the Internet is set in ODIS settings and not CPN (see document "Setup_Iniziale_ODIS_7.0" (*))
- Click on "Cancel" and run the application test (see document "ODIS_ControlloCon-nessione_Server_SVM_7.0" (*)).

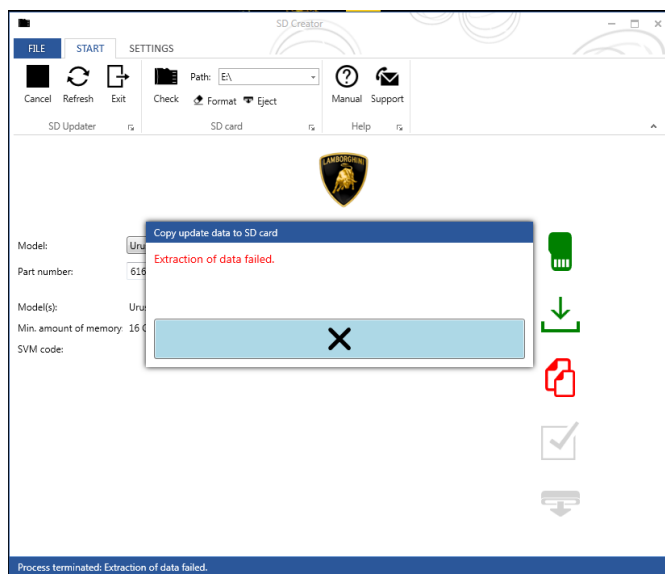
- viii. If the following error should occur, it is necessary to follow the instructions given in **BI.25.18** (Rev.02), which can be downloaded on the Lamborghini HUB portal:
