TI No.: 75.00U21166A

Model: S 417 TC, S 407 CC

TITLE: **S 417 TC, S 407 CC - Fitting arrester cables to the engine compartment flap**

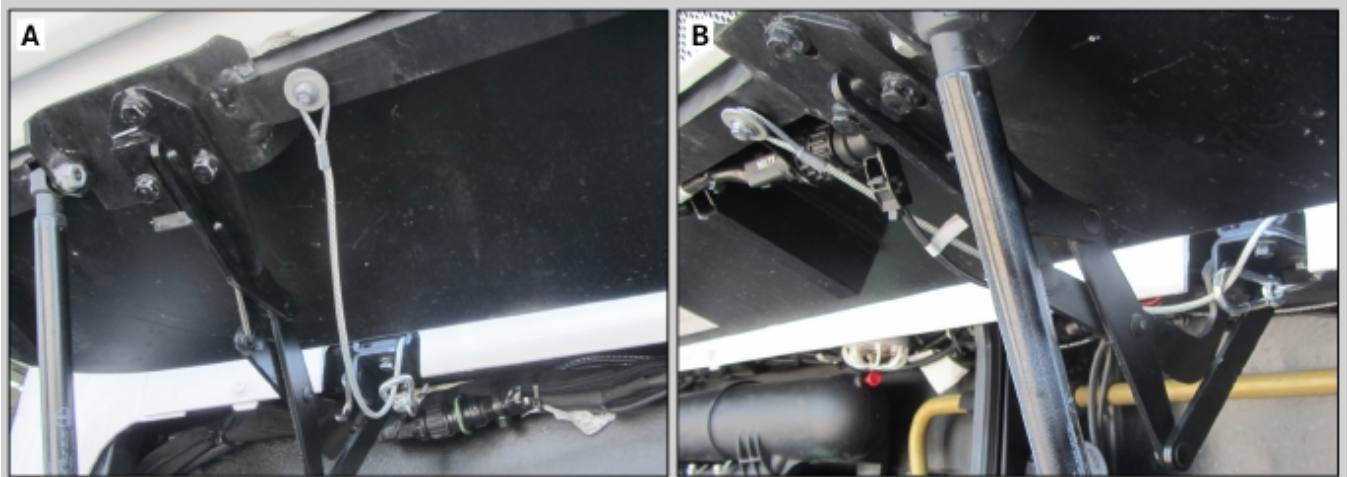
- 18.

Overview of left 'A' and right 'B' side after installation

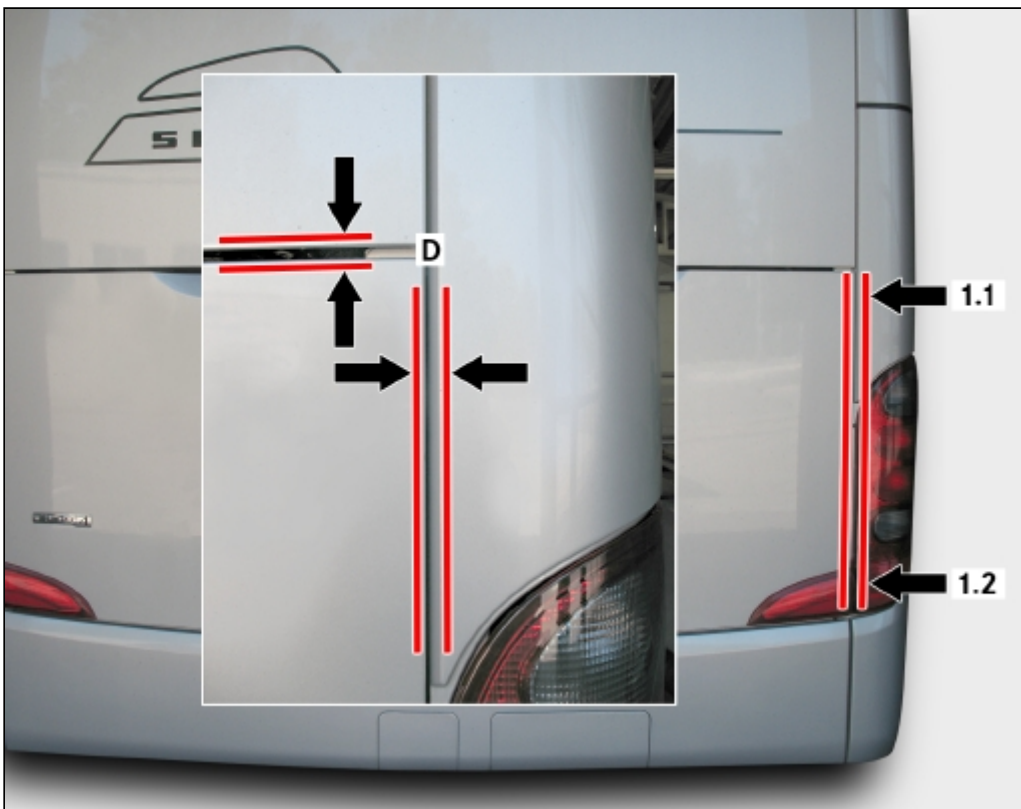
M88.50-0001-81

Reference values

Engine compartment flap gap dimension (D)

6 ... 10 mm

Reference values	
Uniform gap line from (1.1) to (1.2), permissible deviation	1.5

Adjust all gaps around the engine compartment flap in such a way that their dimensions are as equal as possible. The maximum relative deviation is 1.5 mm.
