# SAFETY RECALL BULLETIN

SUBJECT:			No: <b>SR-21-007REV2</b>
<b>SEAT BELT AUTOMATIC LOCKING RETRACTOR (ALR) – SAFETY RECALL CAMPAIGN - REVISION</b>			DATE: <b>November 2021</b>
			MODEL: <b>2022 Outlander</b>
<b>CIRCULATE TO:</b>	<input checked="" type="checkbox"/> GENERAL MANAGER	<input checked="" type="checkbox"/> PARTS MANAGER	<input checked="" type="checkbox"/> TECHNICIAN
<input checked="" type="checkbox"/> SERVICE ADVISOR	<input checked="" type="checkbox"/> SERVICE MANAGER	<input checked="" type="checkbox"/> WARRANTY PROCESSOR	<input checked="" type="checkbox"/> SALES MANAGER

This Safety Recall bulletin supersedes SR-21-007REV issued September 2021, to update the Repair Procedure section.

Certain 2022 Outlander vehicles

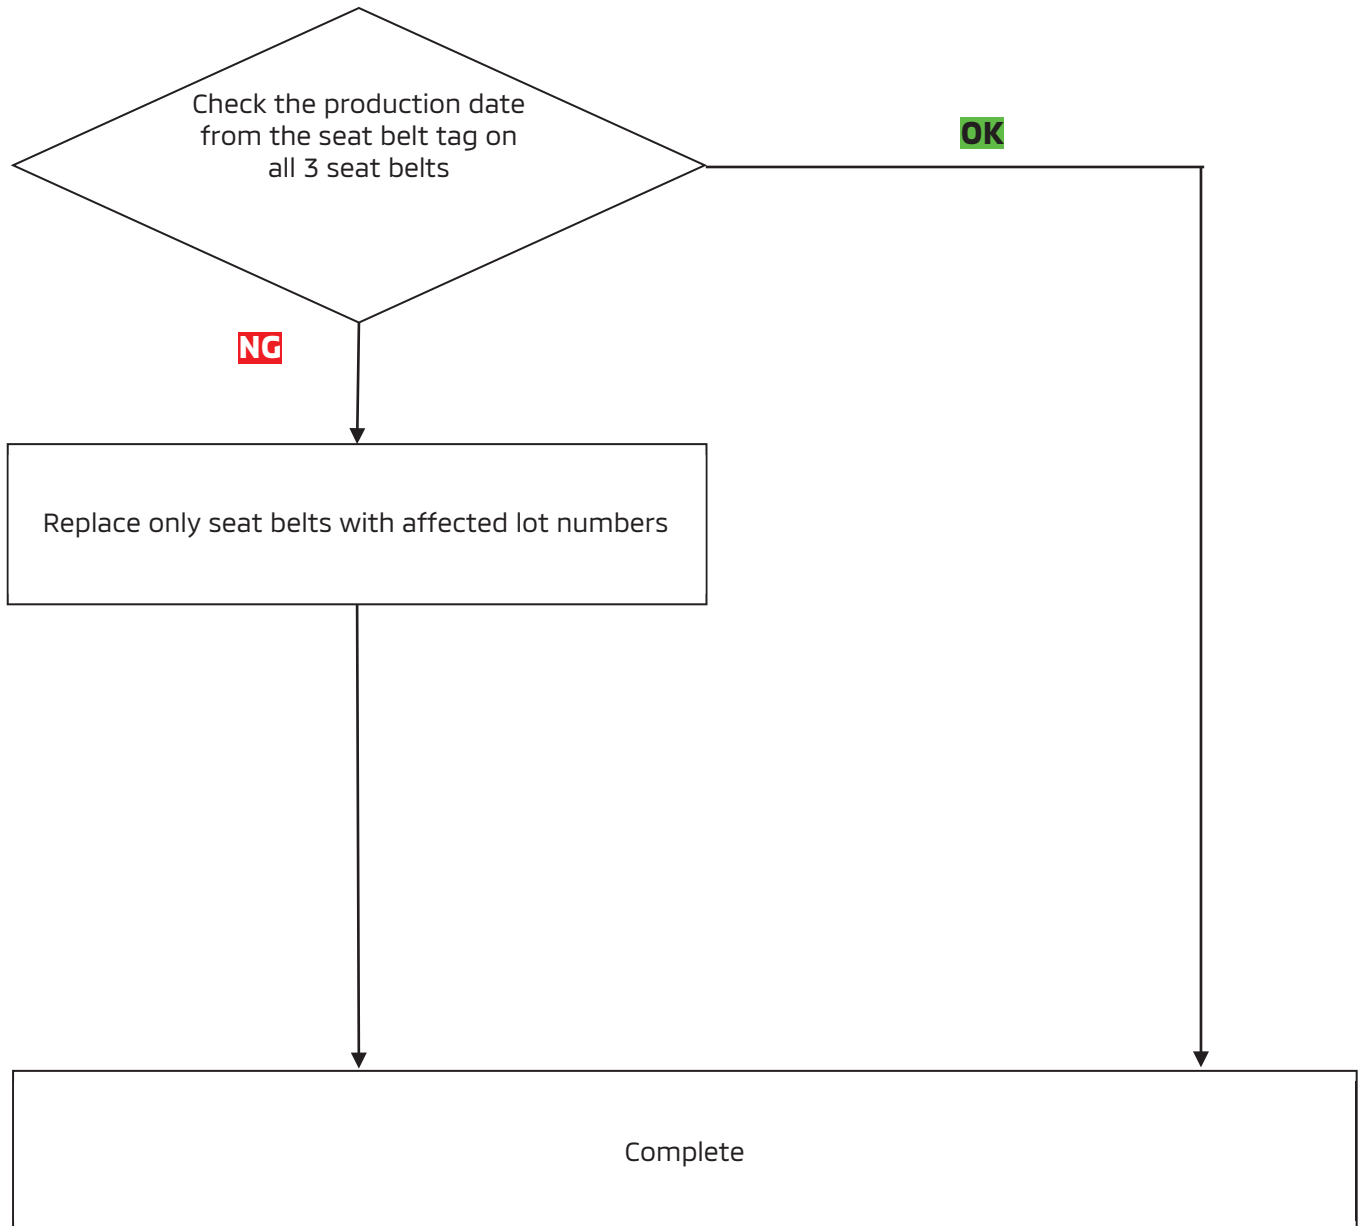
## WORK FLOW

**NG** = NG = The lot "ID.NO." is contained in the affected numbers indicated below  
**OK** = OK = The lot "ID.NO." is **NOT** contained in the affected numbers indicated below  
(See Page 4 of this bulletin for affected lot "ID.NO." numbers)

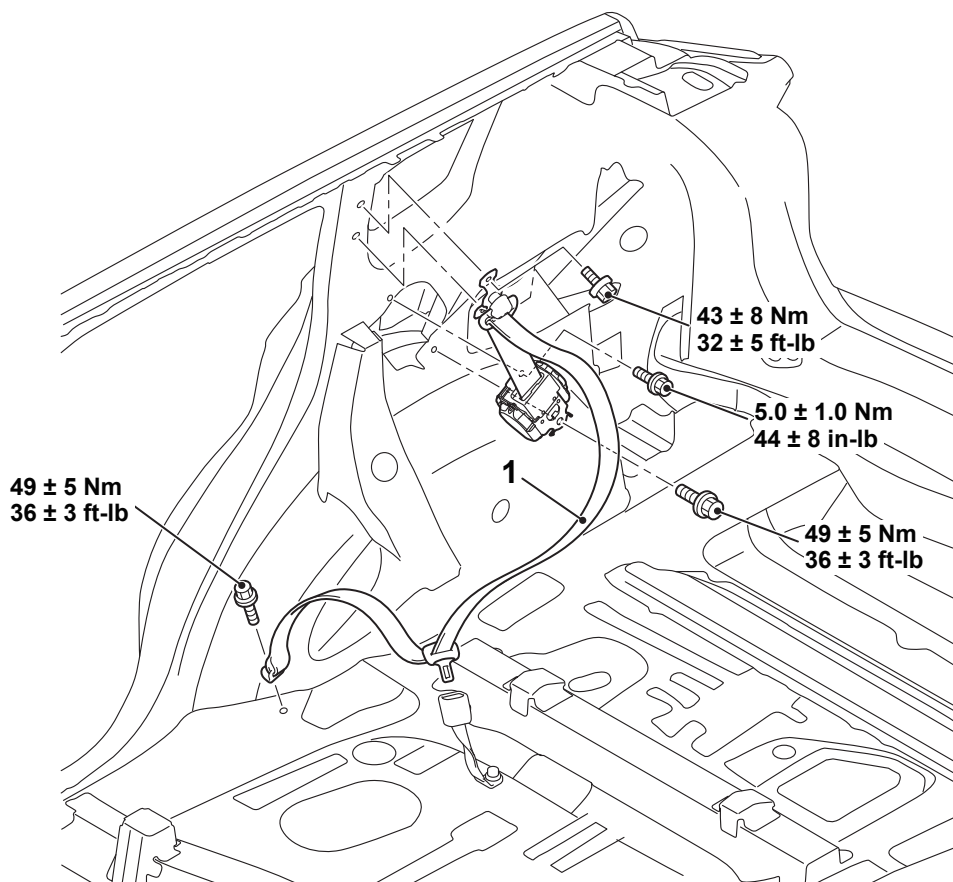
### <SECOND SEAT BELTS>

**USE EXTREME CARE TO AVOID DAMAGE** when releasing the black locking button. **DO NOT ATTEMPT TO REMOVE COMPLETELY!** The locking button is only designed to be raised approximately 1mm which permits removal of the connector.

#### Rear seat belt pre-tensioner removal steps
