# SAFETY RECALL BULLETIN

| SUBJECT: | | | No: <b>SR-21-007REV3</b> |
| <b>SEAT BELT AUTOMATIC LOCKING RETRACTOR (ALR) – SAFETY RECALL CAMPAIGN - REVISION</b> | | | DATE: <b>January 2022</b> |
| | | | MODEL: <b>2022 Outlander</b> |

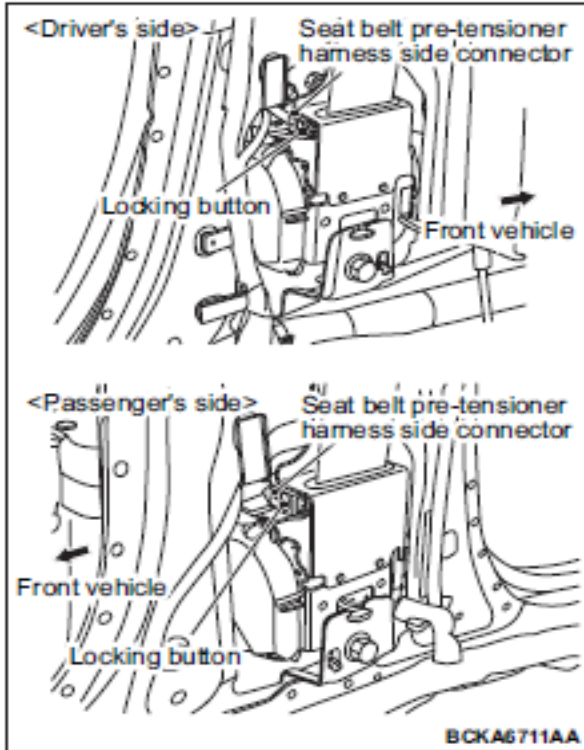
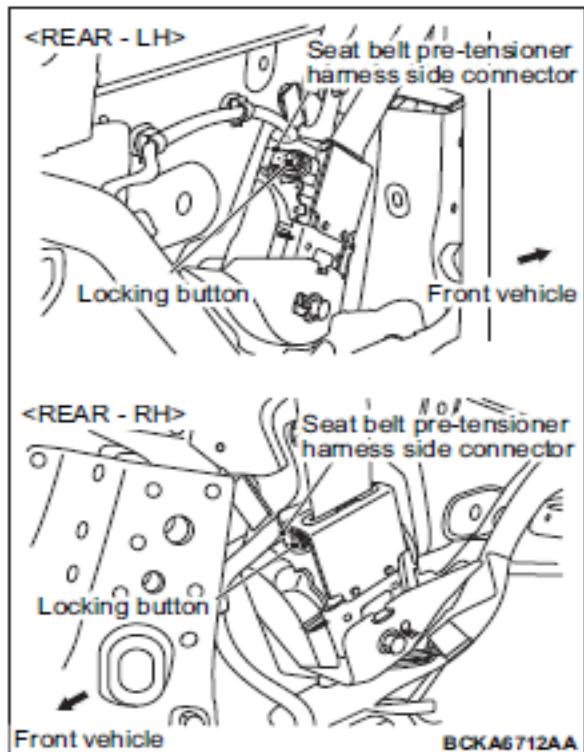
**<<A>> SEAT BELT PRE-TENSIONER REMOVAL**

Failure to follow proper procedure and applying unnecessary force will damage the connectors. The connectors are not available as a service part and replacement of the entire floor harness will be required. Please use the instructions below for proper removal and installation of the pretensioner connector.

**USE EXTREME CARE TO AVOID DAMAGE** when releasing the black locking button. **DO NOT ATTEMPT TO REMOVE COMPLETELY!** The locking button is only designed to be raised approximately 1mm which permits removal of the connector.

1. Removal process to avoid damage.
